1234 Main Street
Anytown OH 00000

10/23/2017

Kreps Home Inspection dba HouseMaster

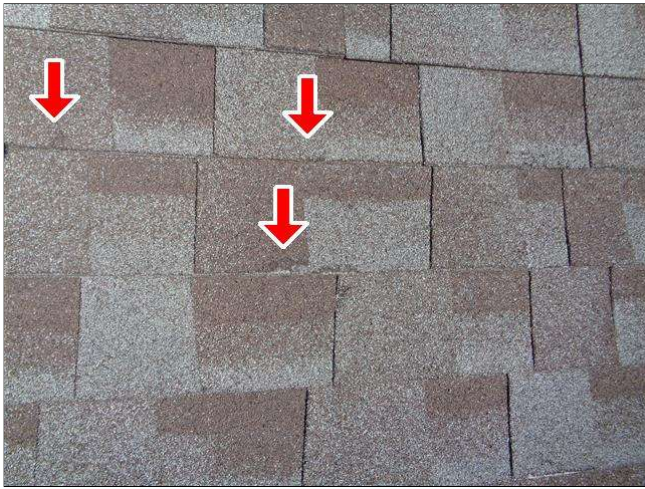
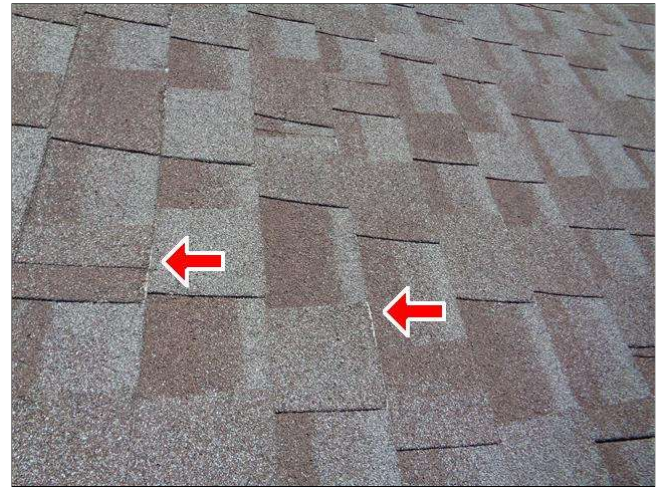
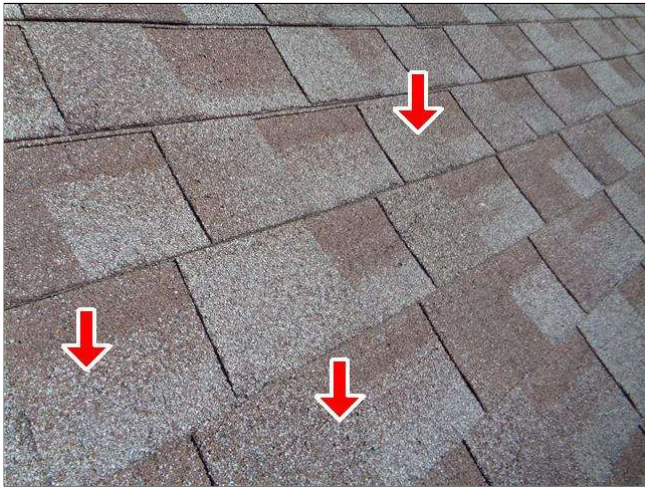
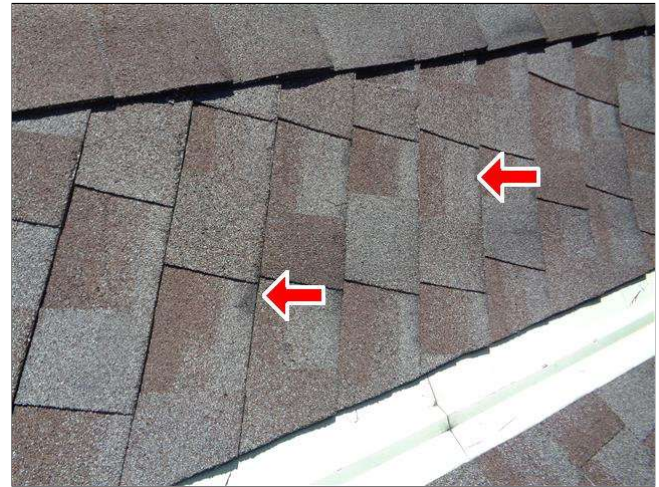
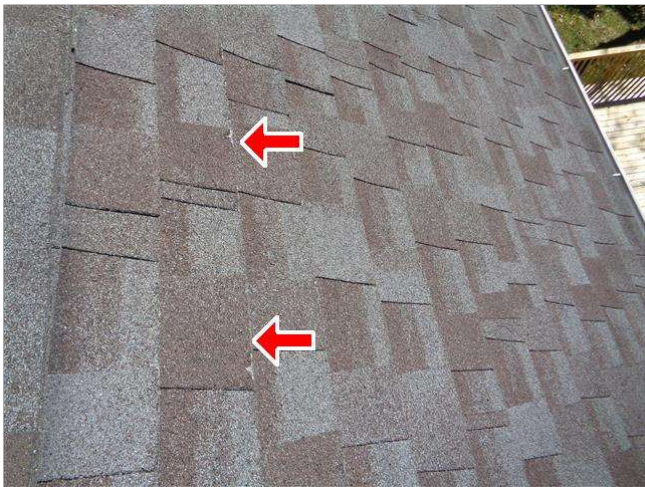
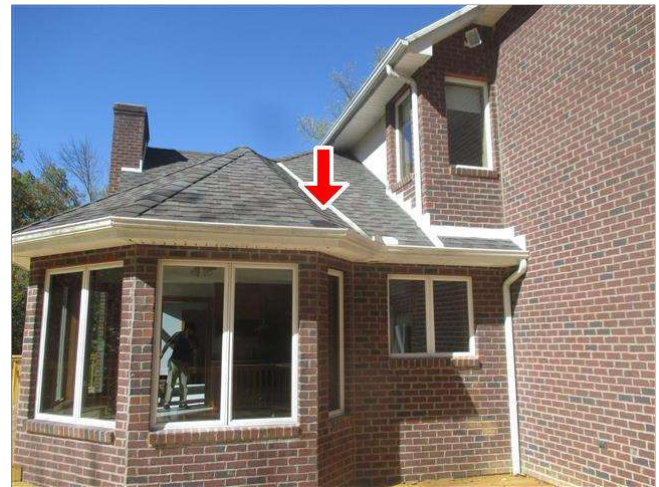
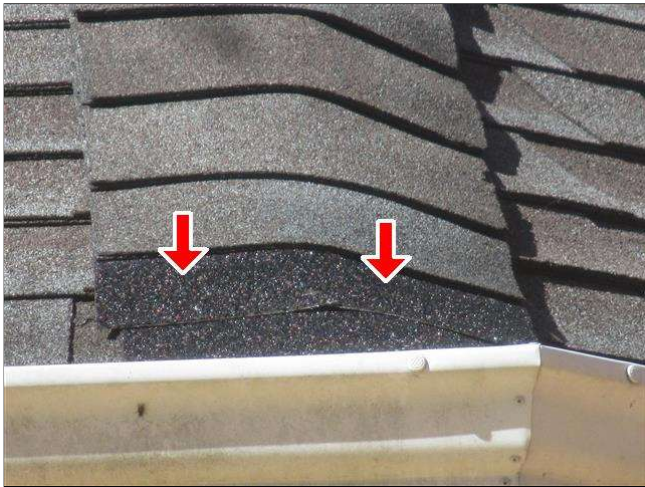
●	●					<p>1.0 ROOFING #1</p> <p>Front slope of roof rated Satisfactory.</p> <p>Rear slope has indications of shingle deterioration in the form of granule loss and fiberglass strands present Item 1(Picture) Item 2(Picture) Item 3(Picture) Item 4(Picture) Item 5(Picture). Missing shingle tabs also observed above rear dinette area Item 6(Picture) Item 7(Picture). These areas of roofing rated Fair and advise evaluation by a roofing professional to determine best option of repair or replacement and make any necessary corrections.</p>
●	●					<p>1.1 CHIMNEYS / VENTS #1</p> <p>Most exterior brick chimney rated Satisfactory with exception of crack in mortar cap Item 1(Picture) that continues down front of chimney Item 2(Picture) and absence of rain guard Item 3(Picture). These areas of exterior brick chimney rated Poor and advise repair and installation of rain guard by the appropriate professional.</p>

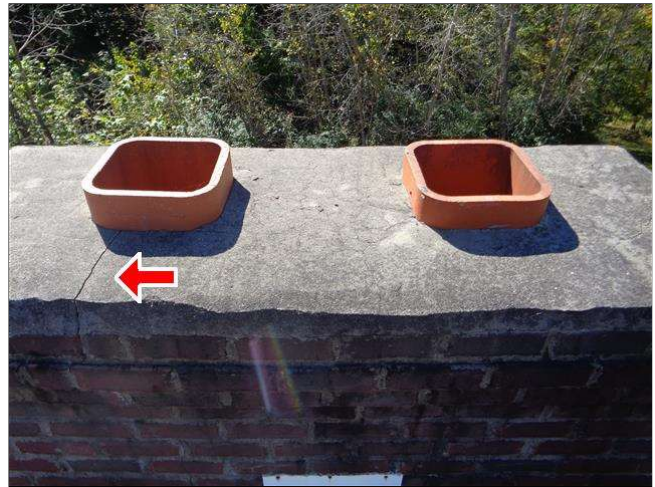
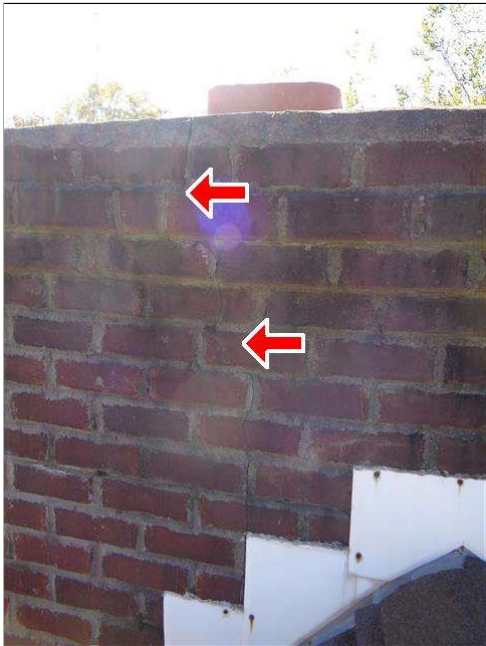
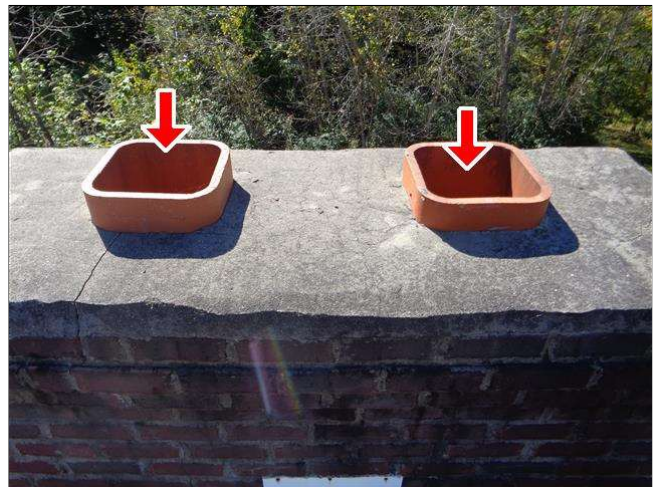
Most exterior brick chimney rated Satisfactory with exception of crack in mortar cap Item 1(Picture) that continues down front of chimney Item 2(Picture) and absence of rain guard Item 3(Picture). These areas of exterior brick chimney rated Poor and advise repair and installation of rain guard by the appropriate professional.

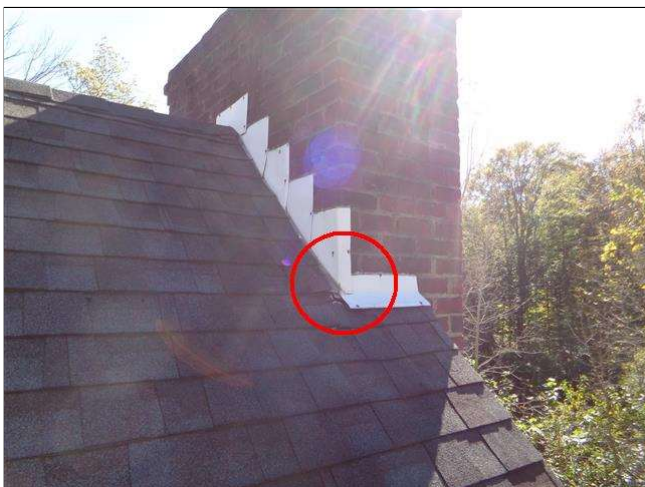
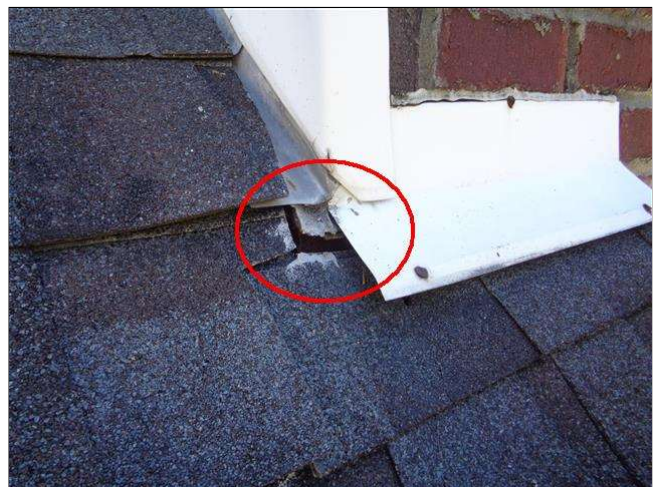
●	●					<p>1.2 EXPOSED FLASHING</p> <p>Most exposed flashing Satisfactory with exception of separation observed at right side base of chimney Item 1(Picture) Item 2(Picture) . No indication of water penetration was observed but this area of flashing rated Poor and advise correction by the appropriate professional to eliminate possible water penetration in the future.</p>
●						<p>1.3 VENTILATION COVERS</p> <p>Ridge Venting</p>
●	●					<p>1.4 PLUMBING STACKS</p> <p>Rear slope center plumbing stack rated Satisfactory.</p> <p>Rubber boot at base of rear slope right side plumbing stack is beginning to crack and split Item 1(Picture) . This area rated Fair and advise repair or replacement of boots to prevent possible water penetration in future.</p>
		●				<p>1.5 RAIN GUTTERS / EAVESTROUGHS</p> <p>Gutters and downspouts filled with debris from surrounding trees Item 1(Picture) Item 2(Picture) Item 3(Picture) Item 4(Picture) Item 5(Picture) . Advise cleaning out and installing debris guard in the future to allow proper drainage.</p>

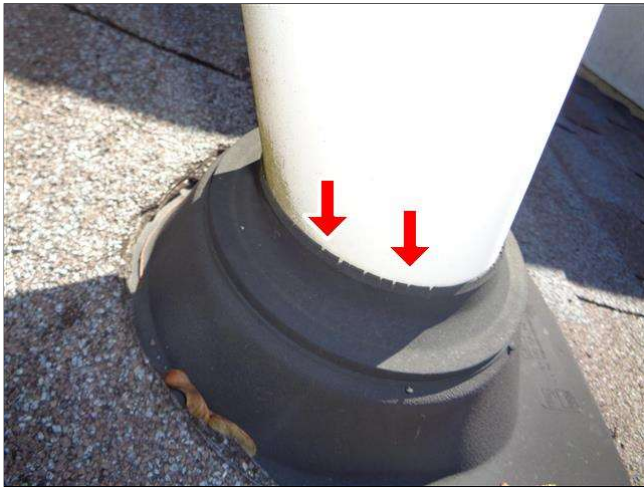
1.4 PLUMBING STACKS Picture 1

Rubber boot at base of rear slope right side plumbing stack is beginning to crack and split Item 1(Picture) . This area rated Fair and advise repair or replacement of boots to prevent possible water penetration in future.

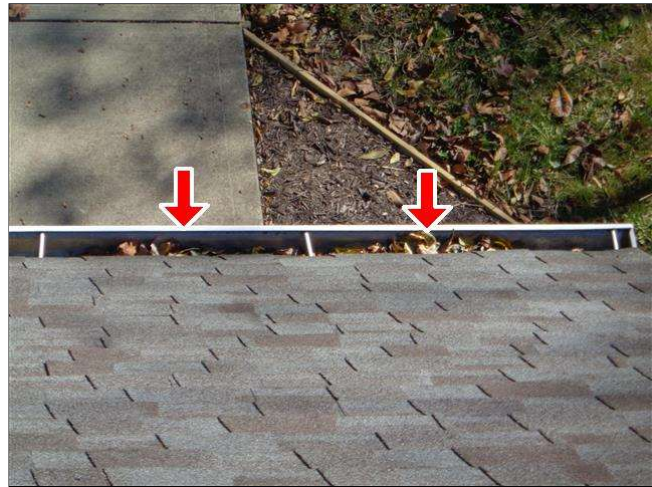
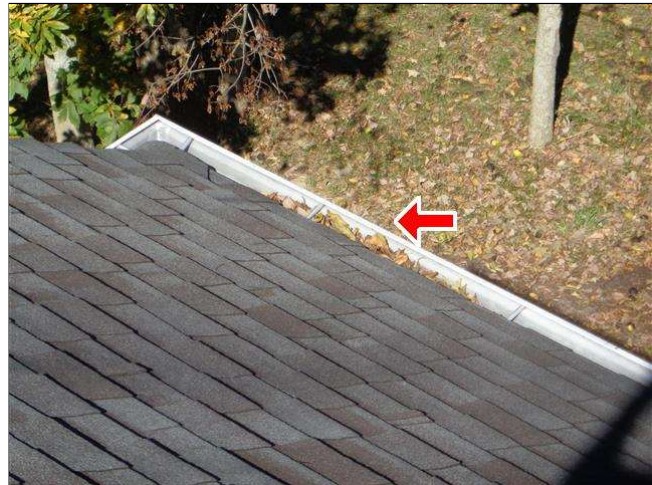
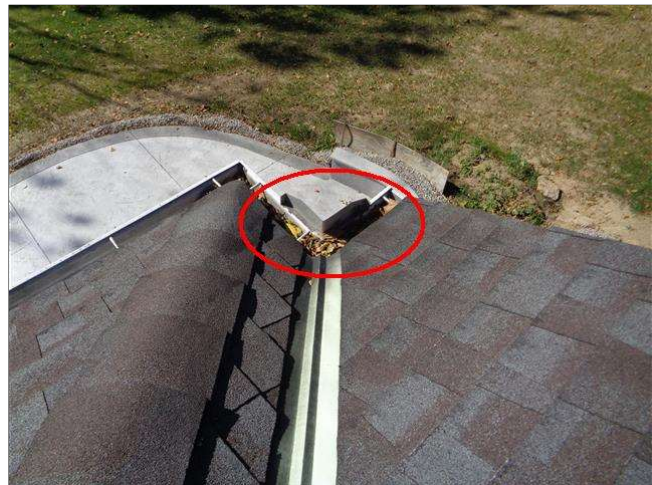
Gutters and downspouts filled with debris from surrounding trees Item 1(Picture) Item 2(Picture) Item 3(Picture) Item 4(Picture) Item 5(Picture) . Advise cleaning out and installing debris guard in the future to allow proper drainage.

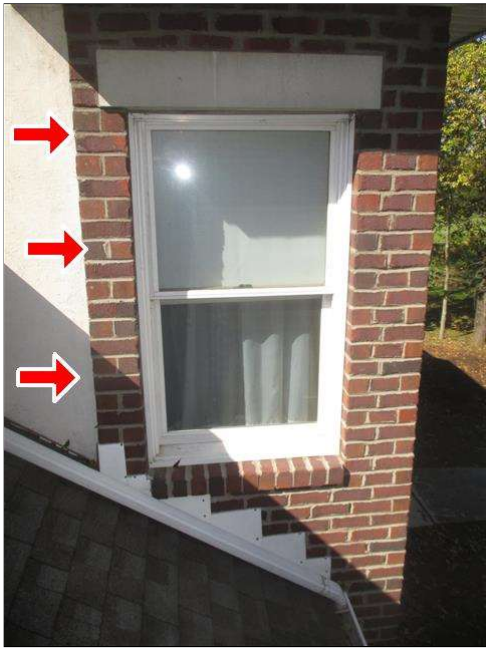
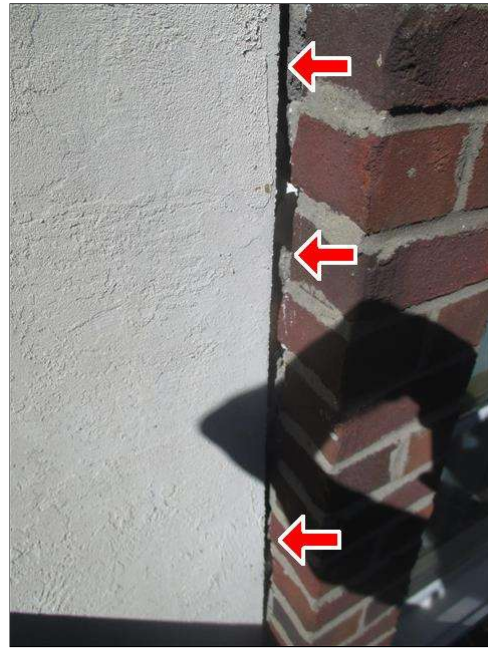
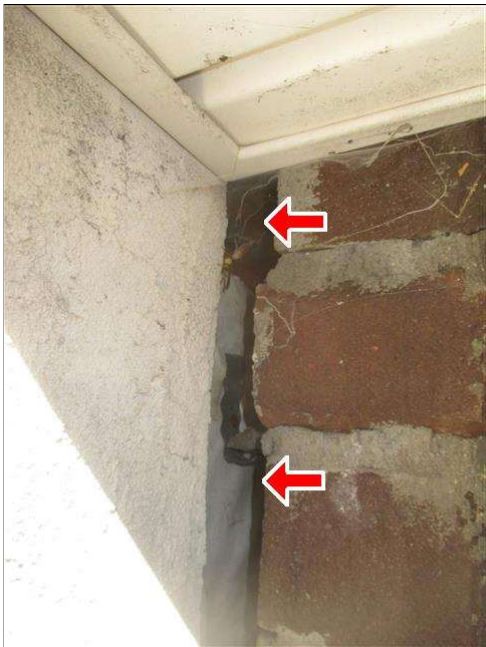
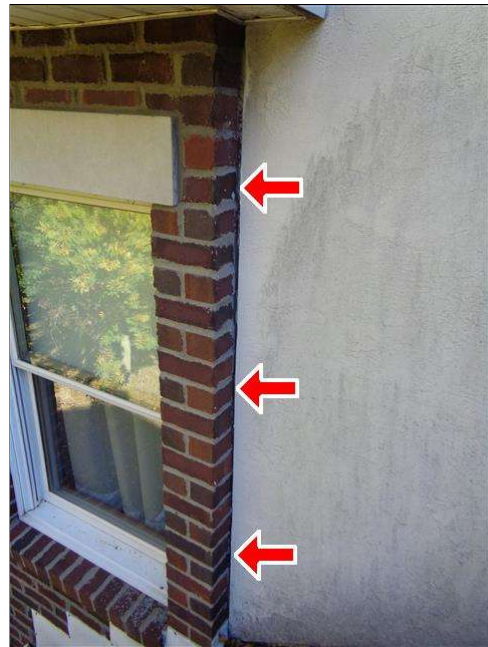
Most brick siding Satisfactory with exception of 1 inch gaps observed where brick siding meets EIFS siding Item 1(Picture) Item 2(Picture) Item 3(Picture) Item 4(Picture) . Wasps and birds nesting in these areas. These areas rated Poor and advise evaluation and correction by the appropriate professional to prevent further nesting and/or water penetration.

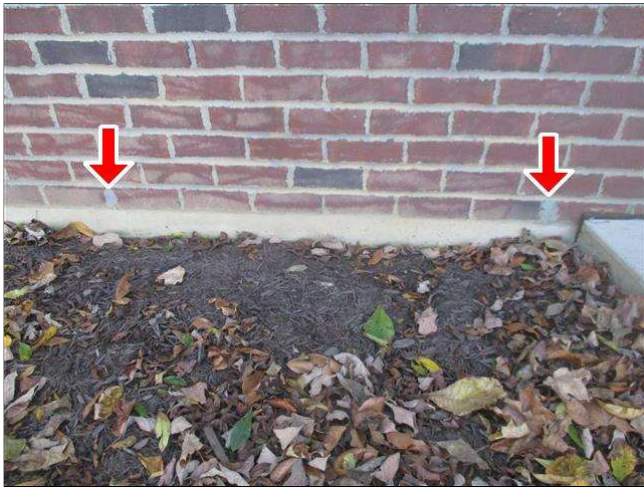
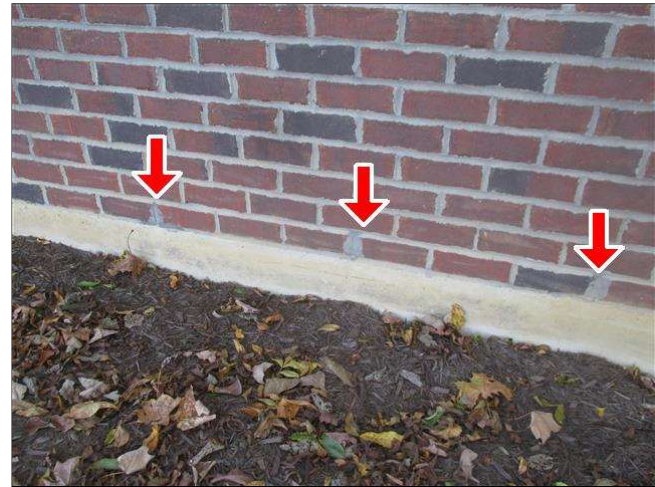
Plastic tubing for weep holes along base of brick siding have been clogged with mud from wasps (mud daubers) Item 5(Picture) Item 6(Picture). Such holes allow moisture to escape from behind siding if necessary. Advise correction in these areas as well.

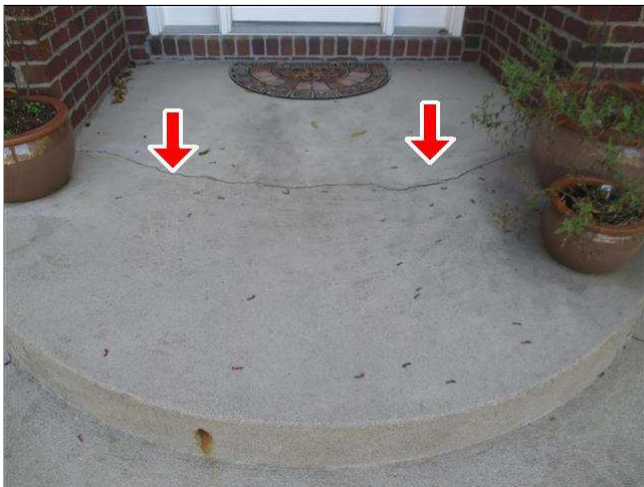
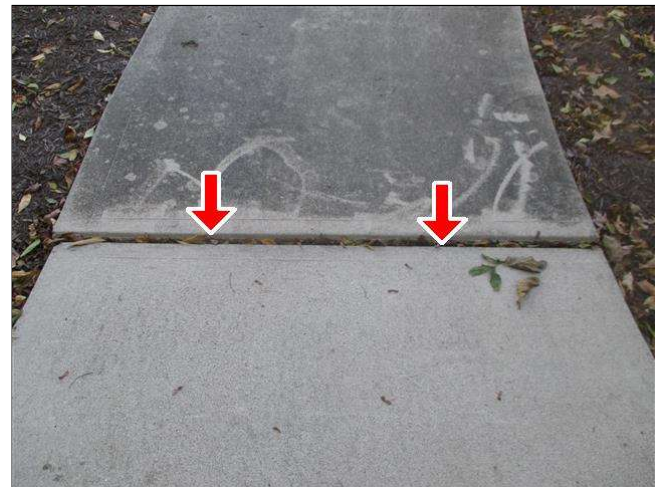
●						<p>2.3 ENTRY DOORS</p>
●						<p>2.4 STAIRS / STOOPS</p>
	●					<p>2.5 PORCH/DECK #1</p> <p>Considerable settlement cracking observed at front porch slab Item 1(Picture) from settling of front walkway section Item 2(Picture) . Advise evaluation by a concrete professional to determine best option of correction and make any necessary repairs.</p>
●						<p>2.6 PORCH/DECK #2</p>
●						<p>2.7 RAILINGS</p>
●						<p>2.8 FOUNDATION SURFACE</p>
●						<p>2.9 ELECTRIC / GFCI</p>
●						<p>2.10 HOSE BIBS</p>

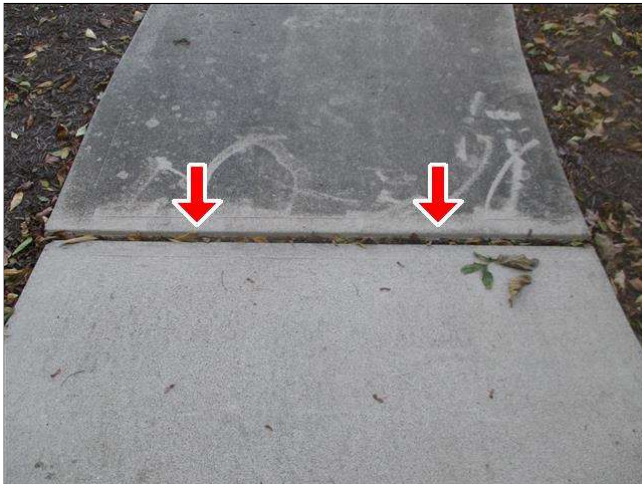
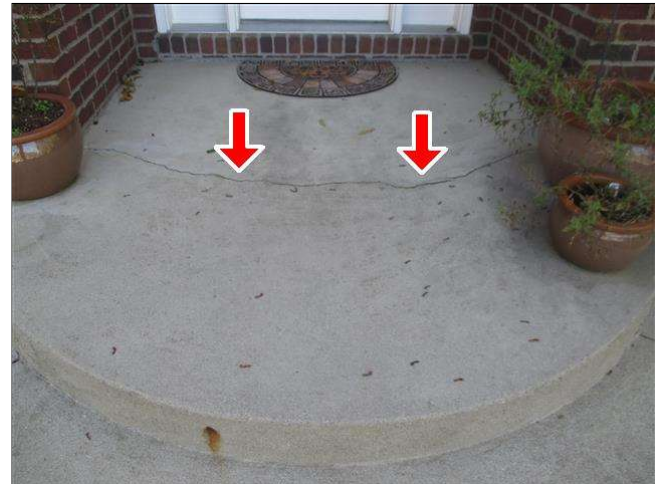
Most walkway Satisfactory with exception of settling at front section Item 1(Picture) . This has affected front porch slab as well Item 2(Picture) . This area of walkway rated Poor and advise evaluation by a concrete professional and make any necessary repairs.

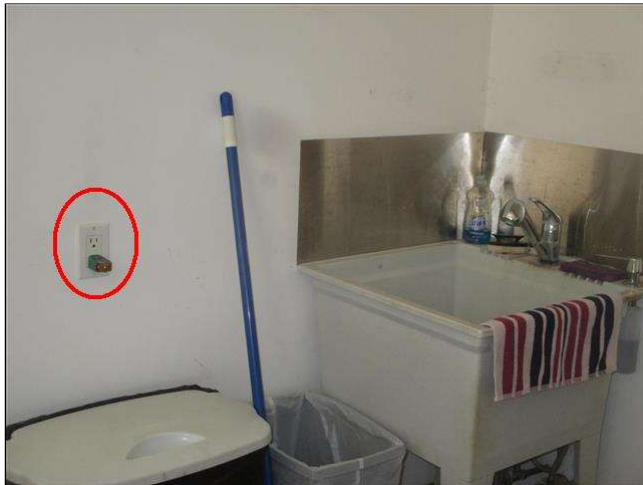
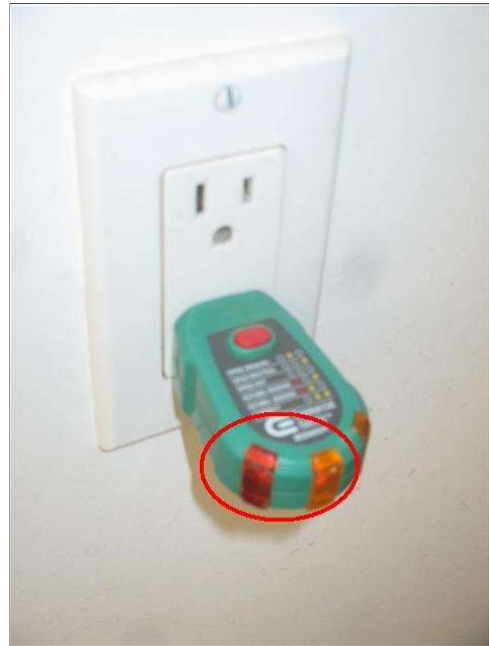
Left side receptacles are grounded, but not GFCI protected and receptacle nearest to utility tub indicates reversed polarity, meaning hot and neutral wiring has been reversed Item 1(Picture) Item 2(Picture) . These receptacles rated Poor and advise correction by an electrical professional.

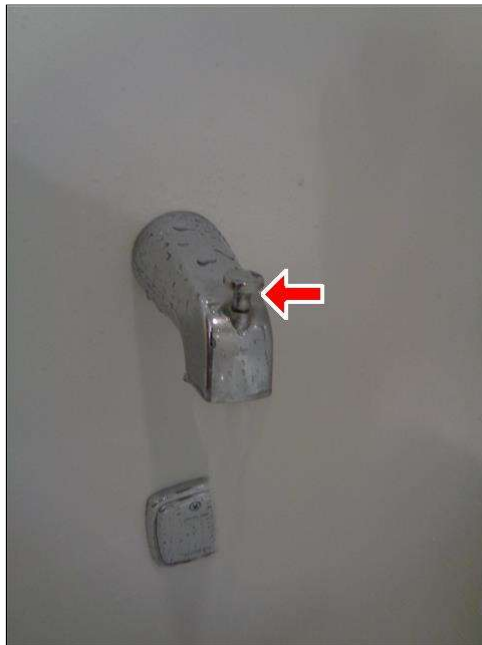
6.2.A BATHTUB Picture 1

Tub activates and drains Satisfactorily however shower diverter is difficult to activate Item 1(Picture). This shower diverter rated Poor and advise repair or replacement by the appropriate professional.

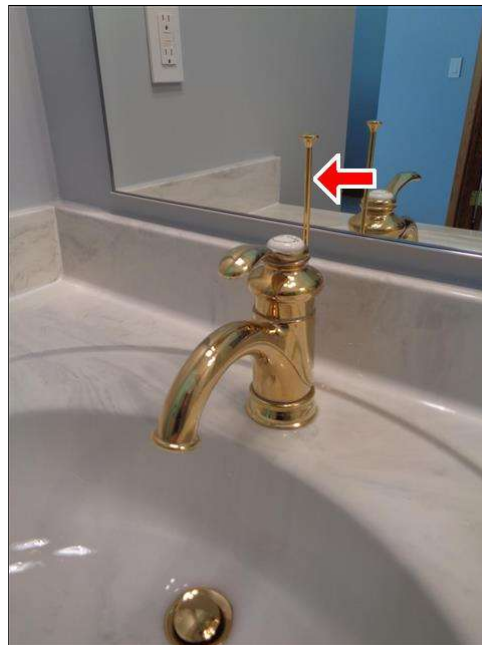
6.0.B SINK(S) Picture 1

Left side sink mostly rated Satisfactory however drain mechanism is difficult to open and close Item 1(Picture). This drain mechanism rated Fair and advise repair or replacement to ensure proper operation.

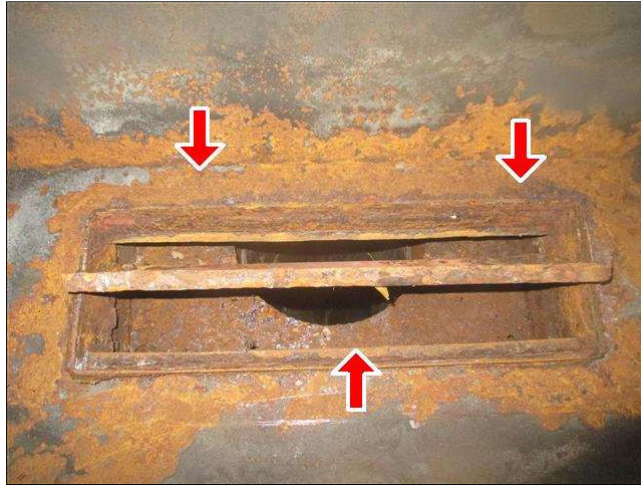
8.9 FIREPLACE #1 Picture 1

Fireplace in great room. Damper assembly at top of firebox functions but is aged and rusted due to no rain guard present at top of chimney Item 1(Picture) . Advise installation of such tp prevent further deterioration.

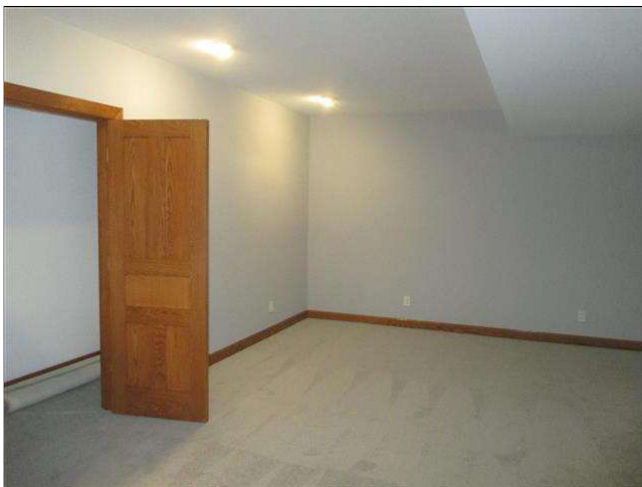
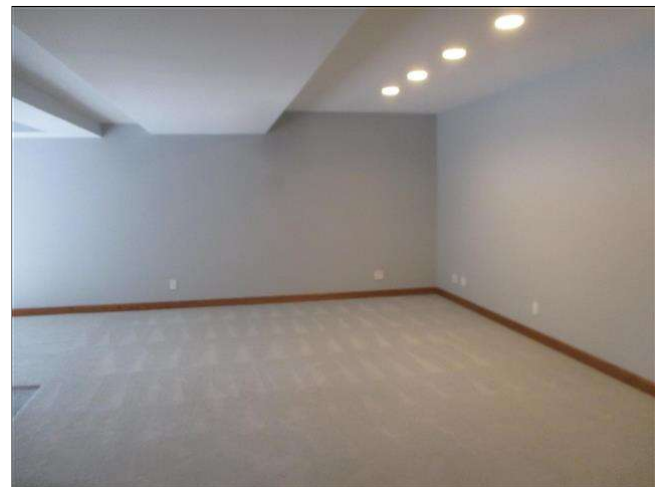
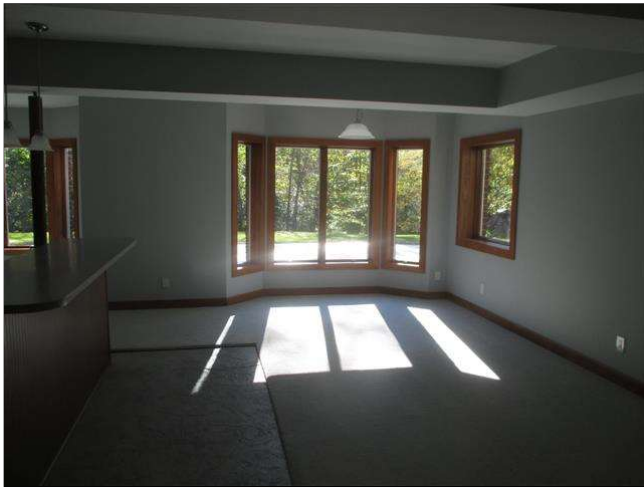
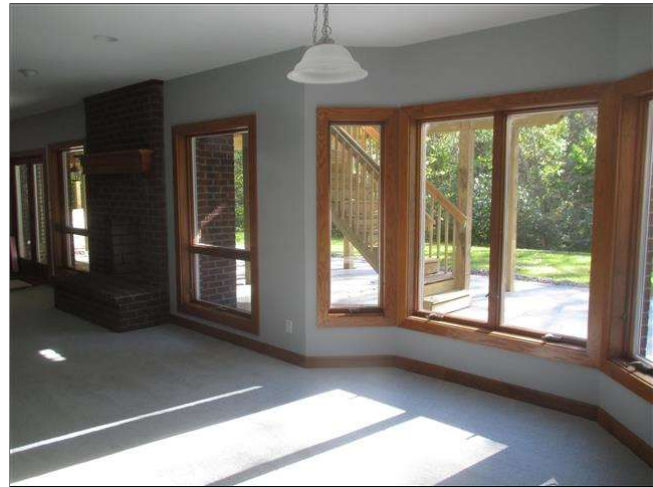
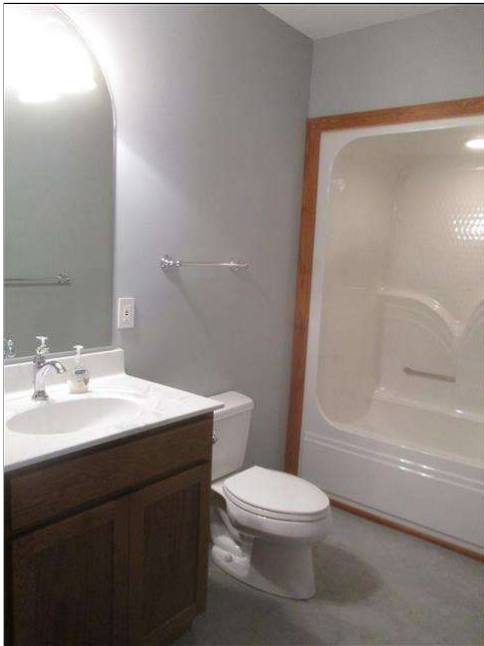
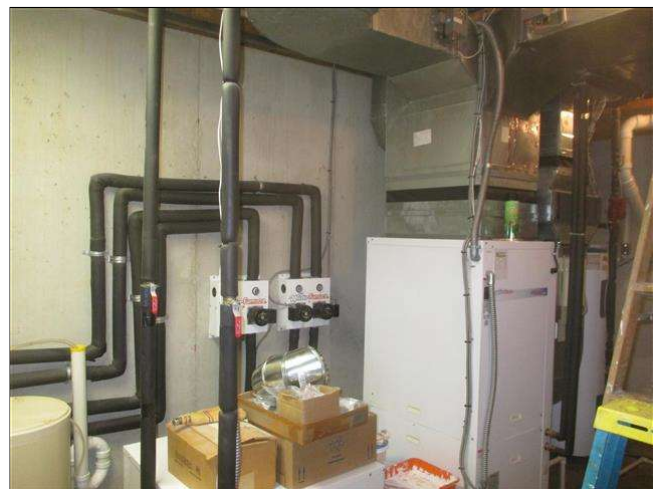
●					9.0 FOUNDATION WALLS Visibility restricted by 75% due to finish materials Item 1(Picture) Item 2(Picture) Item 3(Picture) Item 4(Picture) Item 5(Picture) Item 6(Picture) . Rating is for exposed areas only.
●					9.1 PIERS / COLUMNS
●					9.2 FLOOR FRAMING Visibility restricted by 75% due to finish materials. Rating is for exposed areas only.
				●	9.3 MAIN BEAM(S) Not visible
●					9.4 BASEMENT FLOOR (SLAB) Visibility restricted by 75% due to floor coverings. Rating is for exposed areas only.
●					9.5 STAIRS / RAILINGS

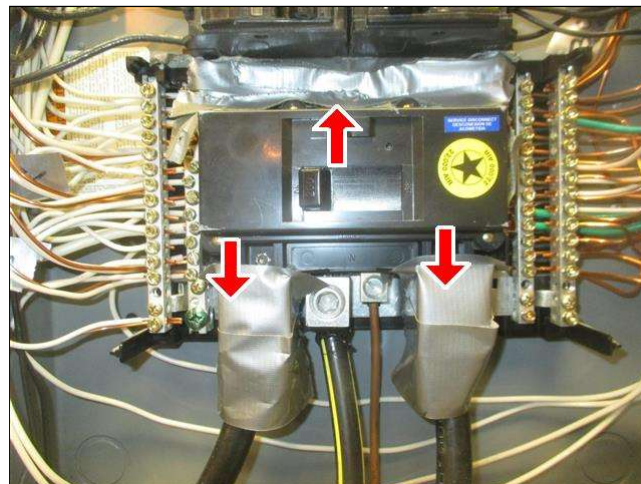
11.2 MAIN DISCONNECT(S) Picture 1

Connections of main disconnect are covered in duct tape Item 1(Picture). Purpose of this application is unknown but duct tape is not a suitable "electrical" tape. Advise evaluation by an electrical professional and make any necessary corrections.

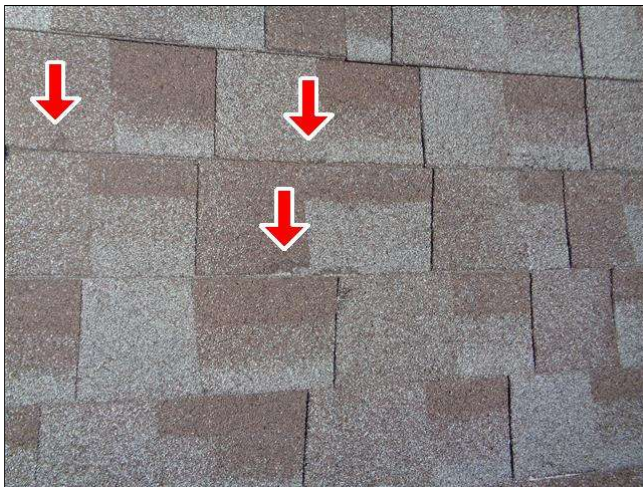
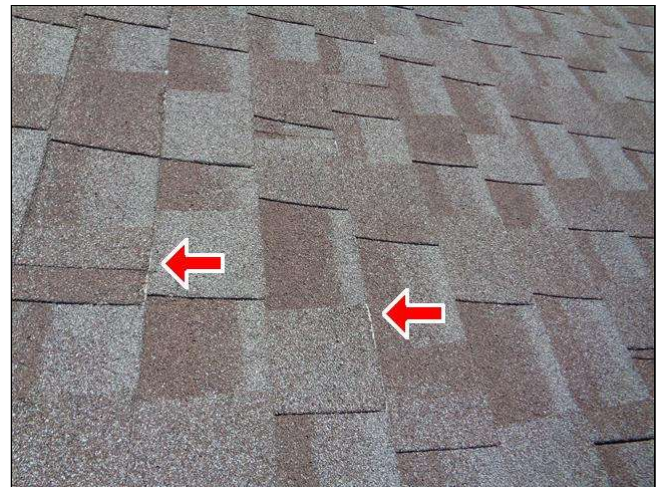
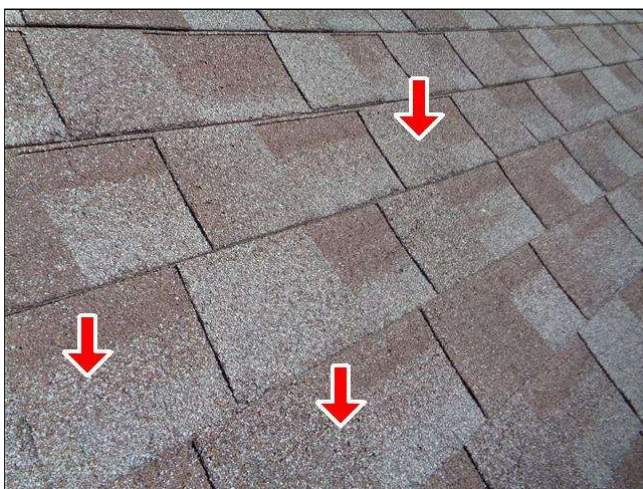
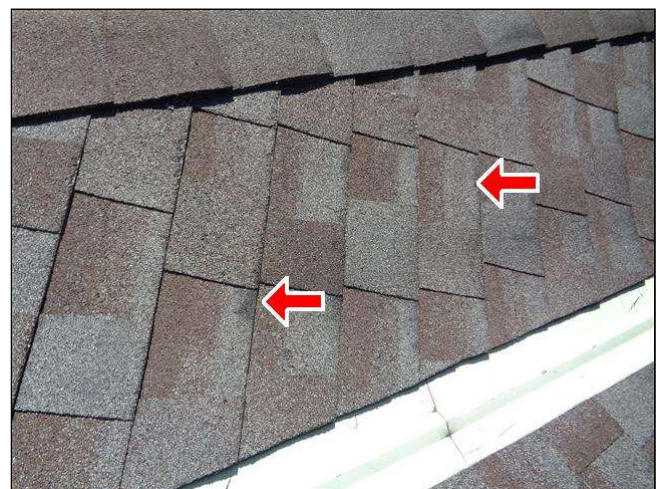
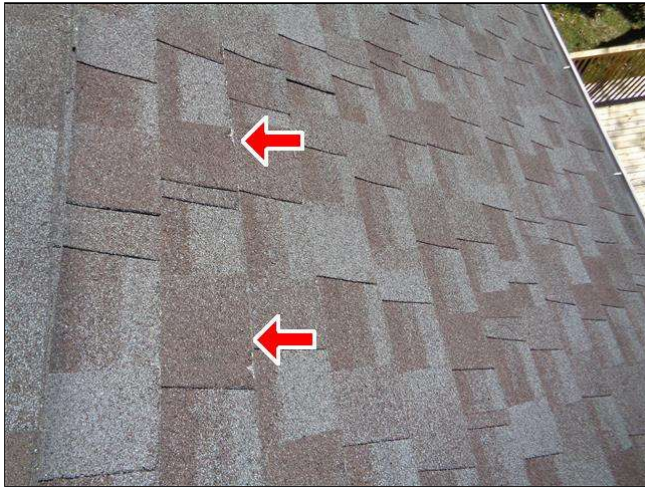
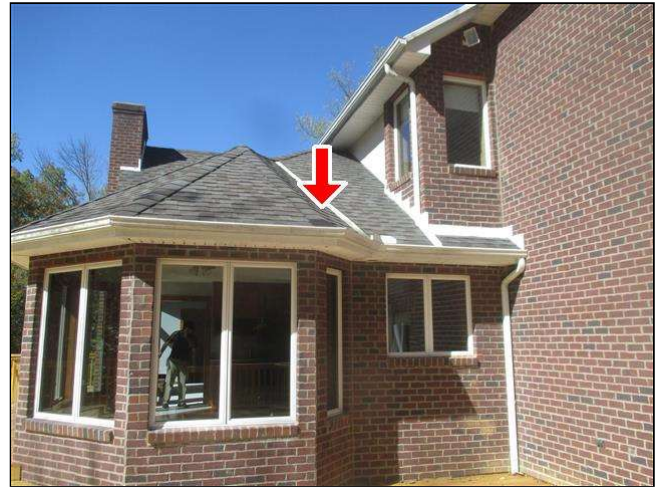
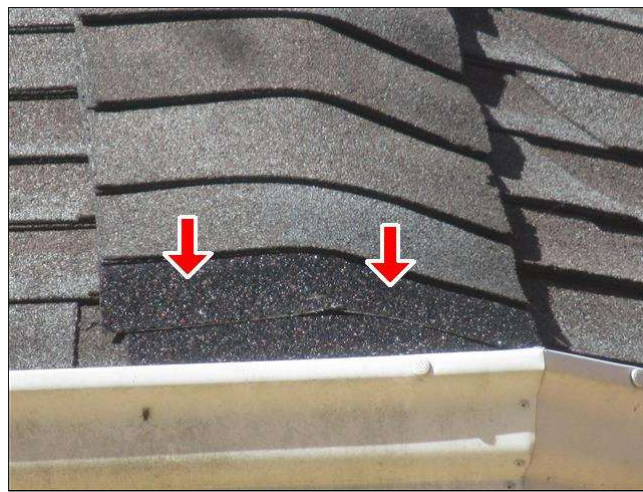
Rear slope has indications of shingle deterioration in the form of granule loss and fiberglass strands present Item 1(Picture) Item 2(Picture) Item 3(Picture) Item 4(Picture) Item 5(Picture). Missing shingle tabs also observed above rear dinette area Item 6(Picture) Item 7(Picture). These areas of roofing rated Fair and advise evaluation by a roofing professional to determine best option of repair or replacement and make any necessary corrections.

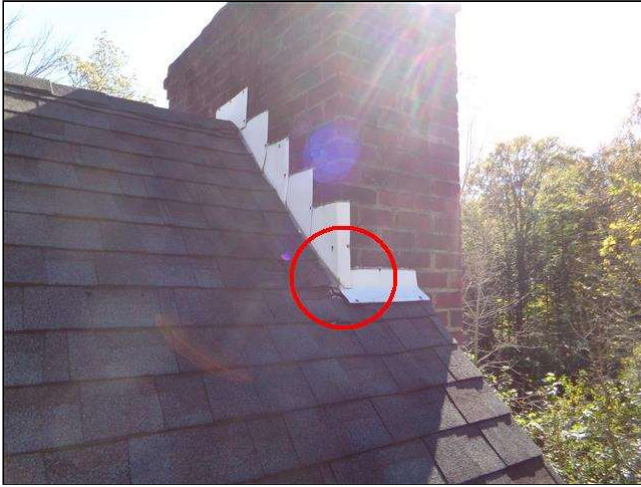
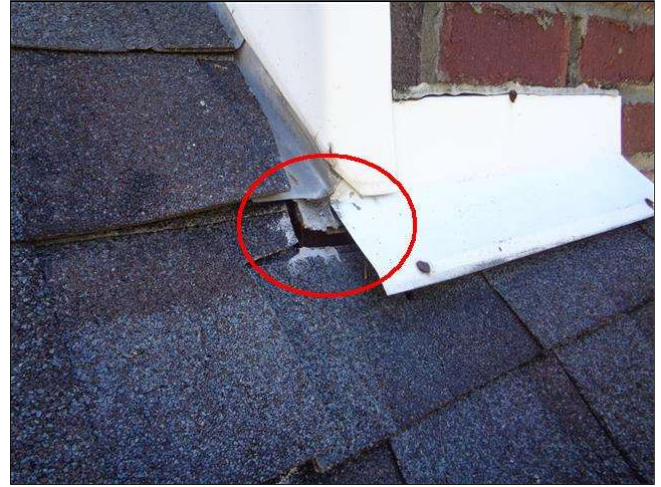
Most exposed flashing Satisfactory with exception of separation observed at right side base of chimney Item 1(Picture) Item 2(Picture) . No indication of water penetration was observed but this area of flashing rated Poor and advise correction by the appropriate professional to eliminate possible water penetration in the future.

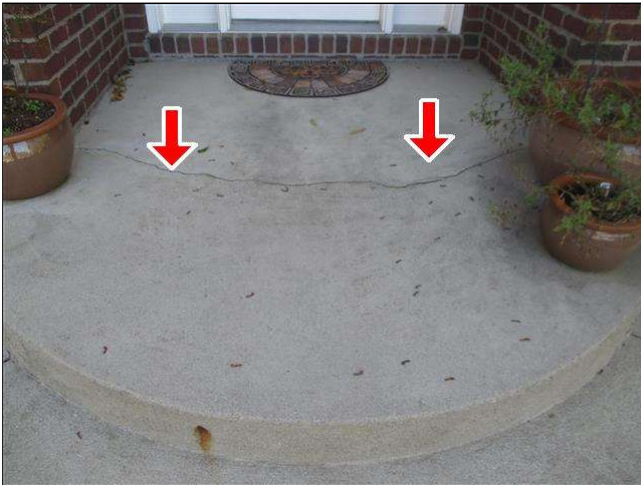
2.5 Item 1(Picture)

Considerable settlement cracking observed at front porch slab Item 1(Picture) from settling of front walkway section Item 2(Picture) . Advise evaluation by a concrete professional to determine best option of correction and make any necessary repairs.
