Prepared for Exclusive Use by:

Address of Property:

Shelby Hendrix

Multi-Unit Property

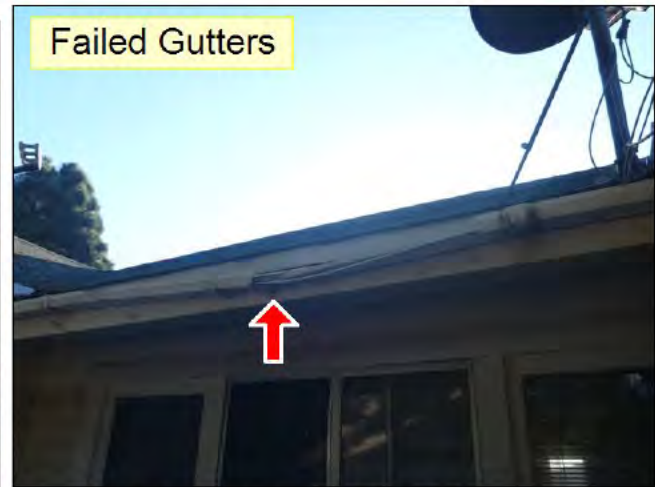
Failed Gutters

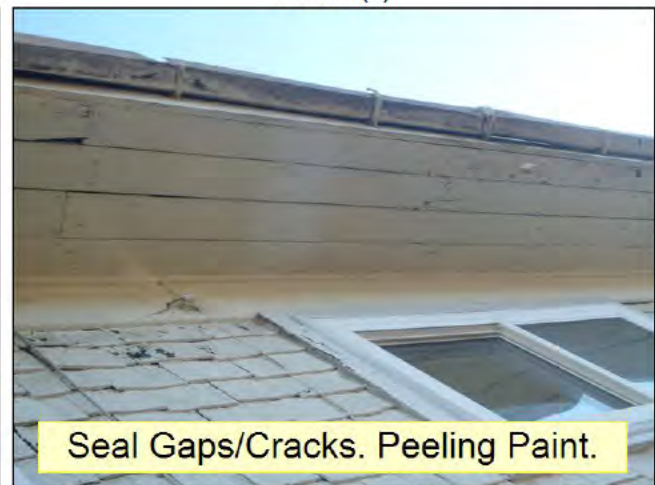
Seal Gaps/Cracks. Peeling Paint.

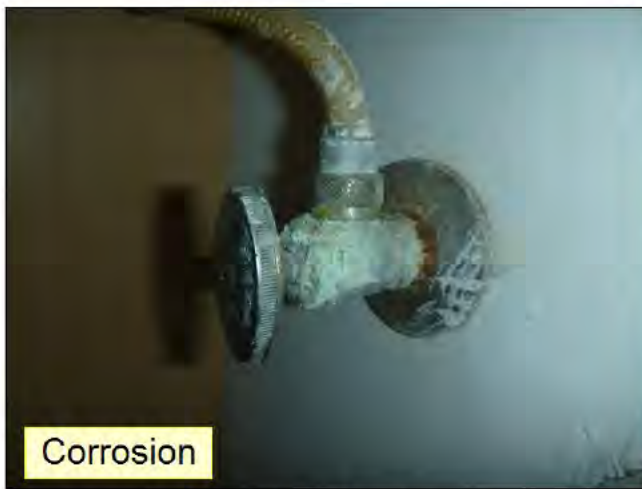
Corrosion

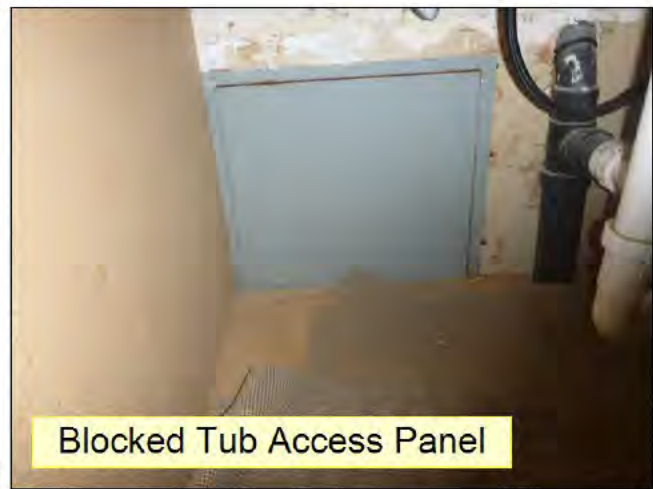
Blocked Tub Access Panel

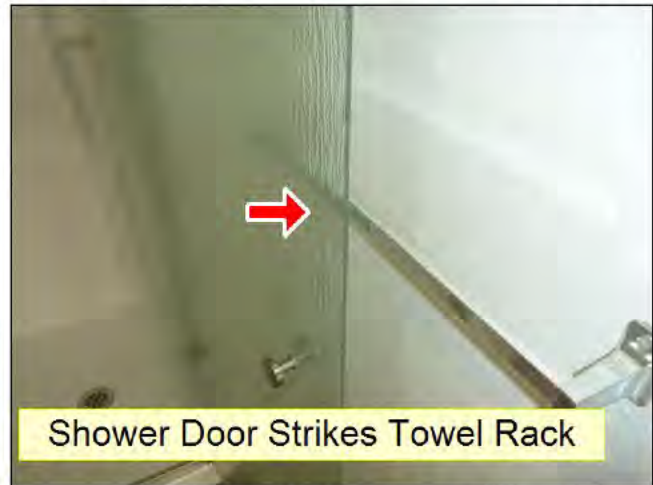
Shower Door Strikes Towel Rack

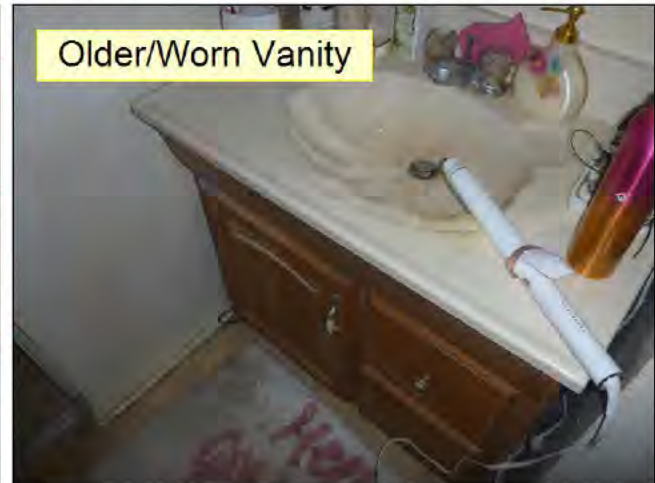
Older/Worn Vanity

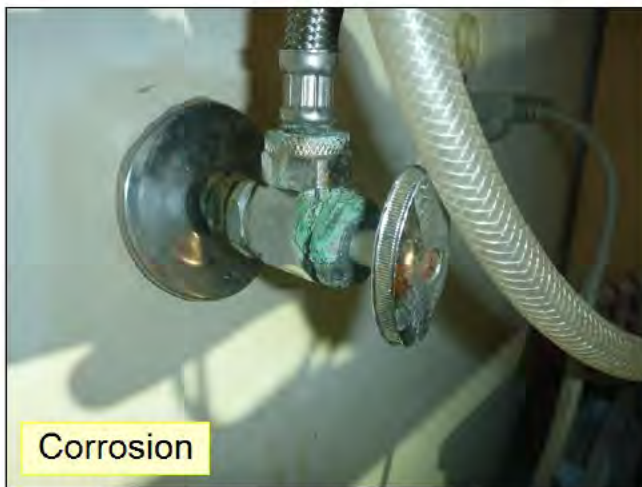
Corrosion

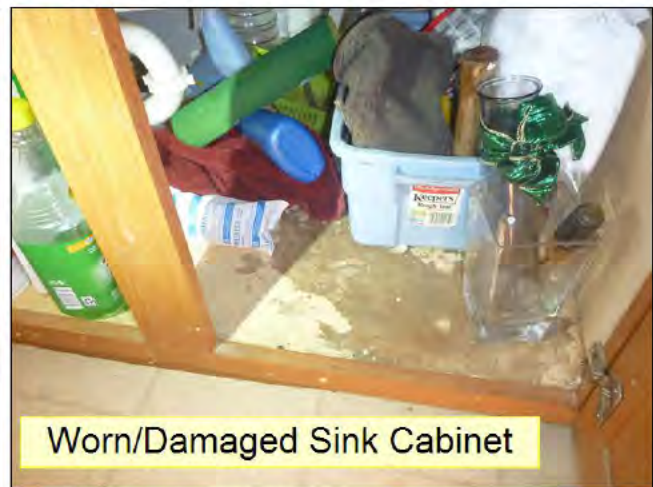
Worn/Damaged Sink Cabinet

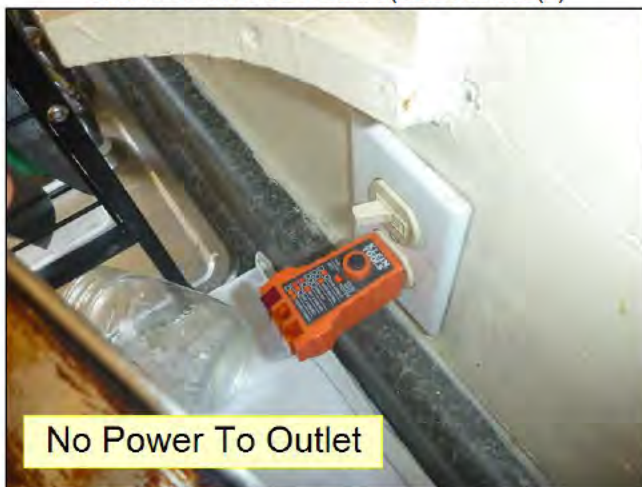
No Power To Outlet

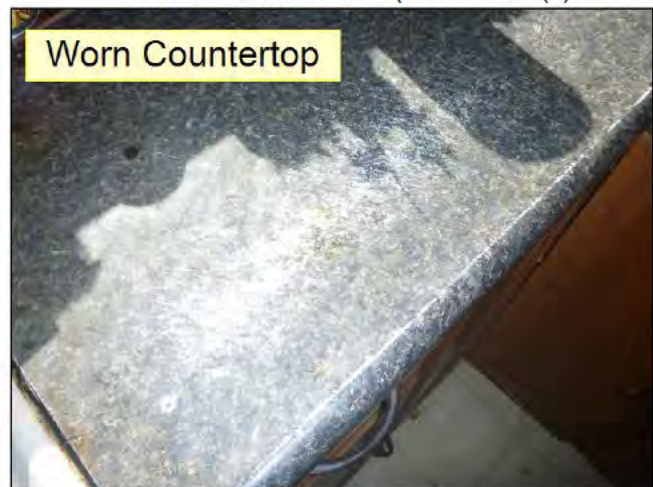
Worn Countertop

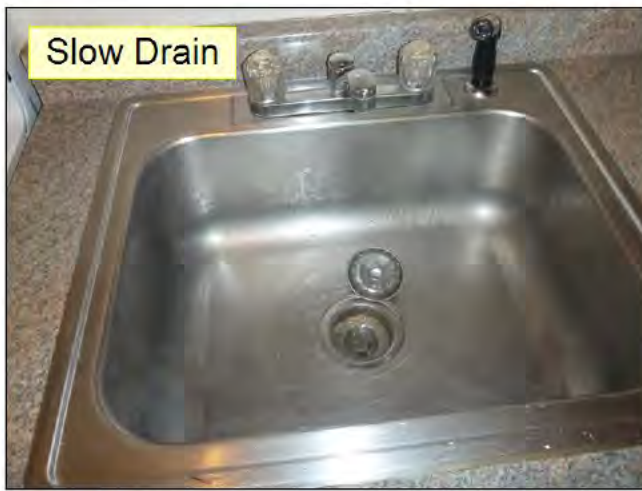
Slow Drain

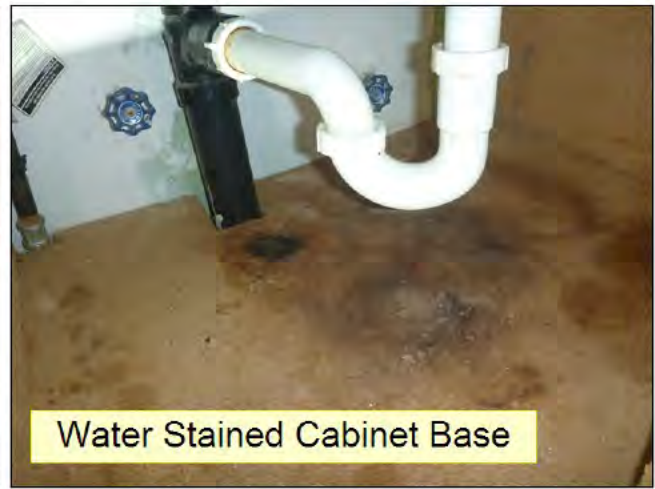
Water Stained Cabinet Base

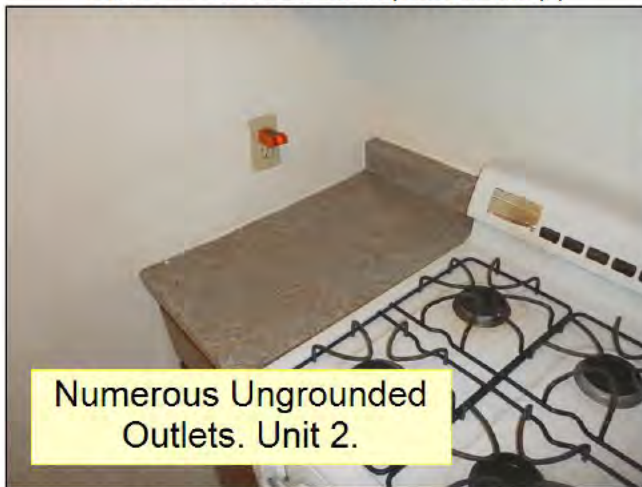
Numerous Ungrounded Outlets. Unit 2.

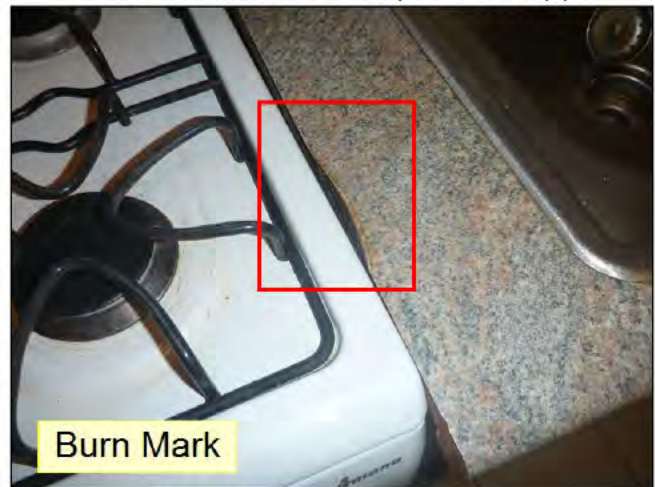
Burn Mark

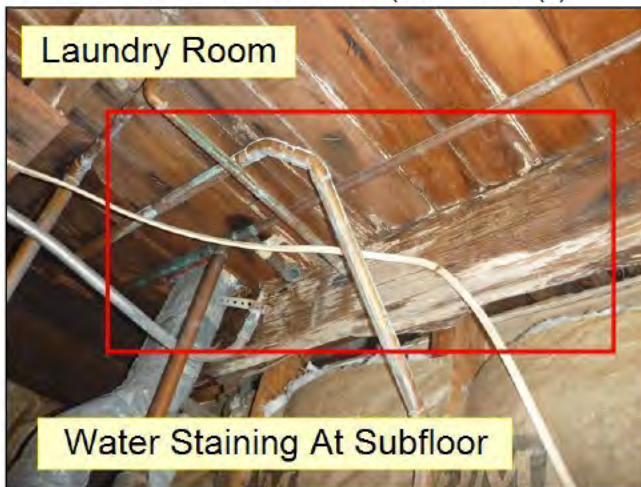
Water Staining At Subfloor

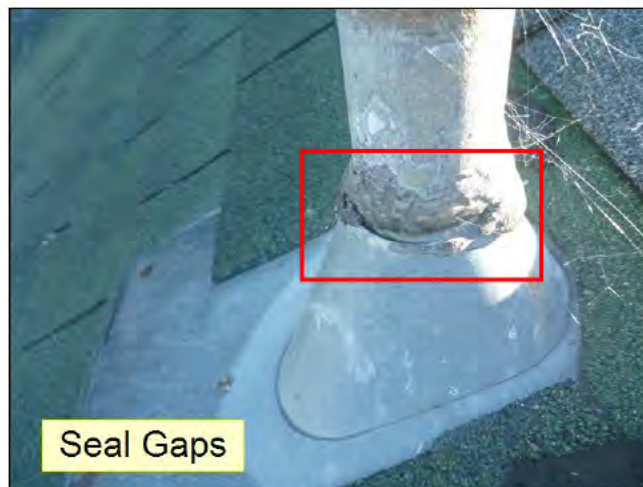
1.2 (See Picture(s))

Gaps noted at roof penetrations. Reseal roof penetrations now and on a routine basis to prevent leakage to interior of structure. (See Picture(s))

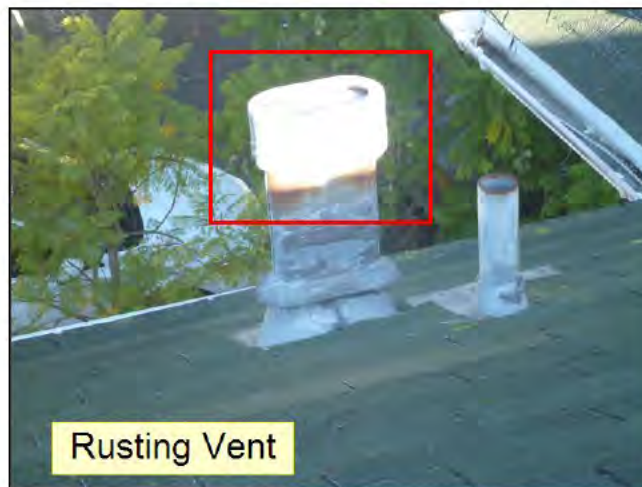
Rusting Vent

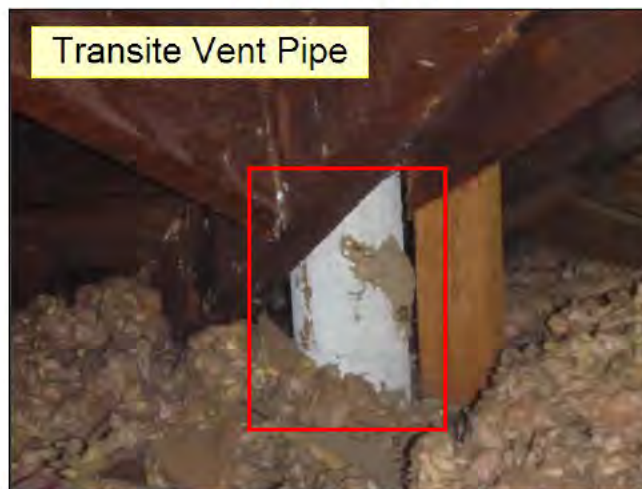
Consider removing transite (asbestos containing) vent pipe in attic when reroofing. (See Picture(s))

Transite Vent Pipe

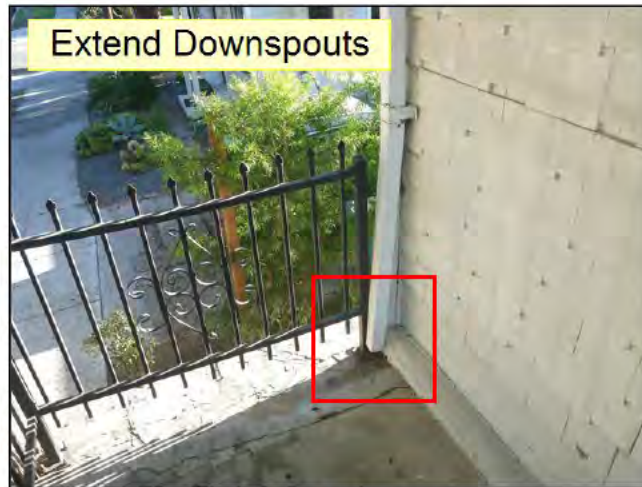
1.5 (See Picture(s))

Recommend extending rain gutter downspouts to move water away from the foundation. Downspouts near structure may allow excessive water to pond and/or penetrate into structure. Consider installing downspouts into built in drains to aide in diverting water run off. (See Picture(s))

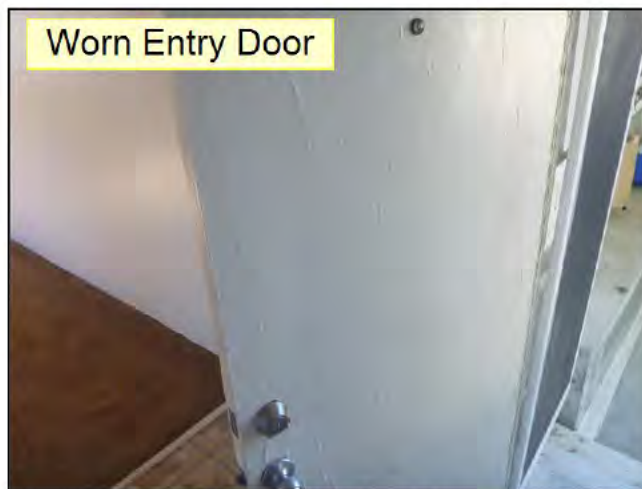
2.1 (See Picture(s))

Multiple weathered front doors and screen doors. Anticipate refinishing, repair, or replacement as desired. (See Picture(s))

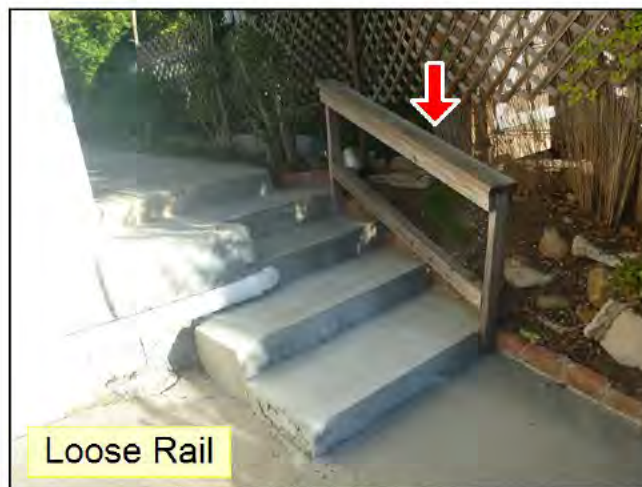
2.3 (See Picture(s))

Suggest adding rails where there is a three foot drop or three steps or more for added safety. (See Picture(s))

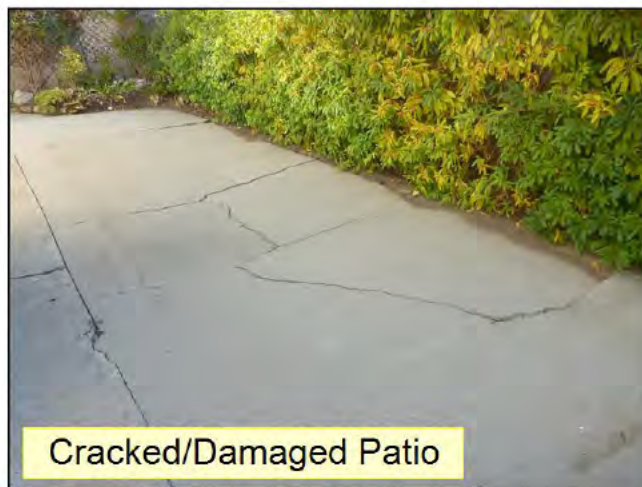
3.1 (See Picture(s))

Cracking and settlement noted at rear concrete patio. Anticipate repairs. See roofing section of report regarding gutter and downspout upgrades to control water from roof cover. (See Picture(s))

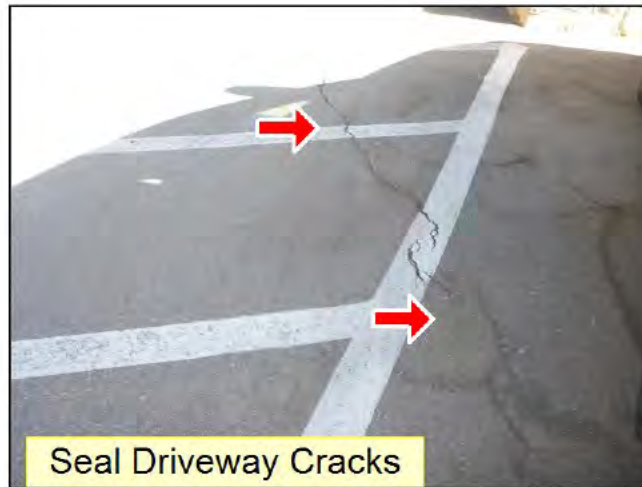
3.2 (See Picture(s))

Cracking noted at driveway. Suggest sealing of cracks to prevent water penetration, further cracking and to extend service life. See roofing section of report regarding rain gutter and downspout upgrades. (See Picture(s))

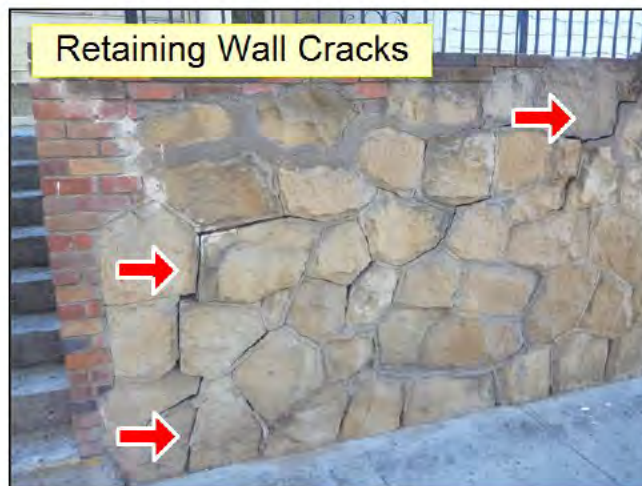
3.4 (See Picture(s))

Cracking/displacement observed at front retaining wall. Consult a contractor for further evaluation and repairs. (See Picture(s))

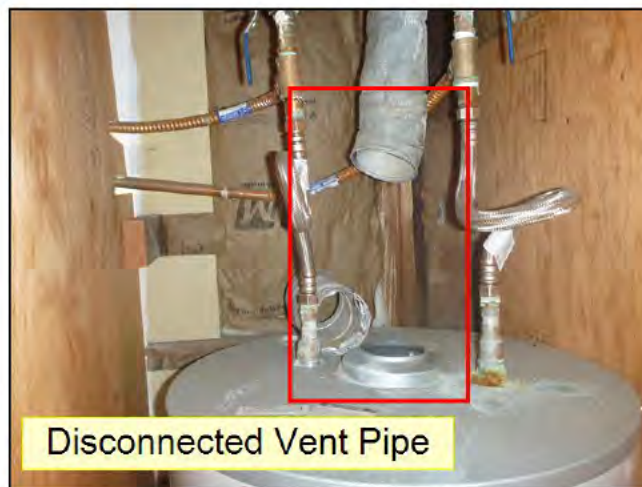
4.1 (See Picture(s))

Vent pipe disconnected at water heater. Contact a plumber for repair to prevent carbon monoxide from entering units. (See Picture(s))

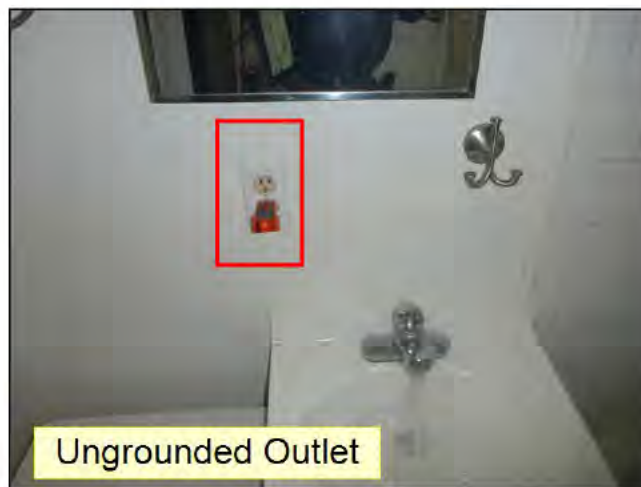
7.3.C (See Picture(s))

Open ground at electrical outlet in primary bathroom. Consult an electrician for correction. Suggest upgrade to GFCI (Ground Fault Circuit Interrupter) type outlets for added safety. (See Picture(s))

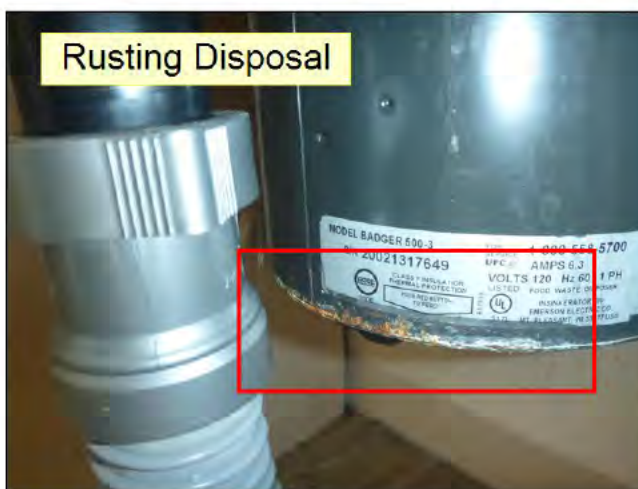
8.1.D (See Picture(s))

Rusting garbage disposal. Anticipate replacement before failure to prevent water leaks. (See Picture(s))

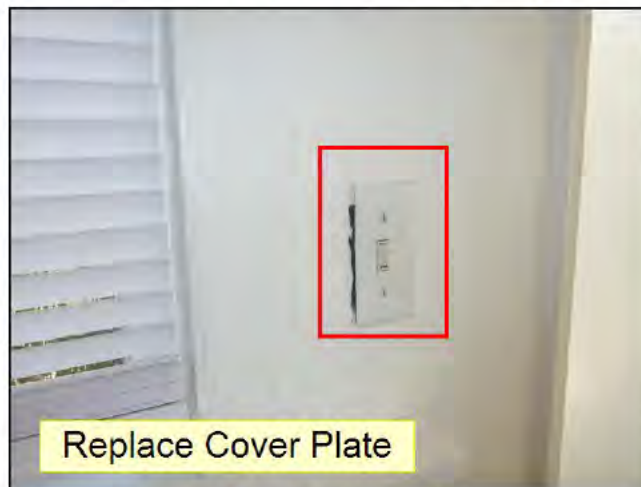
8.6.D (See Picture(s))

Missing cover plate at outlet above hood. Install covers at all outlets and switches for safety. (See Picture(s))

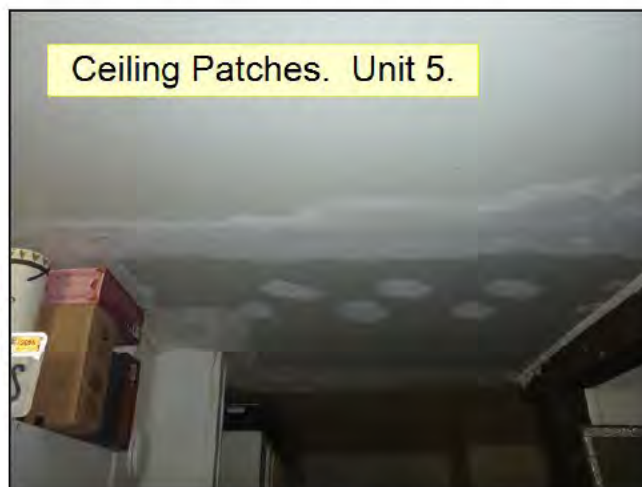
9.1 (See Picture(s))

Damaged ceilings and patching observed at units 4 and 5 were dry at time of inspection. Consult seller on history. Monitor conditions and make repairs as needed. (See Picture(s))

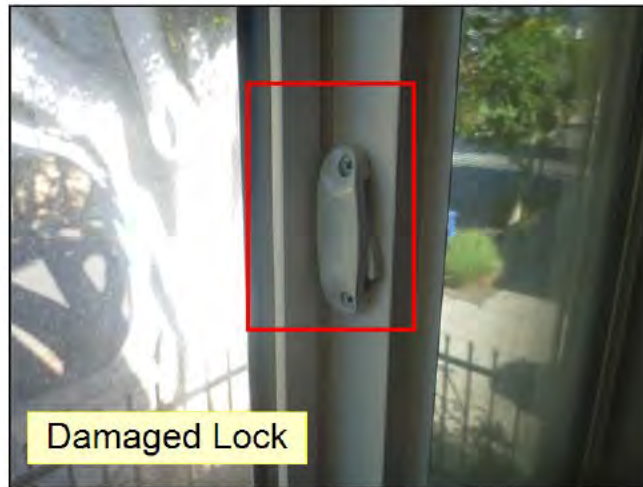
Damaged Lock

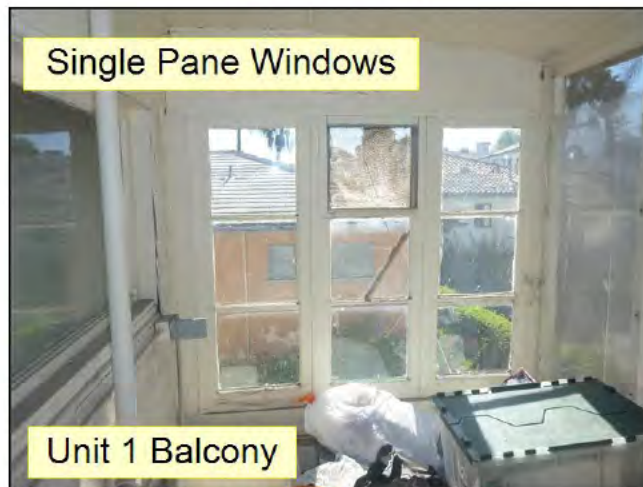
Single Pane Windows

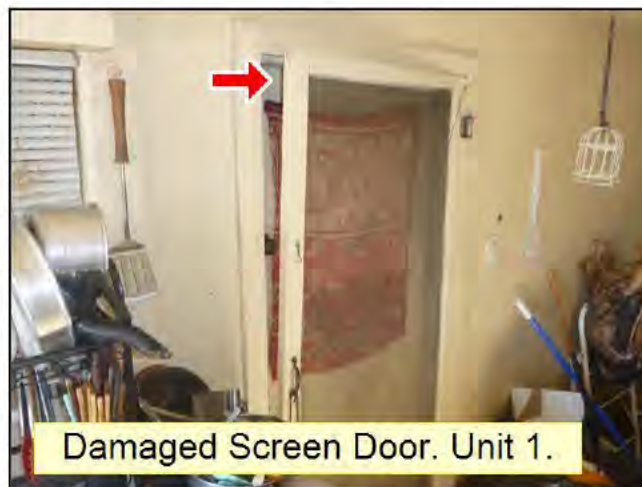
9.5 (See Picture(s))

Damaged screen door and rubbing patio door at unit one. Anticipate repair/replacement. (See Picture(s))

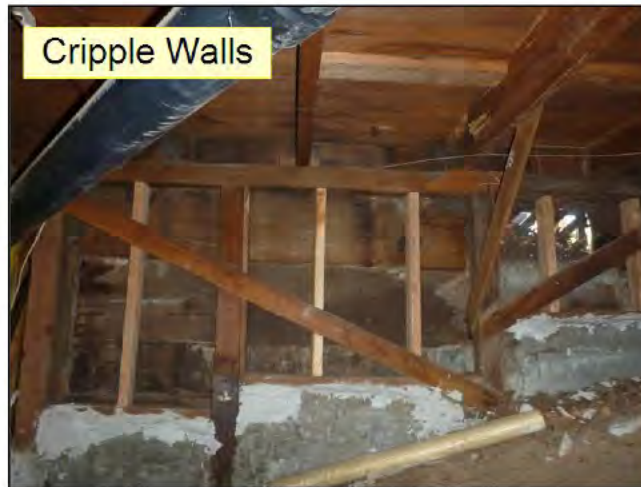
12.0 (See Picture(s))

Cripple walls noted at foundation. Consider shear panel upgrades for added earthquake safety. See California Hazards Disclosure Handbook for information on cripple walls and consult a foundation contractor if desired for cost estimates. (See Picture(s))

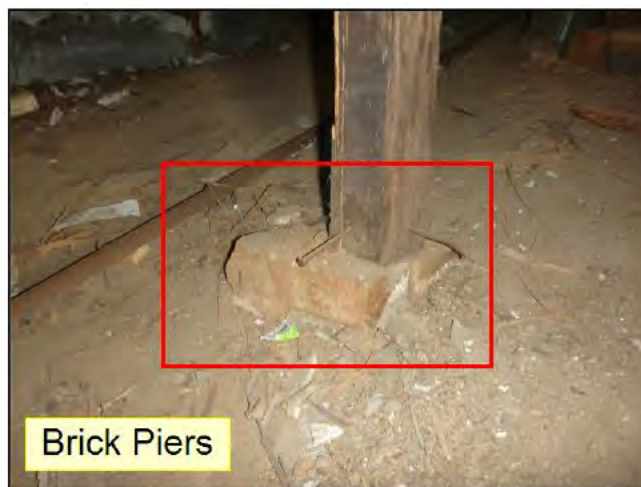
12.1 (See Picture(s))

Earthquake bracing at post and piers are not installed. Consider seismic upgrades for added stability of structure. Consult a foundation contractor if desired. (See Picture(s))
