Prepared for Exclusive Use by:

[REDACTED]
Solvang CA [REDACTED]

HouseMaster
1187 Coast Village Rd. 1-284
Santa Barbara, CA 93108
(805) 898-2698

Commercial

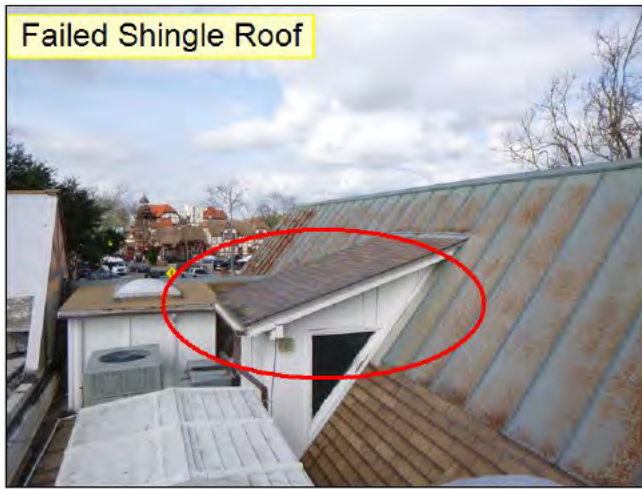
1.0 ROOFING (See Picture(s))

1.0 ROOFING Failing rolled and shingle roofs. Soft/rotting roof deck noted at numerous locations. Consult a roofing contractor for evaluation and replacement cost estimate prior to close of escrow. Anticipate extra expense for roof deck repair/replacement at hidden rotted areas. (See Picture(s)) Rusting metal roof noted. Repainting needed to extend service life. Torn/leaking awning at rear door. Anticipate replacement. (See Picture(s)) Roof coverings require periodic repairs and sealant, especially at roof penetrations. Suggest periodic evaluation and sealing/repairs as needed to aide in preventing water penetration into structure.

Failed Shingle Roof

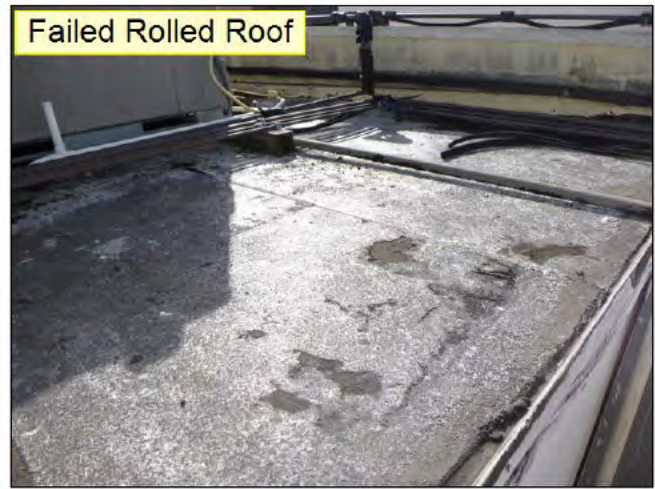
1.0 ROOFING (See Picture(s))

Failed Rolled Roof

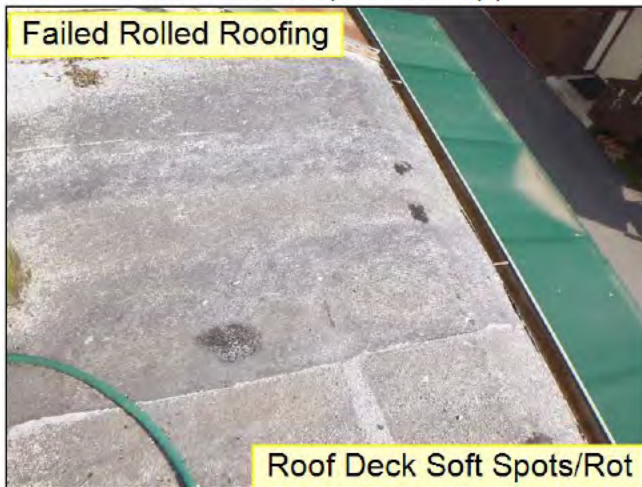
1.0 ROOFING (See Picture(s))

Failed Rolled Roofing

Roof Deck Soft Spots/Rot

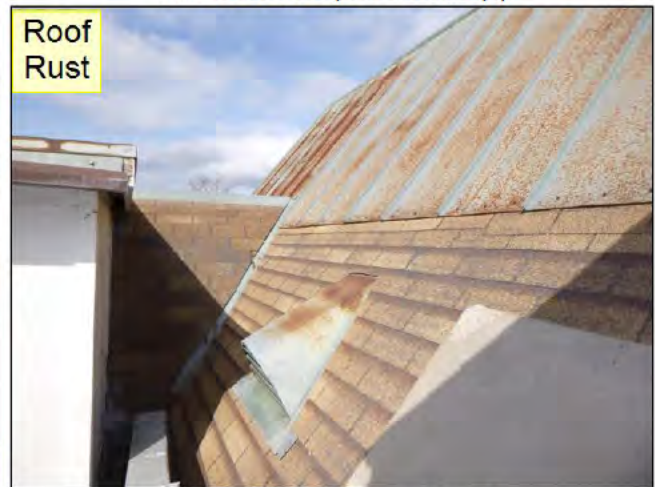
1.0 ROOFING (See Picture(s))

Roof Rust

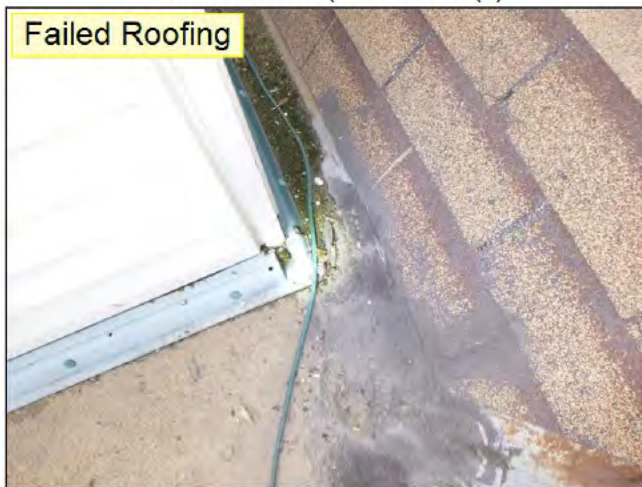
1.0 ROOFING (See Picture(s))

Failed Roofing

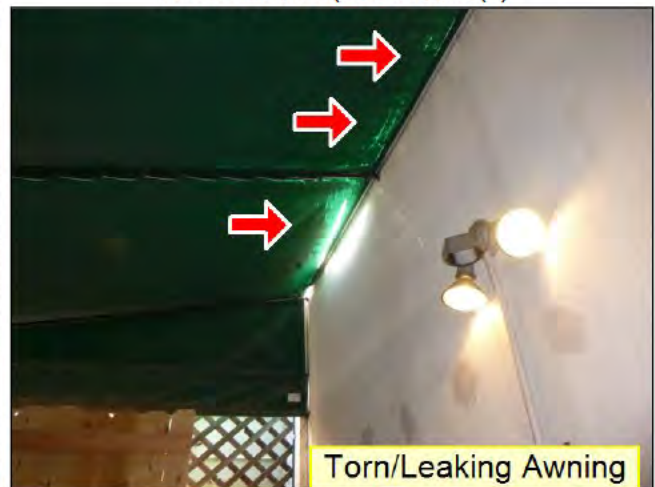
1.0 ROOFING (See Picture(s))

Torn/Leaking Awning

Torn/leaking awning at rear door. Anticipate replacement. (See Picture(s))

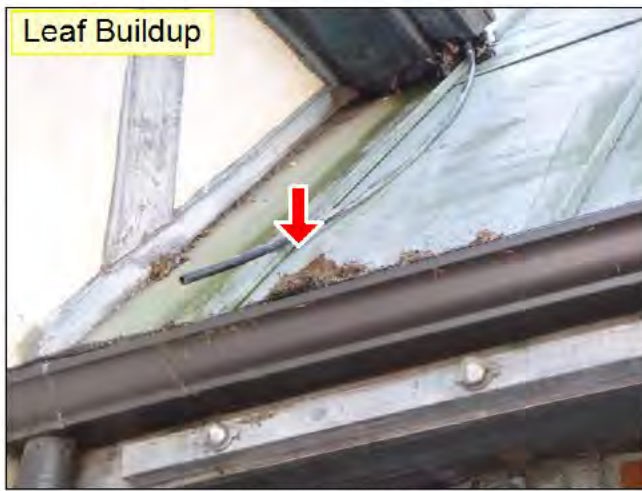
1.4 RAIN GUTTERS / EAVETROUGHES (See Picture(s))

Leaf Buildup

Leaf buildup noted in rain gutters. Suggest cleaning and flushing now and on an annual basis for proper drainage. Consider upgrade of gutter guards to prevent leaf buildup. (See Picture(s))

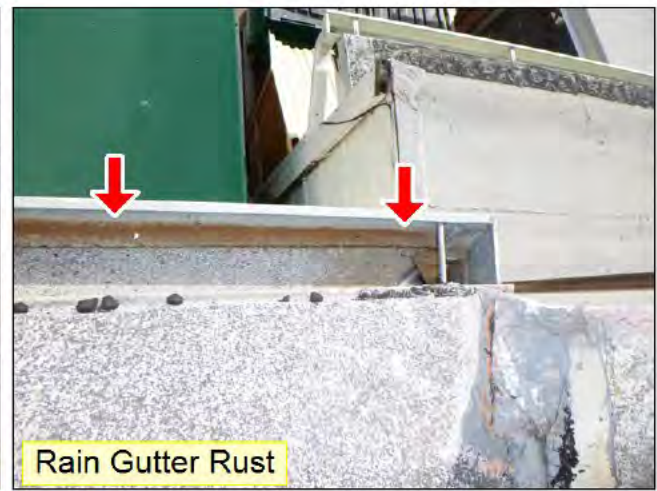
1.4 RAIN GUTTERS / EAVETROUGHES (See Picture(s))

Rain Gutter Rust

Rusted/failing rain gutter sections need replacement. (See Picture(s))

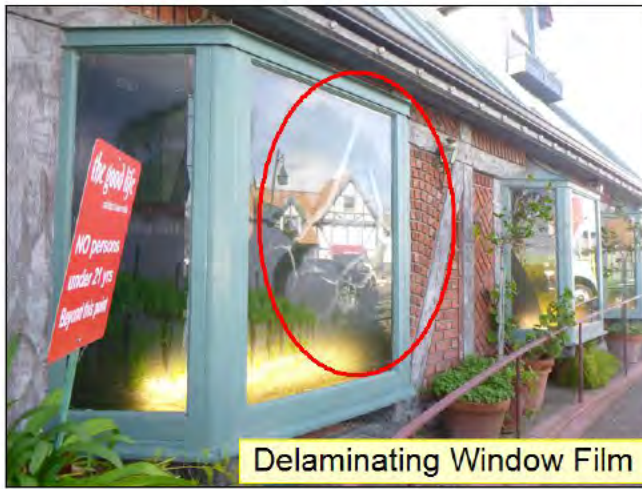
2.1 WINDOWS (See Picture(s))

Delaminating Window Film

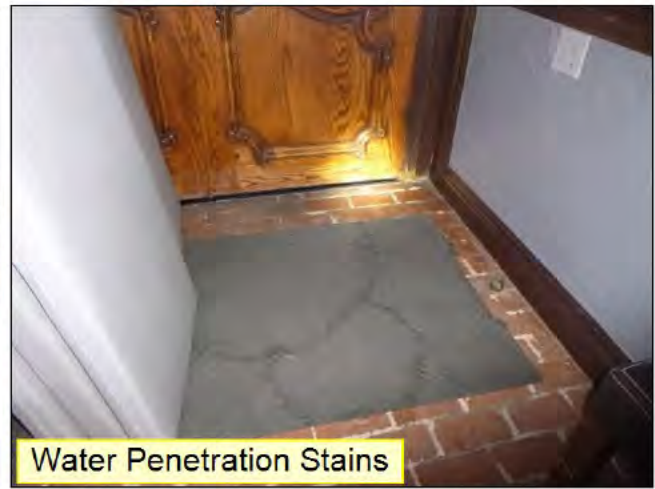
2.2 ENTRY DOORS (See Picture(s))

Water Penetration Stains

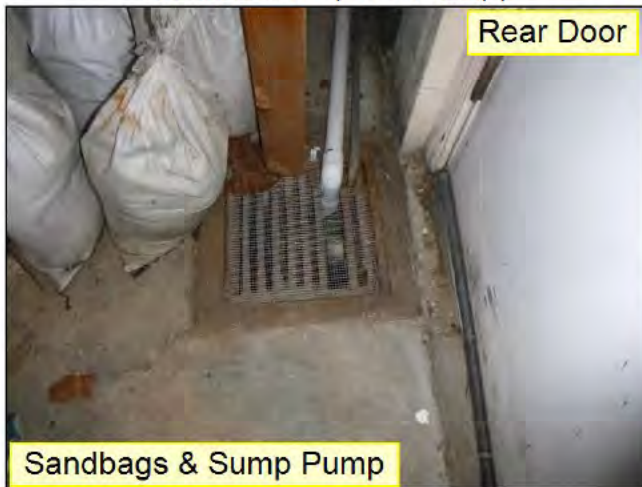
2.2 ENTRY DOORS (See Picture(s))

Rear Door

Sandbags & Sump Pump

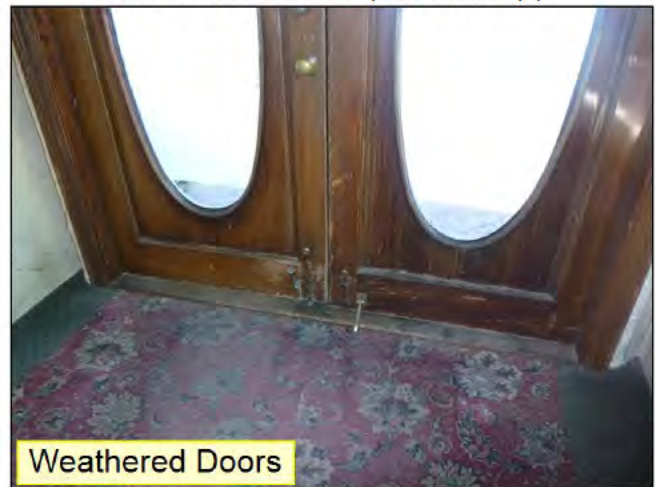
2.2 ENTRY DOORS (See Picture(s))

Weathered Doors

Weathered/worn doors at ground floor. Repaint/stain to extend service life. (See Picture(s))

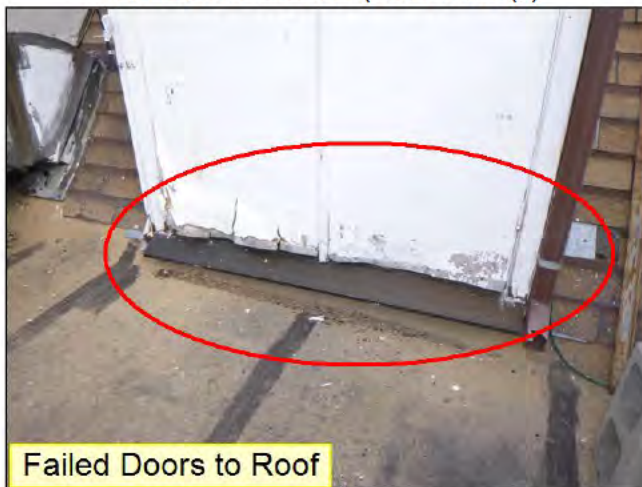
2.2 ENTRY DOORS (See Picture(s))

Failed Doors to Roof

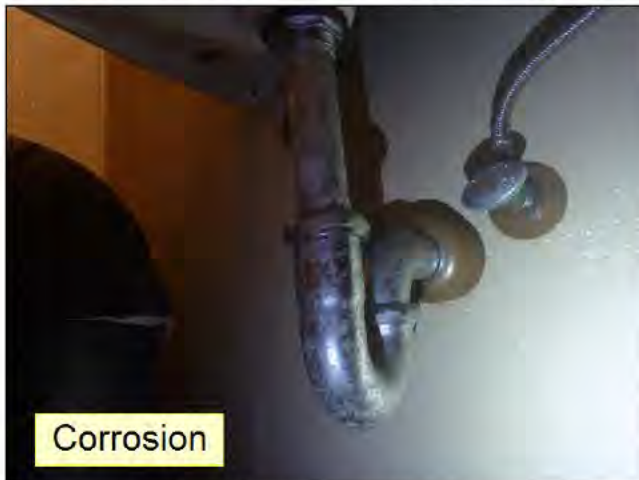
4.0 SINK(S) (See Picture(s))

Corrosion

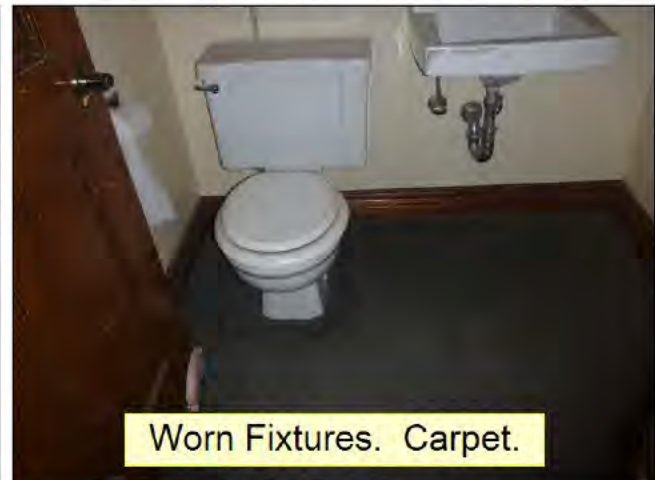
4.0 SINK(S) (See Picture(s))

Worn Fixtures. Carpet.

Older and worn sink and faucet noted. Anticipate replacement. (See Picture(s))

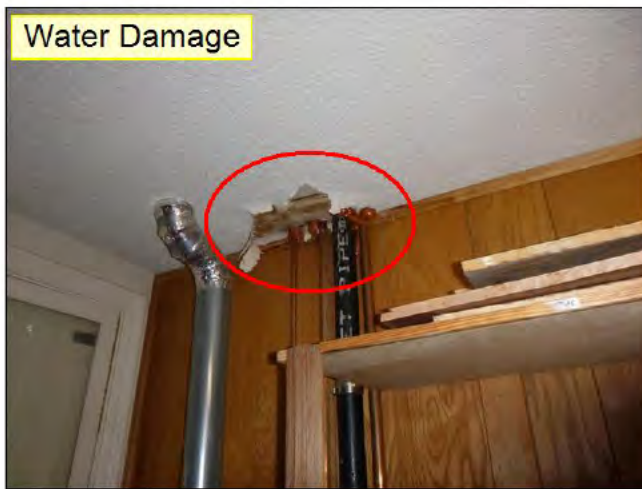
5.0 WALLS (See Picture(s))

Water Damage

Water stains and damage at numerous locations of walls and ceilings. See comments in roof section of report and see window comments below. (See Picture(s))

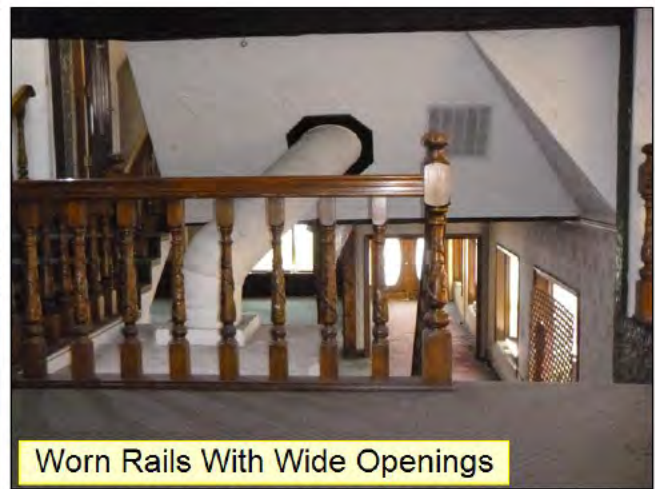
5.3 RAILINGS (See Picture(s))

Worn Rails With Wide Openings

Openings at railings are wider than today's standards allow. Consider upgrades for added safety to protect children and pets. (See Picture(s))

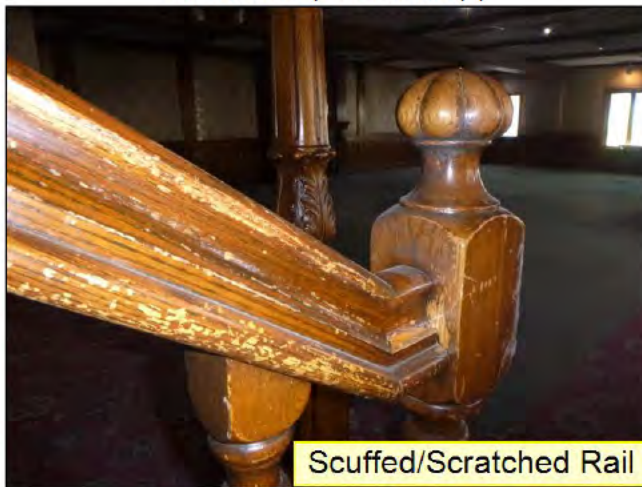
5.3 RAILINGS (See Picture(s))

Scuffed/Scratched Rail

Scuffed/scratched rails are in need of re-staining/painting. (See Picture(s))

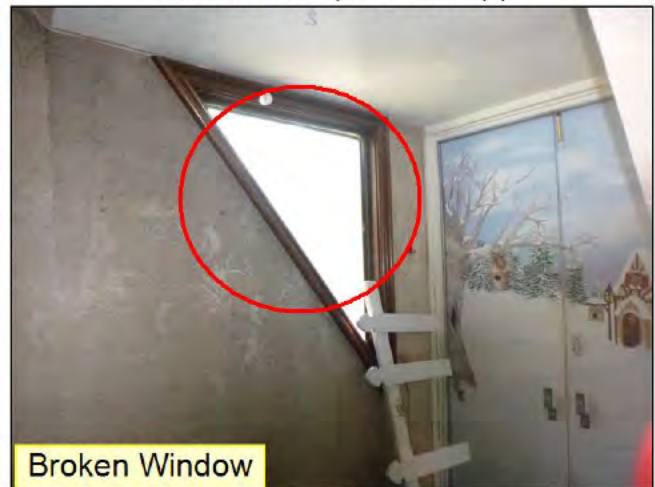
5.5 WINDOWS (See Picture(s))

Broken Window

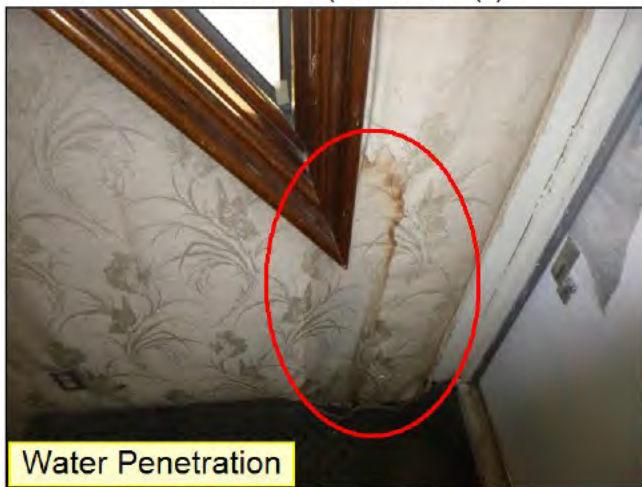
5.5 WINDOWS (See Picture(s))

Water Penetration

Water penetration and rot noted at several windows. Consult a window company for evaluation and repair/replacement cost estimate prior to close of escrow. (See Picture(s))

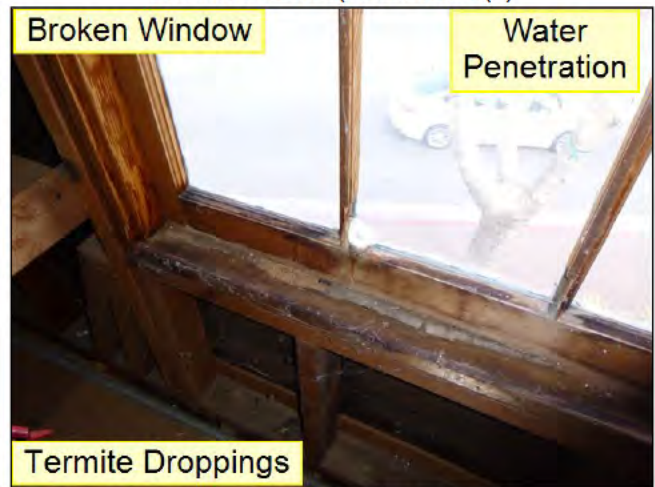
5.5 WINDOWS (See Picture(s))

Broken Window

Water Penetration

Termite Droppings

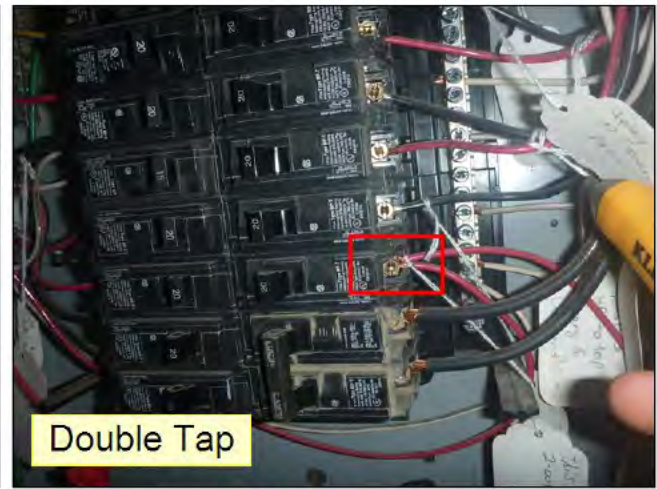
6.6 SUBPANEL (See Picture(s))

Double Tap

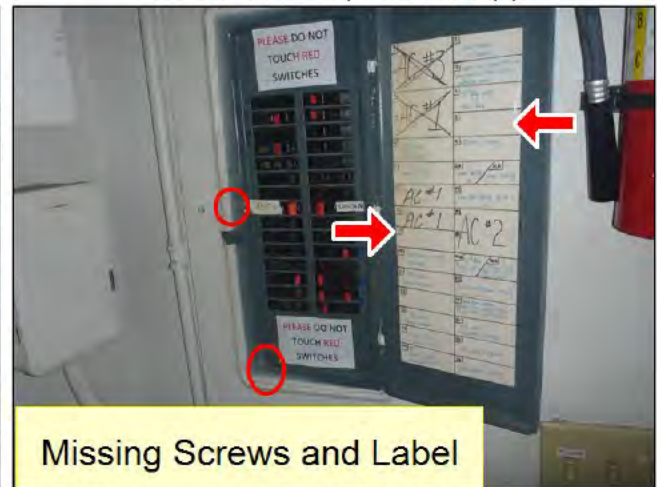
6.6 SUBPANEL (See Picture(s))

Missing Screws and Label

Missing screws in dead panel plate at 1656 subpanel. Install missing screws for correct installation. (See Picture(s))

1656 sub panel is not fully labeled. Have panel fully labeled for safety. (See Picture(s))

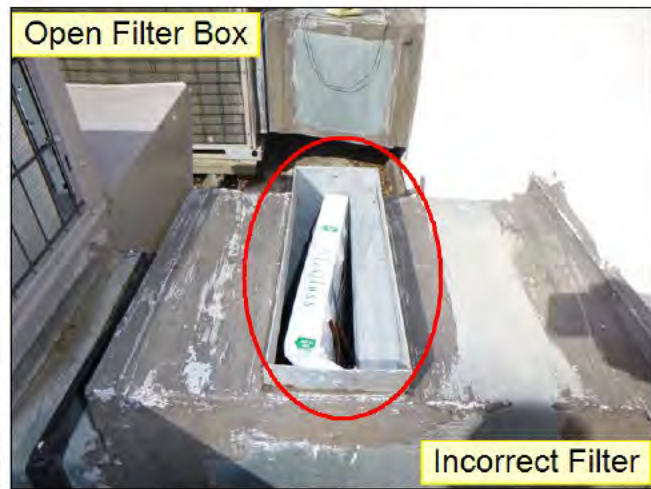
7.5 BLOWER (See Picture(s))

Incorrect Filter

Open filter box is allowing water to enter and incorrectly sized filter is installed at one unit. Consult a HVAC contractor for correction. (See Picture(s))

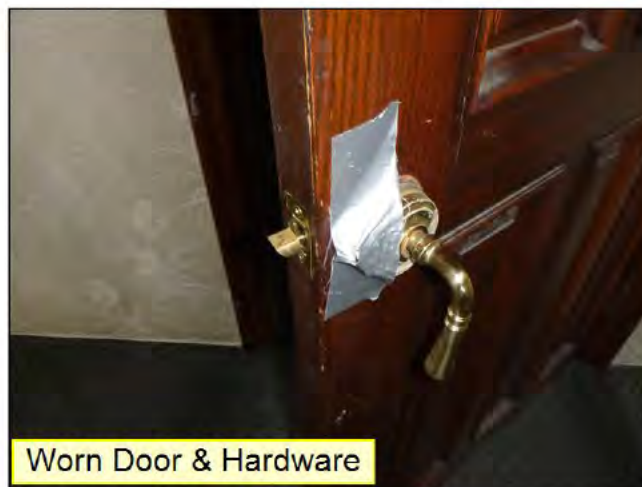
5.6 (See Picture(s))

Worn/scratched door and hardware. Anticipate repair/repainting/replacement. (See Picture(s))

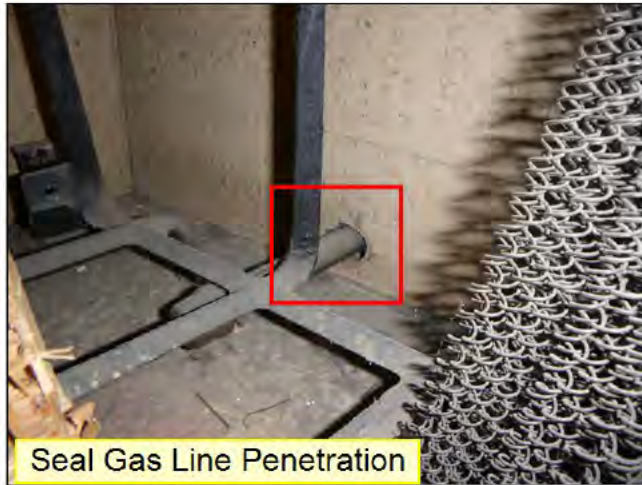
5.7 (See Picture(s))

High temperature sealant is needed around gas pipe where it enters into upper level fireplace to keep heat and flames from entering wall cavity. (See Picture(s))

Seal Gas Line Penetration

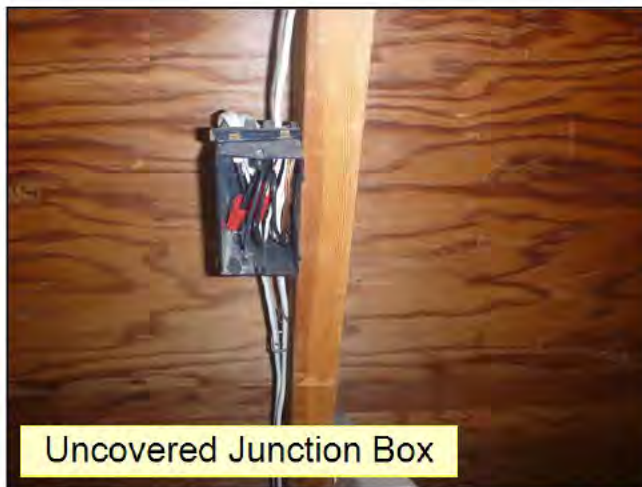
6.5 (See Picture(s))

Open junction boxes with exposed wiring noted in attic. Add cover plates at any/all open junction boxes and/or properly terminate wiring for proper and safe installation. (See Picture(s))

Uncovered Junction Box

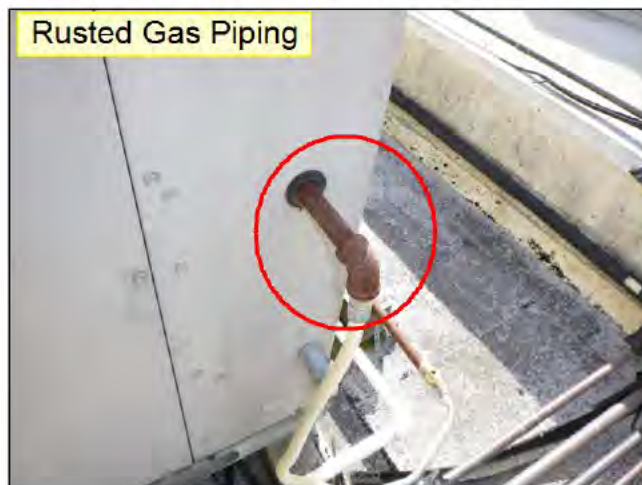
7.3 (See Picture(s))

Rusted gas piping on roof. Paint or replace to prevent leaks. See photos in plumbing section of report. (See Picture(s))

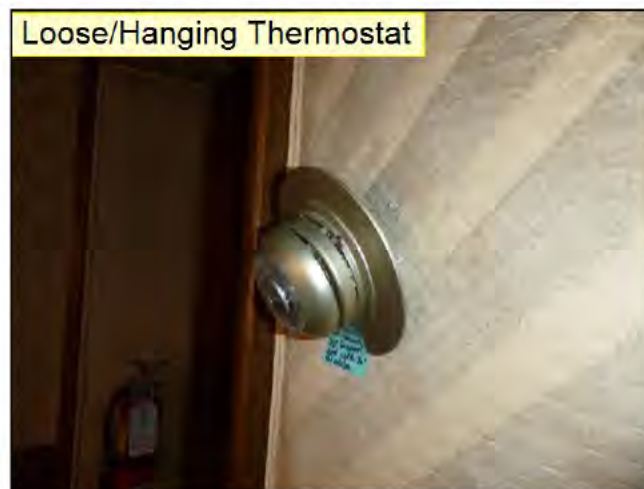
7.7 (See Picture(s))

Secure loose/hanging thermostat at upper level for proper installation. (See Picture(s))

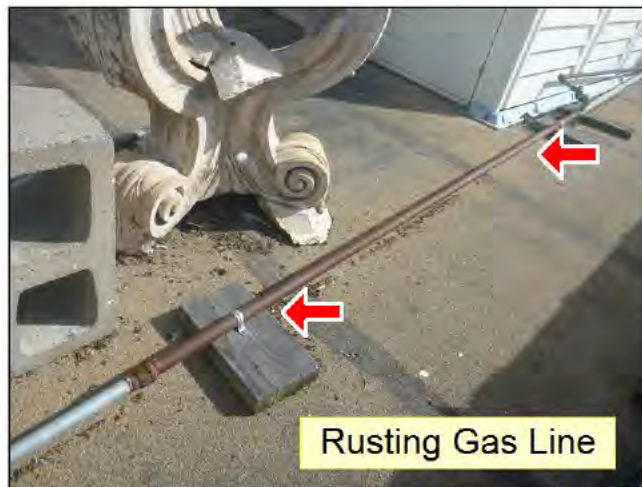
8.7 (See Picture(s))

Rusting gas lines noted at meter. Suggest painting to extend service life. No gas leaks detected at the time of inspection. (See Picture(s))

Suggest installation of an emergency gas shutoff valve and/or keeping a valve handle at gas meter shut off valve in order to shutoff gas in an emergency.

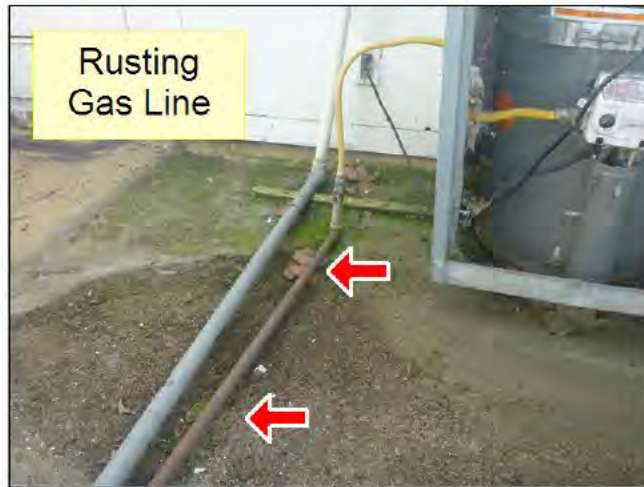
9.2 (See Picture(s))

Rusting rigid gas line to water heater. Contact plumber for replacement with suitable material.
