Address of Inspected Property:

[REDACTED]
Santa Barbara CA [REDACTED]

Dayne Haigh

HouseMaster

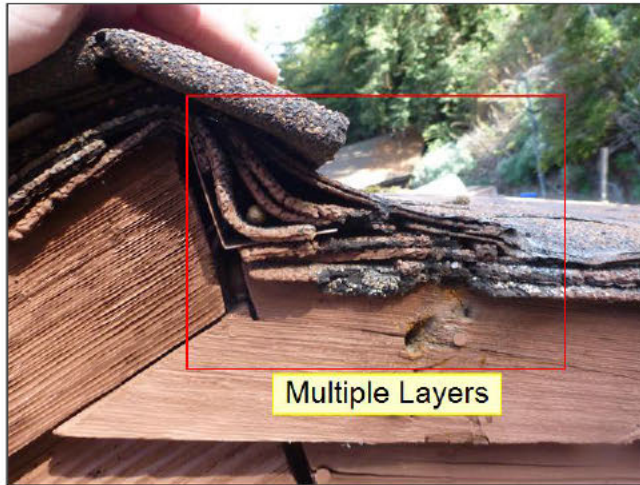
1.0 ROOFING (See Picture(s))

●			1.0 ROOFING Roof shingles are failing. Granule loss and exposed fiberglass noted. Consult roofer for repair/ replacement cost estimates prior to close of escrow. Roof sag noted. Multiple layers noted. Stripping will be required when re-roofing. Consult roofer for cost estimate. A determination should be made at time of re-roofing as to if flashing and roof decking replacement will be necessary.(See Picture(s)) Roof coverings require periodic repairs and sealant, especially at exposed/rusting nails, flashings and around roof penetrations. Suggest sealing penetrations now and annual evaluation/servicing as needed to prevent water penetration. Tree branches noted in contact with roof. Suggest trimming/ removing branches to eliminate pest access to roof and roof wear.(See Picture(s))
		●			1.1 EXPOSED FLASHING Lifting/exposed and rusting nails noted. Consult a roofing contractor for repairs as required to prevent water penetration.(See Picture(s)) Rusting noted at flashings. Suggest painting to prevent water penetration and extend service life.(See Picture(s)) Missing drip flashing noted at various locations of eaves. Consult a roofing contractor for evaluation/ proper installation to prevent moisture damage to sheathing. (See Picture(s))

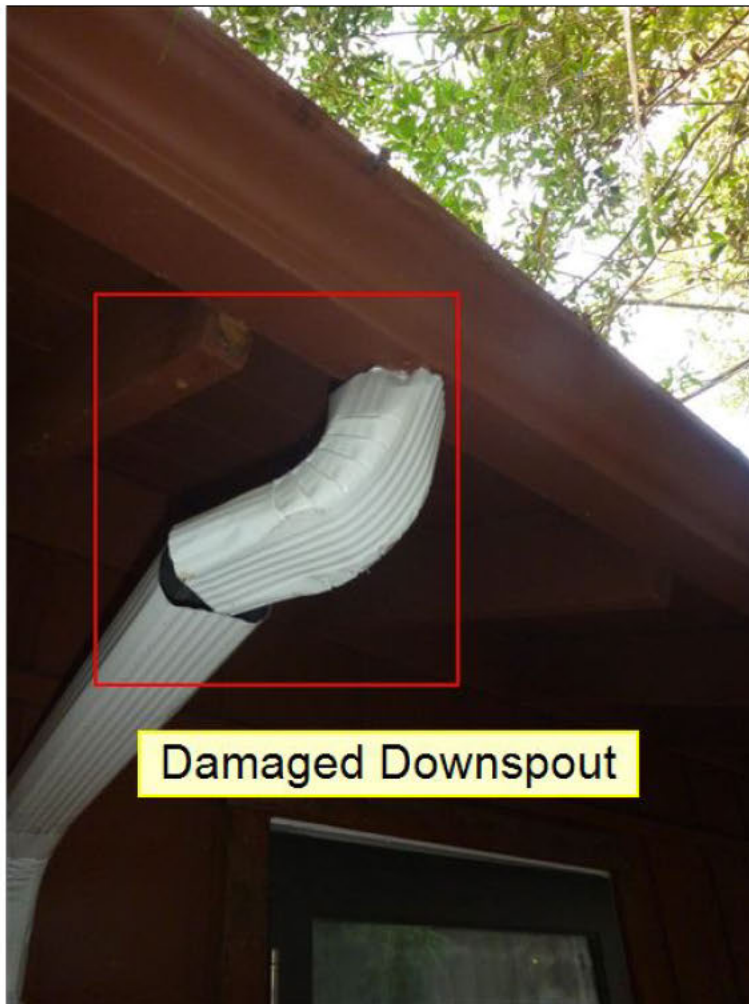
1.6 DOWNSPOUTS / ROOF DRAINS (See Picture(s))

Damaged Downspout

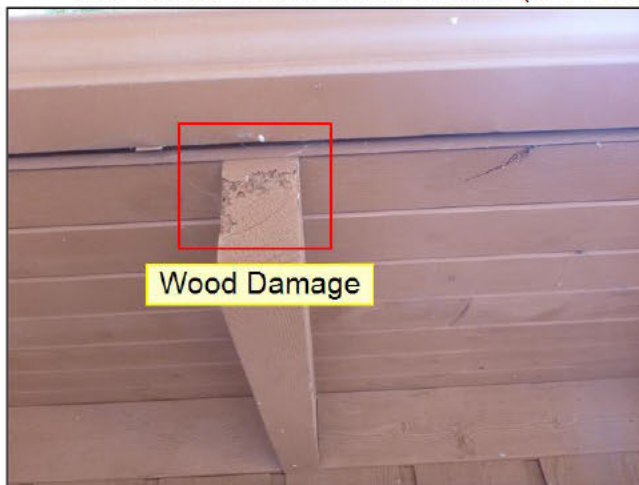
1.7 FASCIA / SOFFITS (See Picture(s))

Wood damage noted at fascia/eaves/soffit members. Anticipate repairs. Consult pest control company for evaluation and repair cost estimate for damaged wood.(See Picture(s))

Wood Damage

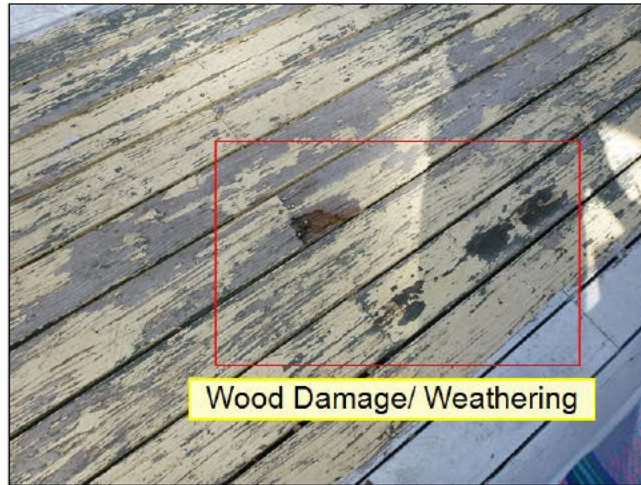
2.4 PORCH(ES) / DECK(S) (See Picture(s))

Wood Damage/ Weathering

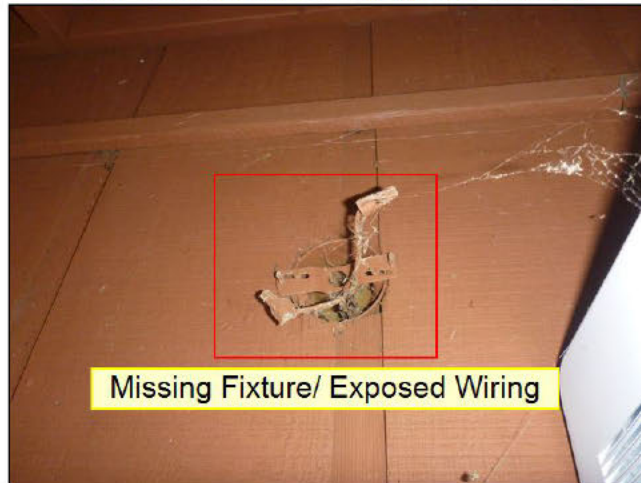
2.5 ELECTRIC / GFCI (See Picture(s))

Missing Fixture/ Exposed Wiring

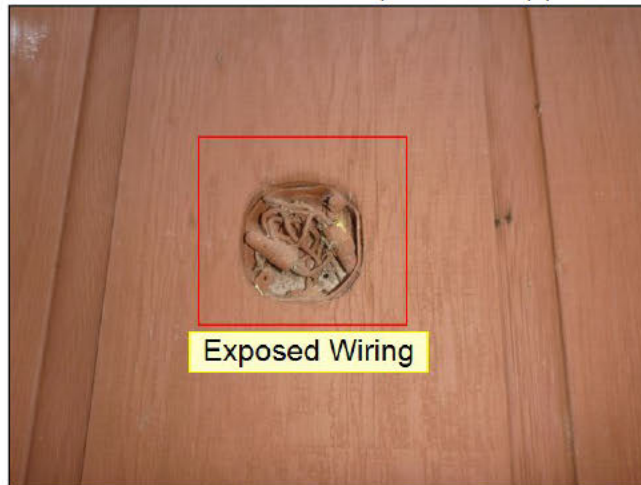
2.5 ELECTRIC / GFCI (See Picture(s))

Exposed Wiring

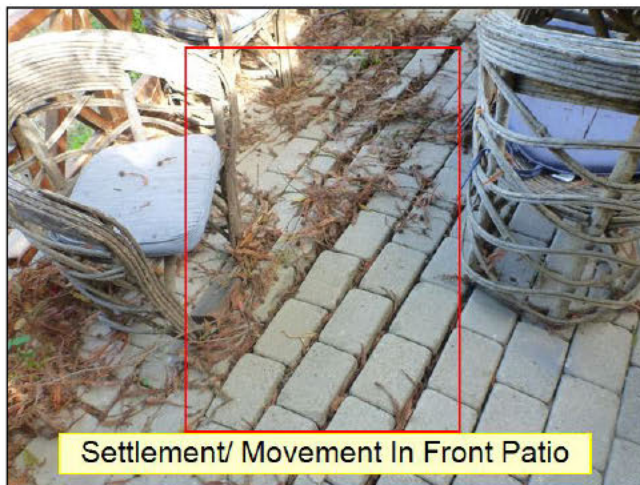
3.2 PATIO(S) (See Picture(s))

Settlement/ Movement In Front Patio

Settlement noted at front patio. Anticipate repairs. Suggest drainage upgrades and controlling water from roof cover. Consult a contractor for evaluation/ repairs.(See Picture(s))

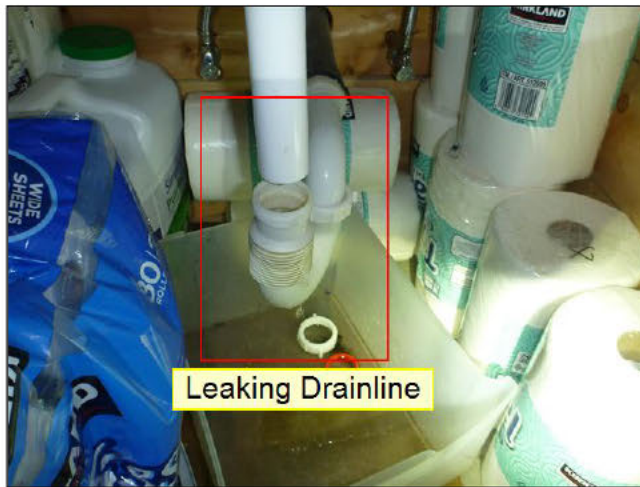
4.0 SINK(S) (See Picture(s))

Leaking Drainline

Leak at plumbing under hall bath sink noted. Consult plumber for further evaluation and repairs.(See Picture(s))

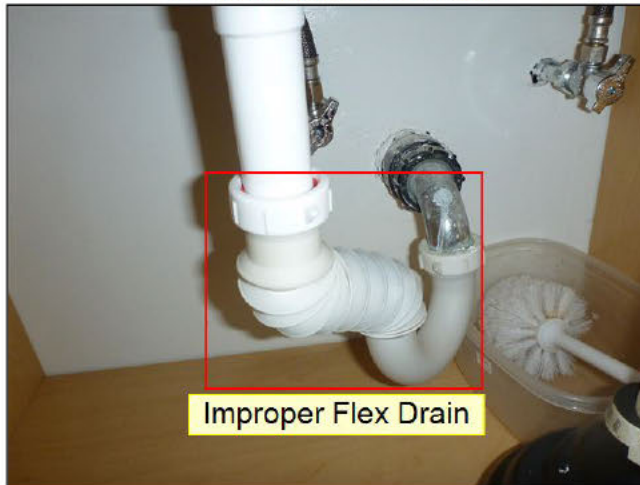
4.0 SINK(S) (See Picture(s))

Improper Flex Drain

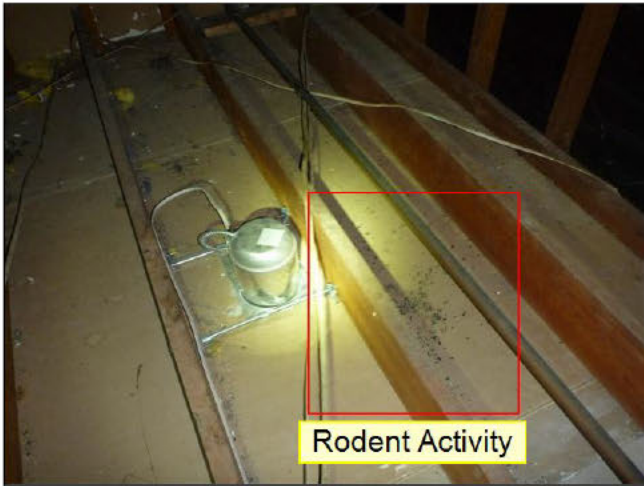
5.0 ROOF FRAMING (See Picture(s))

●					5.0 ROOF FRAMING No structural conditions to report in attic. See pest control report for conditions related to wood framing members. Rodent activity noted in the attic. Consult a pest control professional for evaluation and remediation as required.
	●				5.1 ROOF DECK / SHEATHING Stains noted at framing in the attic appear to be from water leaks prior to current roof installation. See pest control report. Evidence of possible wood destroying organisms and/or damage noted in attic. Consult pest control company to evaluate and repairs/remediation as required. Anticipate repairs.
●					5.2 VENTILATION PROVISIONS
●					5.3 INSULATION No insulation installed in attic. Consider insulation upgrade for occupant comfort and energy efficiency.

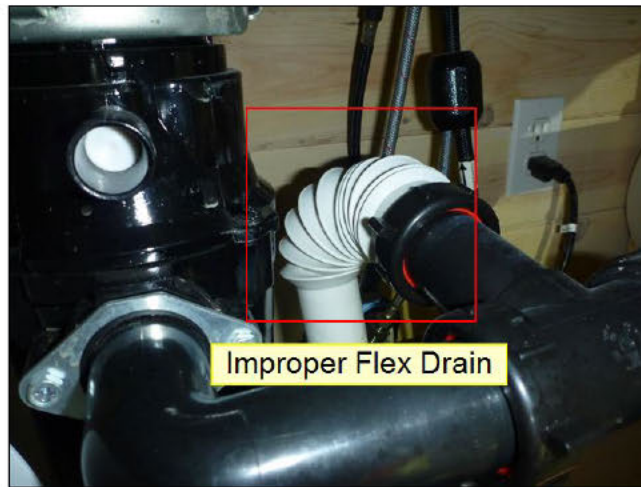
6.0 PLUMBING / SINK (See Picture(s))

Flexible drain trap noted under guest unit kitchen sink. This is not approved per the plumbing codes. Suggest changing to approved trap by a licensed plumber.(See Picture(s))

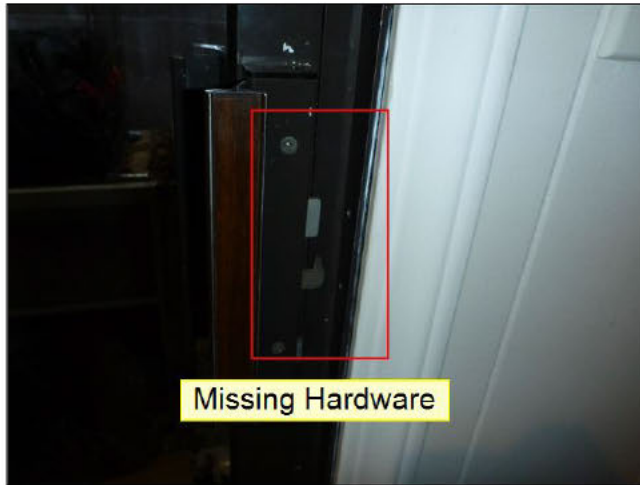
7.5 PATIO / DECK DOORS(S) (See Picture(s))

Missing Hardware

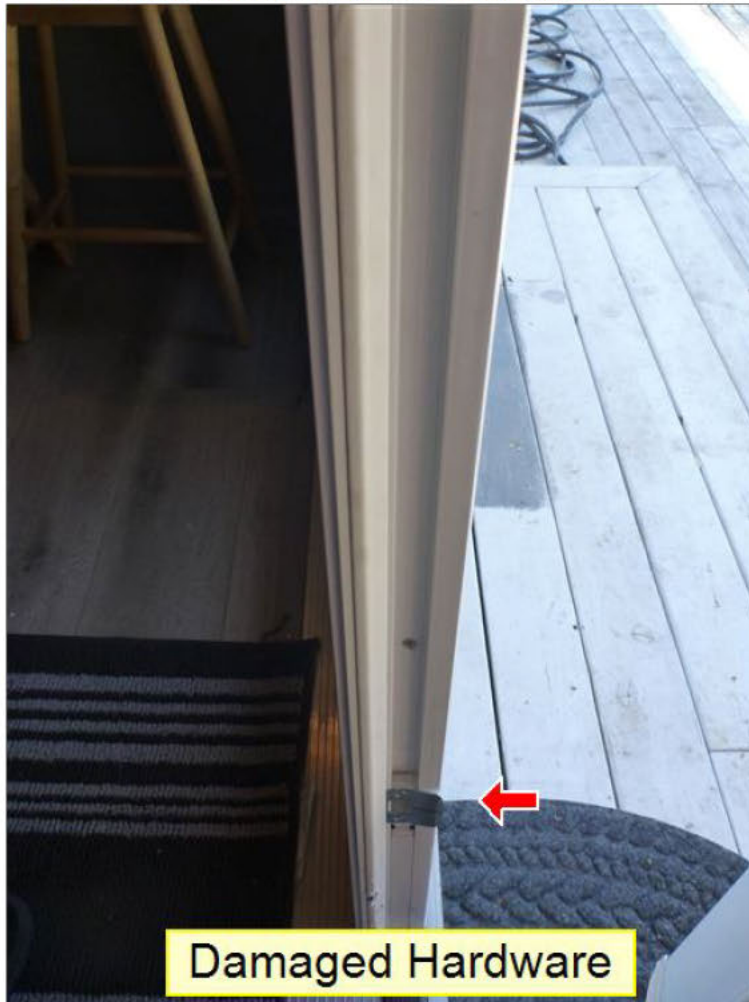
7.5 PATIO / DECK DOORS(S) (See Picture(s))

Damaged Hardware

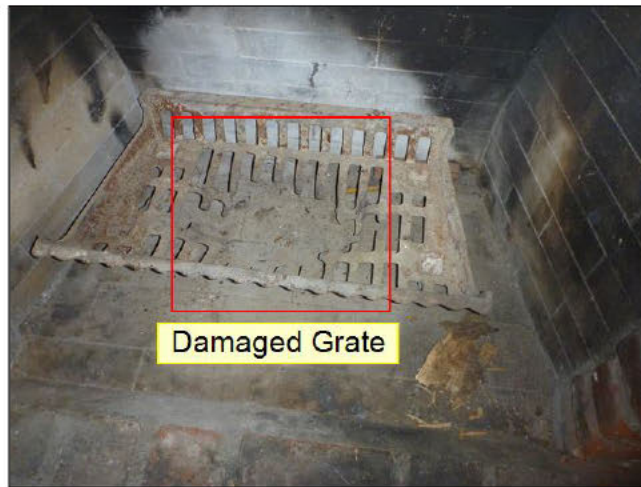
7.7 FIREPLACE(S) (See Picture(s))

Damaged Grate

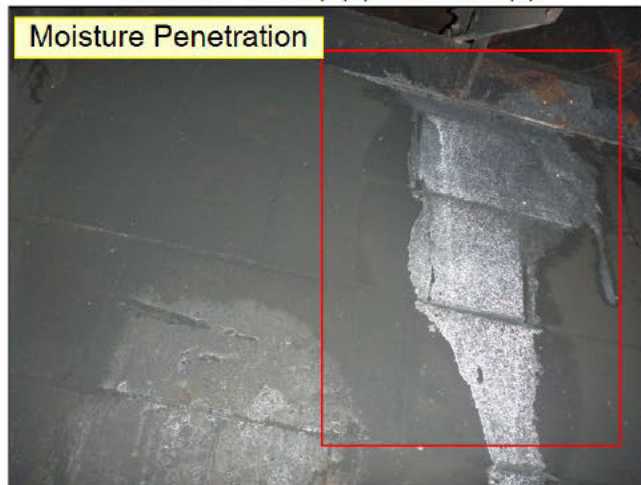
7.7 FIREPLACE(S) (See Picture(s))

Moisture Penetration

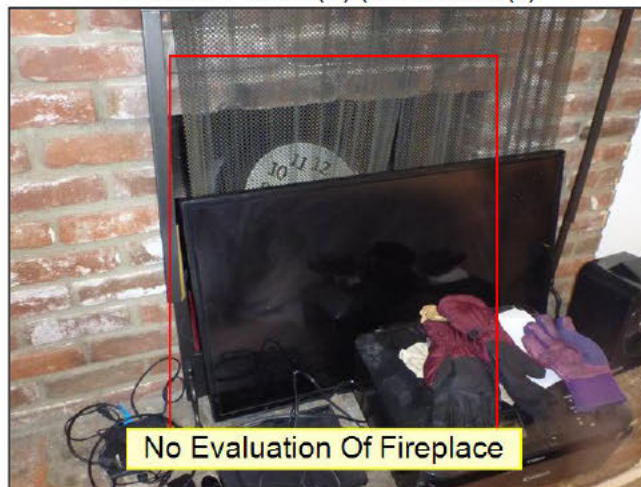
7.7 FIREPLACE(S) (See Picture(s))

No evaluation of master bedroom fireplace noted due to storage. Suggest evaluation by a chimney specialist prior to close of escrow.

No Evaluation Of Fireplace

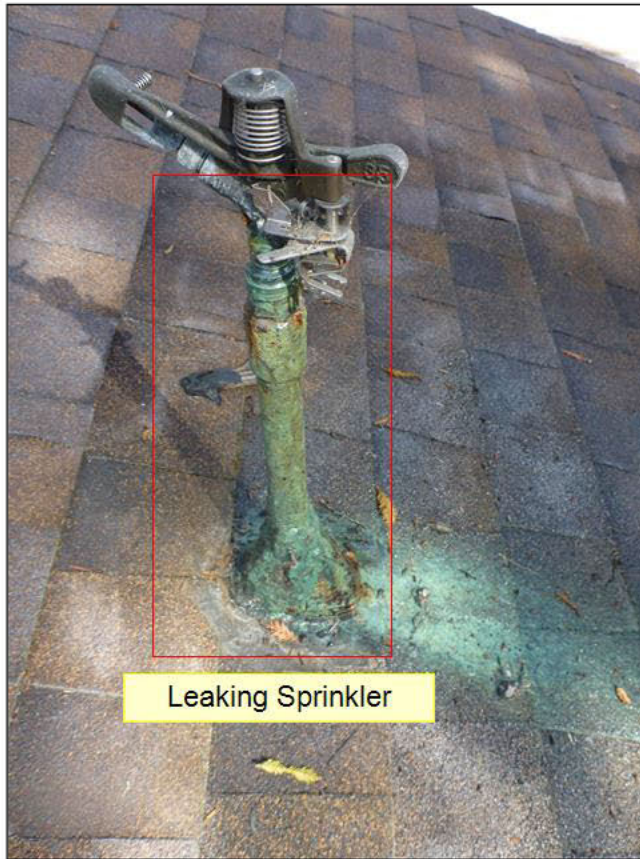
11.0 WATER PIPING (See Picture(s))

Leaking Sprinkler

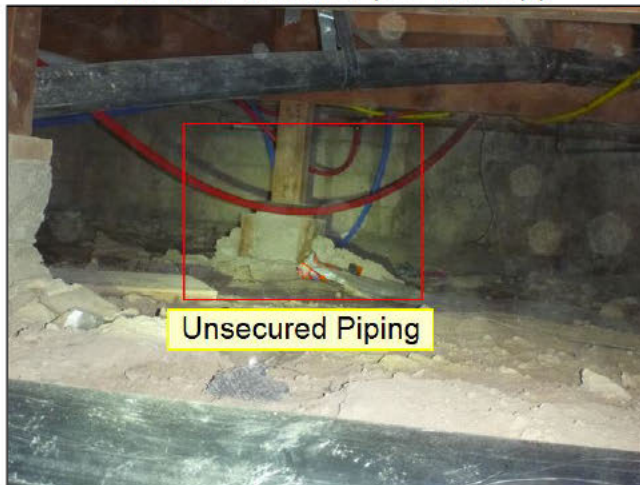
11.0 WATER PIPING (See Picture(s))

Unsecured Piping

Improper secured PEX piping noted in the crawlspace. Consult a plumber for evaluation/ proper installation to prevent damage to piping.(See Picture(s))

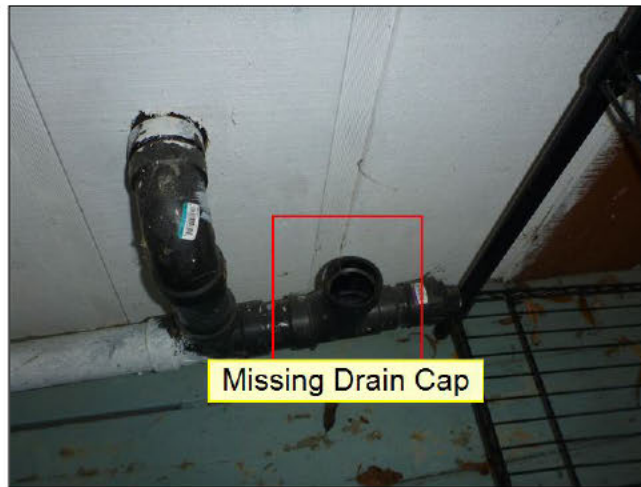
11.2 DRAIN / WASTE PIPING (See Picture(s))

Missing Drain Cap

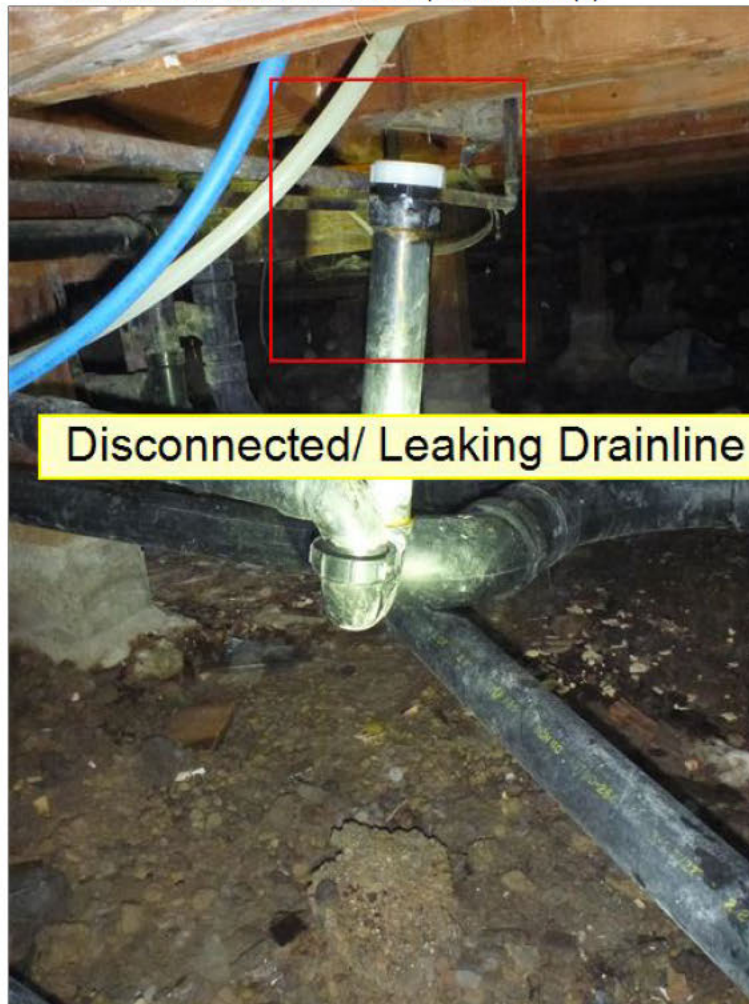
11.2 DRAIN / WASTE PIPING (See Picture(s))

Disconnected/ Leaking Drainline

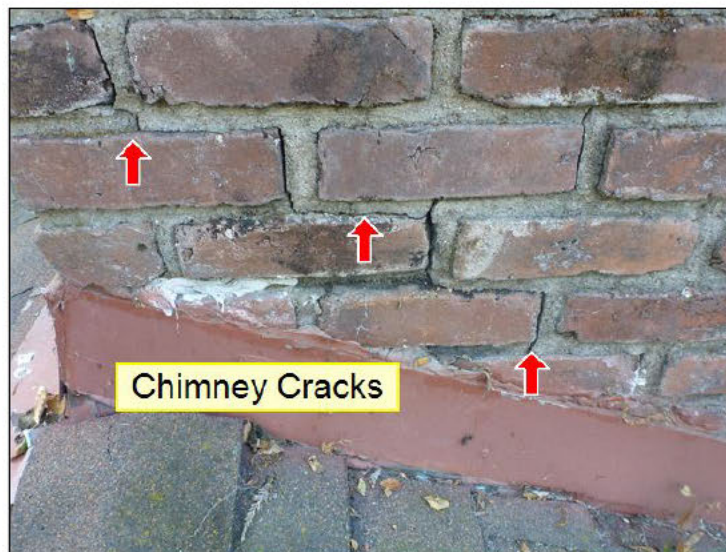
1.2 (See Picture(s))

Cracking noted at chimney. Suggest consulting qualified chimney professional for further evaluation and repairs prior to close of escrow.(See Picture(s))

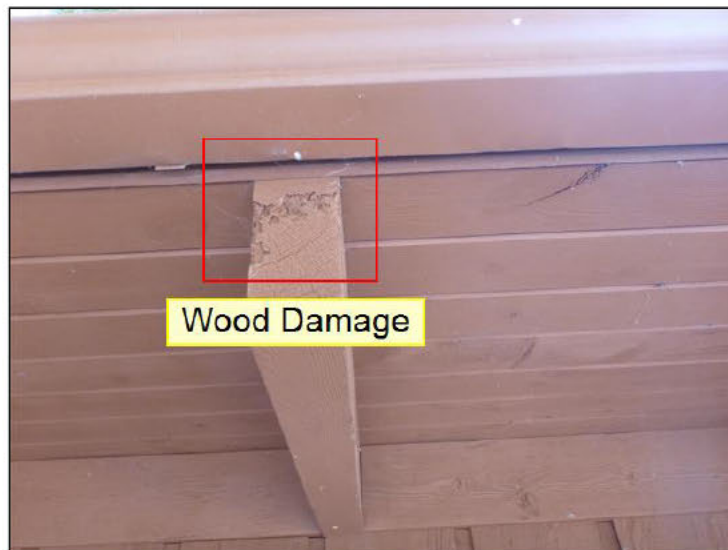
1.7 (See Picture(s))

Wood damage noted at fascia/eaves/soffit members. Anticipate repairs. Consult pest control company for evaluation and repair cost estimate for damaged wood.(See Picture(s))

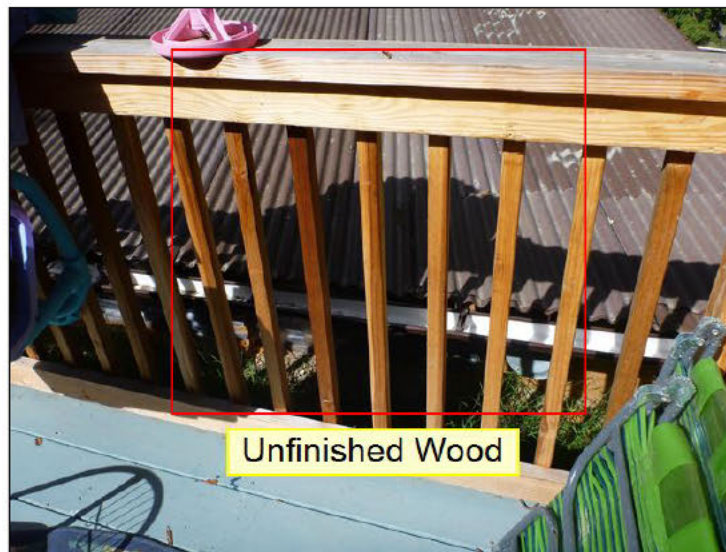
2.3 (See Picture(s))

Unfinished wood noted in various locations. Have wood properly sealed for protection and enhanced lifespan.(See Picture(s))

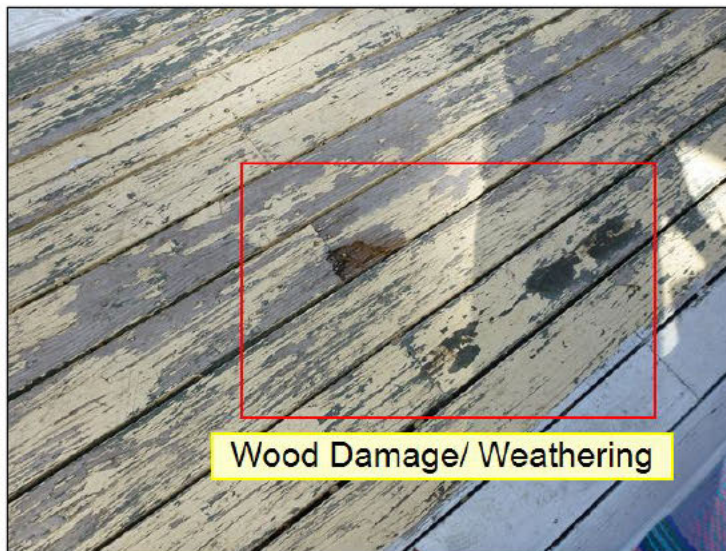
2.4 (See Picture(s))

Wood Damage/ Weathering

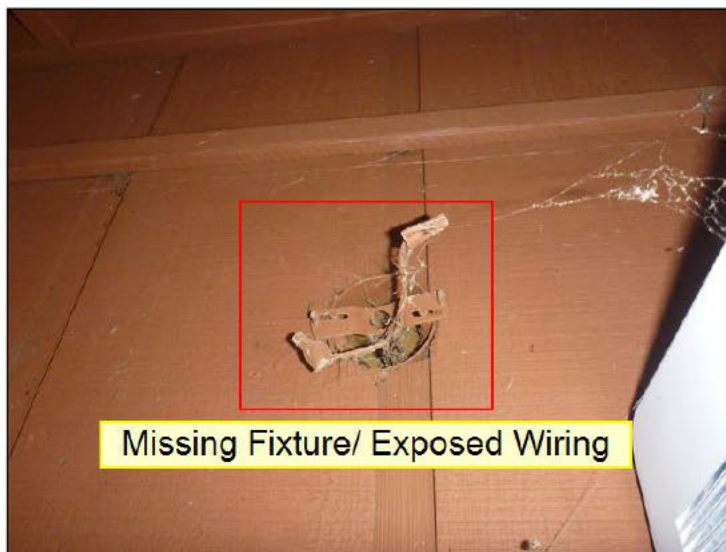
2.5 (See Picture(s))

Missing Fixture/ Exposed Wiring

Suggest upgrades to Ground Fault Circuit Interrupters (GFCI) outlets at all exterior outlets for added safety. Consult licensed electrical contractor for installation.

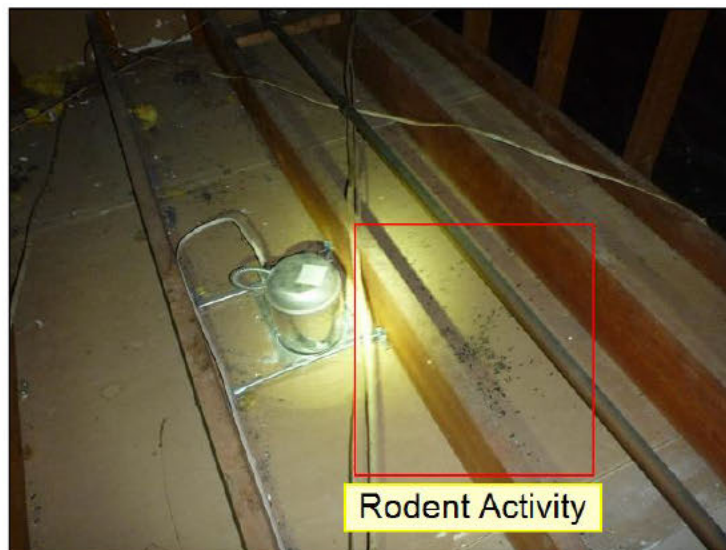
5.0 (See Picture(s))

Rodent activity noted in the attic. Consult a pest control professional for evaluation and remediation as required.

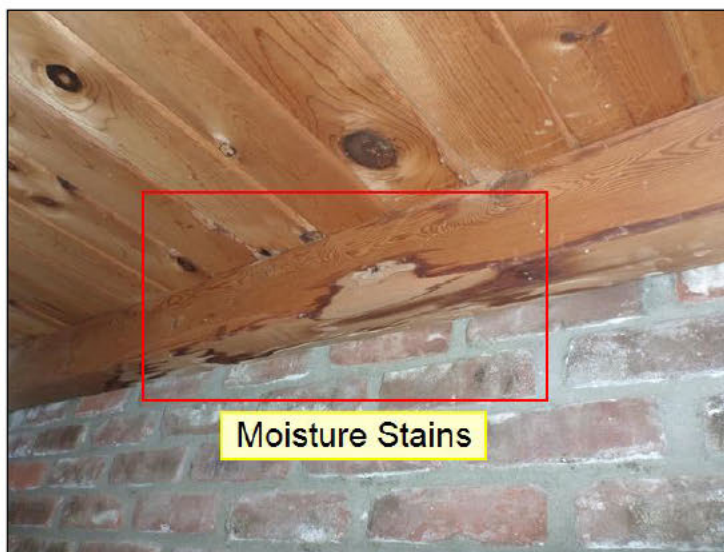
7.1 (See Picture(s))

Staining and discoloration noted at ceiling(s). Possible leakage from exterior and/or roof cover. Consult seller regarding prior water penetration. Check for hidden damage.(See Picture(s))

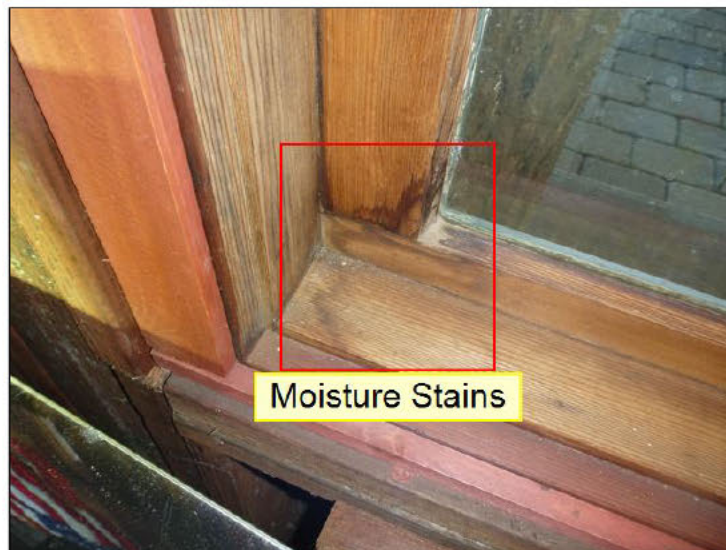
7.3 (See Picture(s))

Moisture stains noted at windows in guest area. Consult seller as to history and contractor for repairs. Unable to determine if any hidden damage exists.(See Picture(s))

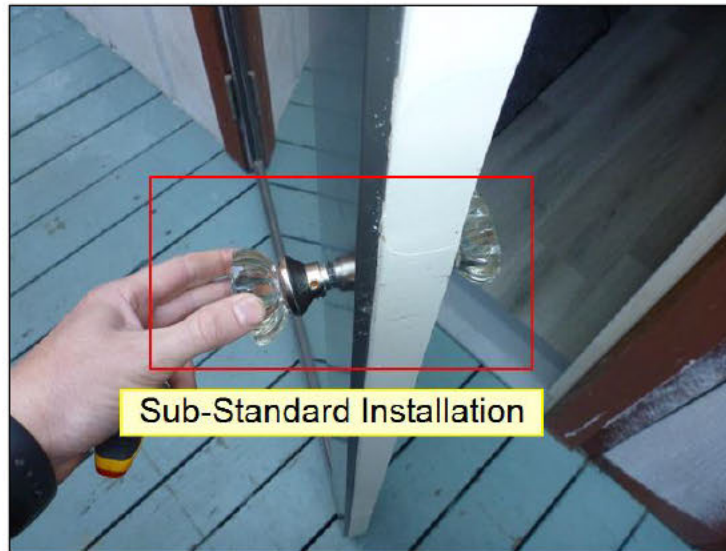
7.5 (See Picture(s))

Inoperable/ damaged/ missing hardware noted at french doors/ sliding glass door. Sub-standard installation of hardware noted at various entrance doors. Consult a contractor for evaluation/ proper installation as needed.(See Picture(s))

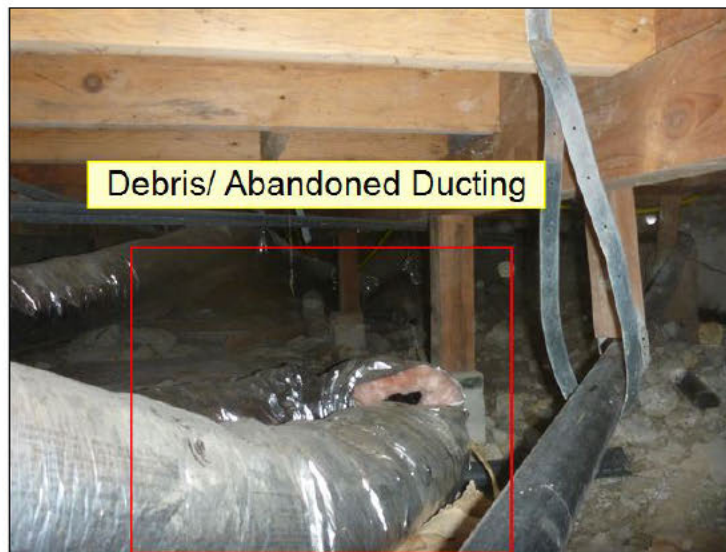
8.0 (See Picture(s))

Debris noted in crawlspace. Anticipate removal of debris.(See Picture(s))

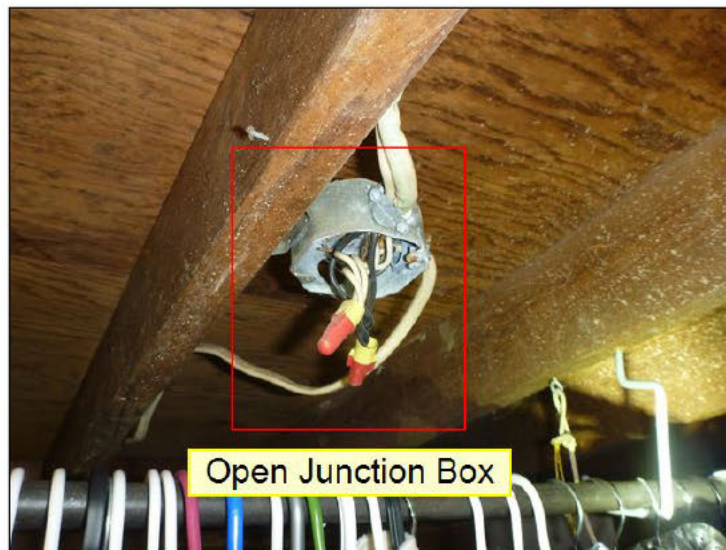
9.5 (See Picture(s))

Sub-standard installation of romex wiring noted at various locations. Consult an electrician for evaluation/ repairs for safety prior to close of escrow.(See Picture(s))

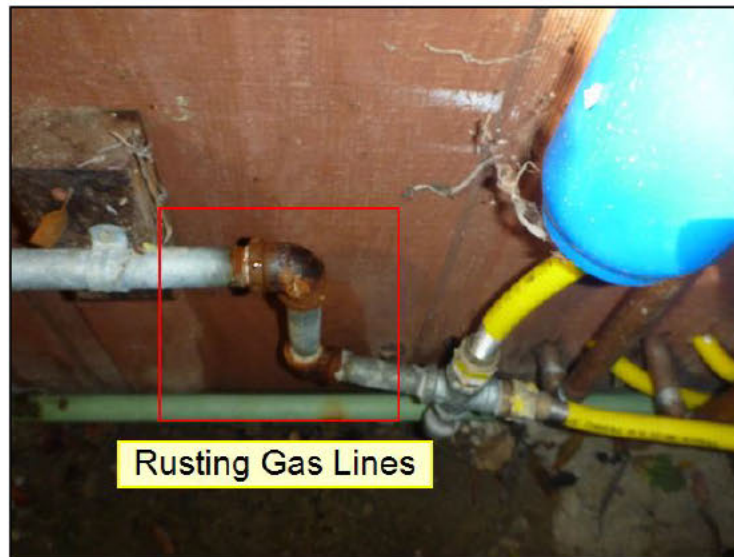
11.6 (See Picture(s))

Gas leak noted at main house water heater. Consult a plumber for evaluation/ repairs for safety prior to close of escrow.
Rusting gas lines noted. Suggest painting to extend service life.(See Picture(s))

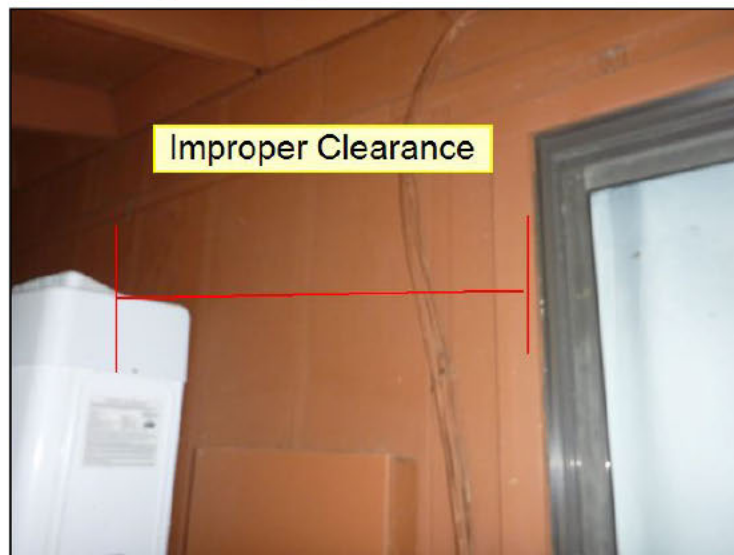
12.1 (See Picture(s))

Improper clearance noted at water heater exhaust vent. Vent is within 3 feet of an operable door. Consult a plumber for proper/ safe install thru the roof eave for safety prior to close of escrow.(See Picture(s))
