██████████ Winery

██████████
Santa Ynez Ca ██████████

HouseMaster

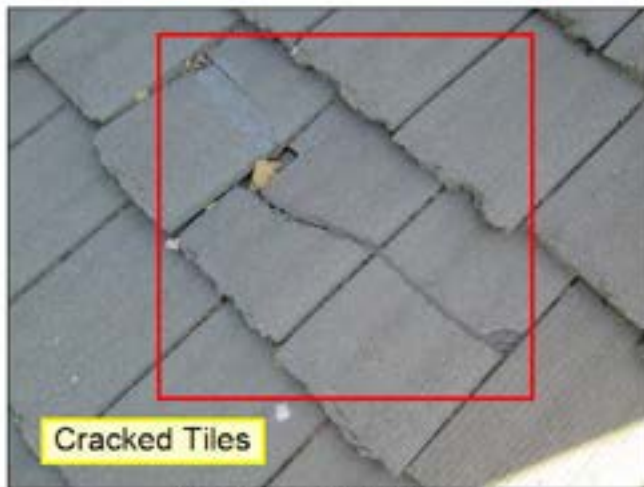
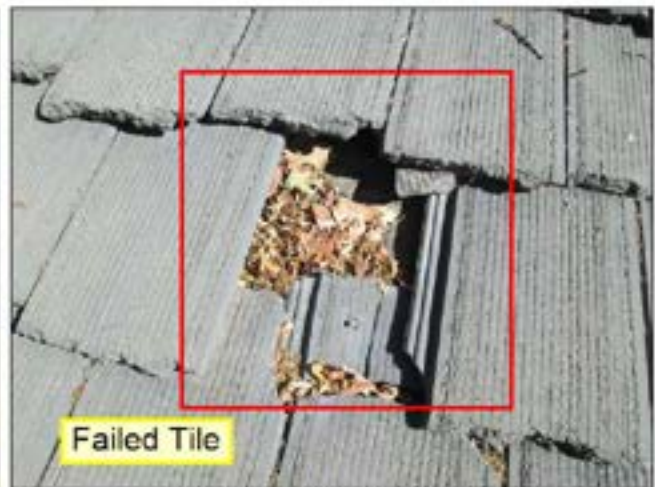
●	<p>1.0.A ROOFING</p> <p>Main house concrete roof tiles are damaged at numerous locations. Consult roofer to evaluate and make repairs. (Picture 1&2)</p> <p>Anticipate periodic repairs and sealing of roof penetrations. Maintain roof tiles to aide in preventing water penetration into structure. Limit access to roof cover to aide in preventing damage to roof tiles.</p>
						●	<p>1.1.A CHIMNEYS / VENTS</p> <p>Inspection of chimney is limited to visible areas only. See interior section of report for comments related to firebox.</p>
						●	<p>1.2.A EXPOSED FLASHING</p> <p>Clean leaf debris out of valleys. Debris in valleys will lead to deterioration of valley flashing and may cause water to back up and cause water penetration into structure. (Picture 1)</p> <p>Recommend regular cleaning to ensure proper roof drainage.</p>
						●	<p>1.3.A PLUMBING STACKS</p>
						●	<p>1.4.A VENTILATION COVERS</p> <p>Suggest annual inspection and sealing around all vent covers and plumbing stacks, to aide in preventing water penetration.</p>

1.0.A ROOFING Picture 1

1.0.A ROOFING Picture 2

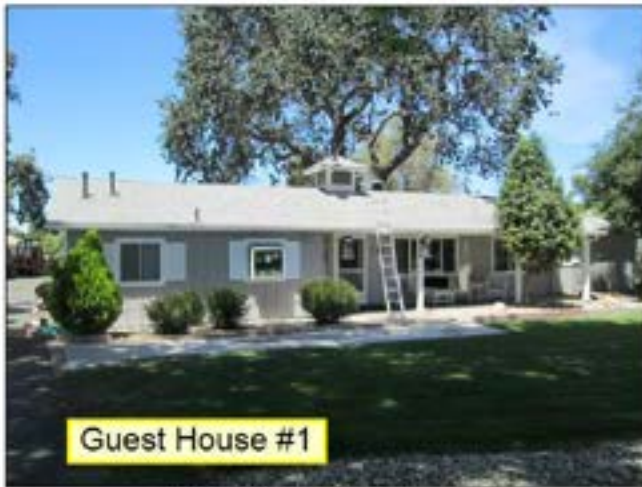
1.0.B ROOFING Picture 1

●				<p>1.0.B ROOFING New roof cover noted. Suggest obtaining paper work from current owner and/or contacting installer and manufacture regarding possible warranty. (Picture 1) TV cables running on roof should be re-routed off of roof for proper installation. (Picture 2)</p>
	●			<p>1.1.B CHIMNEYS / VENTS Rain Cap is not installed at chimney. Installation required for fire safety and to help prevent moisture damage to chimney components. Consult a chimney professional for installation. See interior section of report for comments related to firebox, unlined chimneys, lack of dampers and suggestion for chimney sweep inspection of all units. (Picture 1)</p>
●				<p>1.2.B EXPOSED FLASHING</p>
●				<p>1.3.B PLUMBING STACKS</p>
●				<p>1.4.B VENTILATION COVERS Suggest annual inspection and sealing around all vent covers and plumbing stacks, to aide in preventing water penetration.</p>
●				<p>1.5.B RAIN GUTTERS / EAVETROUGHES Consider adding more rain gutters and downspouts to aide in controlling water run off away from structure. Consider adding built in drains/ subsurface drains and connecting downspouts into drainage system. Gutters and downspouts help aide in reducing water runoff from splashing onto/penetrating into structure.</p>

Guest House #1

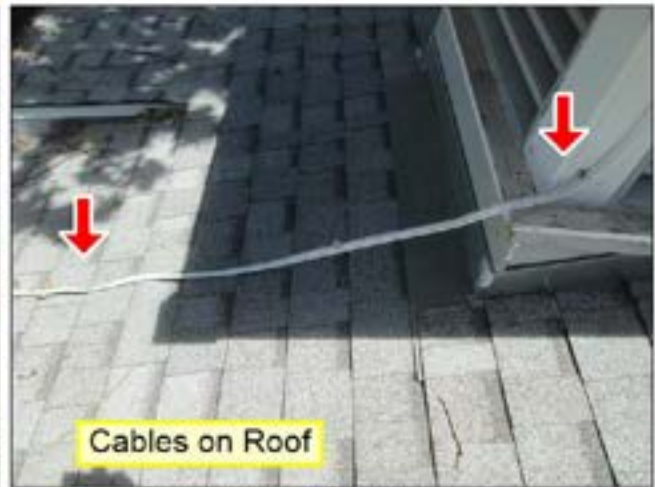
1.0.B ROOFING Picture 2

Cables on Roof

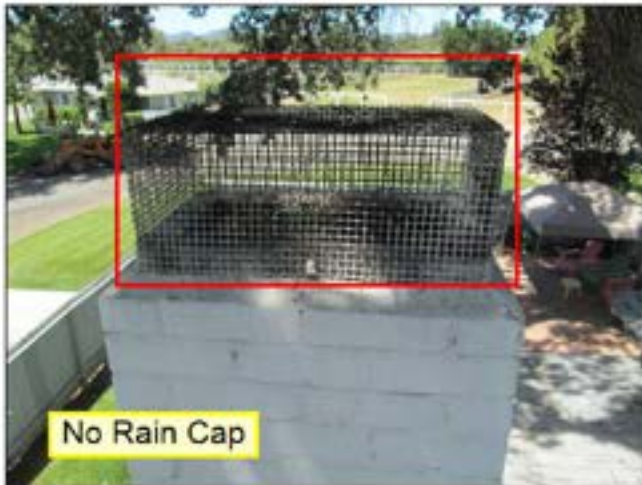
1.1.B CHIMNEYS / VENTS Picture 1

No Rain Cap

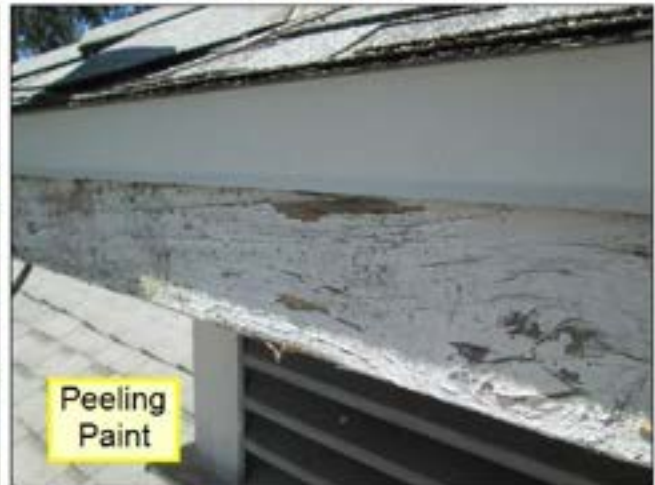
1.7.B FASCIA / SOFFITS Picture 1

●				<p>1.6.B DOWNSPOUTS / ROOF DRAINS Recommend extending rain gutter downspouts to move water away from the foundation. Downspouts near structure may allow excessive water to pond and/or penetrate into structure. Consider installing downspouts into built in drains to aide in diverting water run off. See supplemental comments for additional information.</p>
●				<p>1.7.B FASCIA / SOFFITS Paint is peeling/loose at various locations. Anticipate repainting. See pest control report. (Picture 1)</p>

Peeling Paint

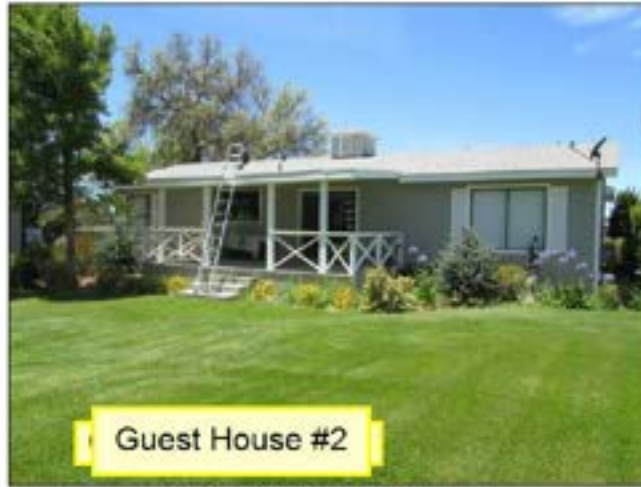
1.0.C ROOFING Picture 1

●				<p>1.0.C ROOFING</p> <p>Roof coverings require periodic repairs and sealant, especially around roof penetrations. Suggest periodic evaluation and repairs as needed to aide in preventing water penetration into structure. (Picture 1)</p> <p>New roof cover noted. Suggest obtaining paper work from current owner and/or contacting installer and manufacture regarding possible warranty.</p>
●				<p>1.1.C CHIMNEYS / VENTS</p> <p>Rain Cap is not installed at chimney. Installation required for fire safety and to help prevent moisture damage to chimney components. Consult a chimney professional for installation. See interior section of report for comments related to firebox, unlined chimneys, lack of dampers and suggestion for chimney sweep inspection of all units.</p>
●				<p>1.2.C EXPOSED FLASHING</p>
●				<p>1.3.C PLUMBING STACKS</p>
●				<p>1.4.C VENTILATION COVERS</p> <p>Suggest annual inspection and sealing around all vent covers and plumbing stacks, to aide in preventing water penetration.</p>

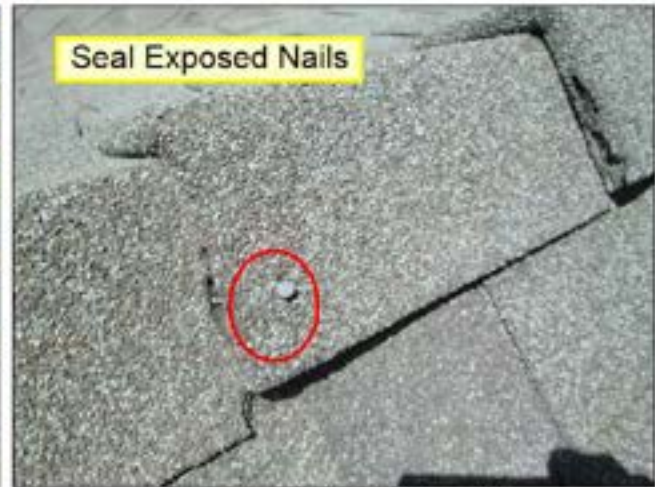
1.0.D ROOFING Picture 2

●				<p>1.0.D ROOFING</p> <p>Roof coverings require periodic repairs and sealant, especially at exposed nails and flashings. Suggest painting and sealing now and annual evaluation/servicing as needed to prevent water penetration. (Picture 2)</p> <p>Newer roof cover noted. Suggest obtaining paper work from current owner and/or contacting installer and manufacture regarding possible warranty. (Picture 1)</p>
●				<p>1.1.D CHIMNEYS / VENTS</p> <p>Rain Cap is not installed at chimney. Installation required for fire safety and to help prevent moisture damage to chimney components. Consult a chimney professional for installation. See interior section of report for comments related to firebox. (Picture 1)</p>
●				<p>1.2.D EXPOSED FLASHING</p>
●				<p>1.3.D PLUMBING STACKS</p>
●				<p>1.4.D VENTILATION COVERS</p> <p>Suggest annual inspection and sealing around all vent covers and plumbing stacks, to aide in preventing water penetration.</p>

Seal Exposed Nails

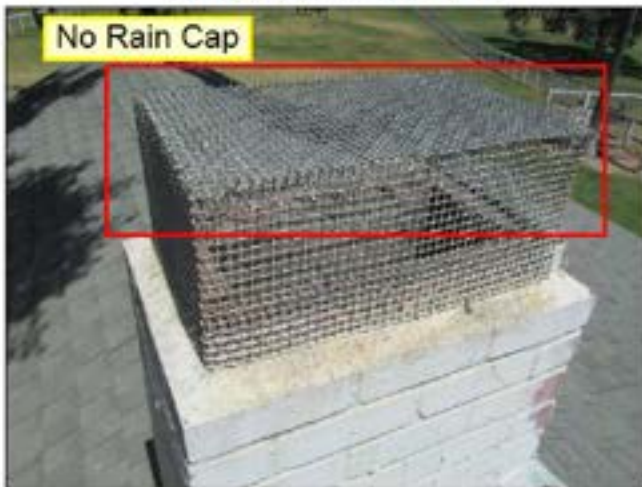
1.1.D CHIMNEYS / VENTS Picture 1

No Rain Cap

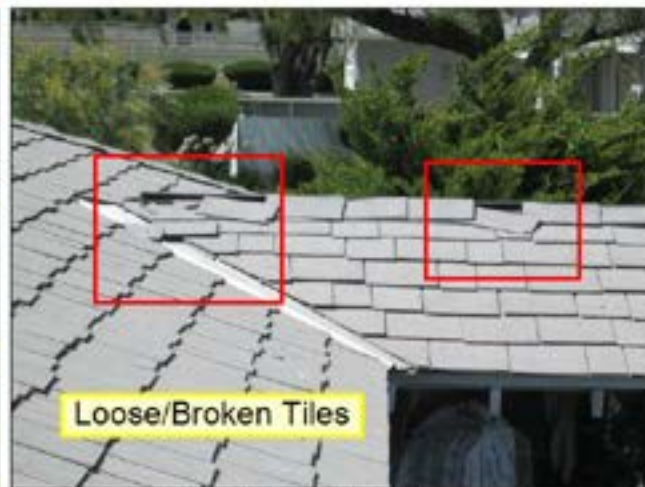
1.0.E ROOFING Picture 2

●	1.0.E ROOFING Numerous roof tiles at bunk house are broken/missing and need repair and/or replacement. Consult roofer to evaluate and make repairs. (Picture 2)
●	1.1.E PLUMBING STACKS Gaps noted at roof penetrations. Reseal roof penetrations now and on a routine basis to prevent leakage to interior of structure.
●	1.2.E RAIN GUTTERS / EAVETROUGHES Consider adding gutters and downspouts to aide in controlling water run off away from structure. Consider adding built in drains/ subsurface drains and connecting downspouts into drainage system. Gutters and downspouts help aide in reducing water runoff from splashing onto/penetrating into structure.
●	1.3.E FASCIA / SOFFITS Wood damage noted at fascia/ soffit areas. Consult pest control company for evaluation and repair cost estimate for damaged wood.

Loose/Broken Tiles

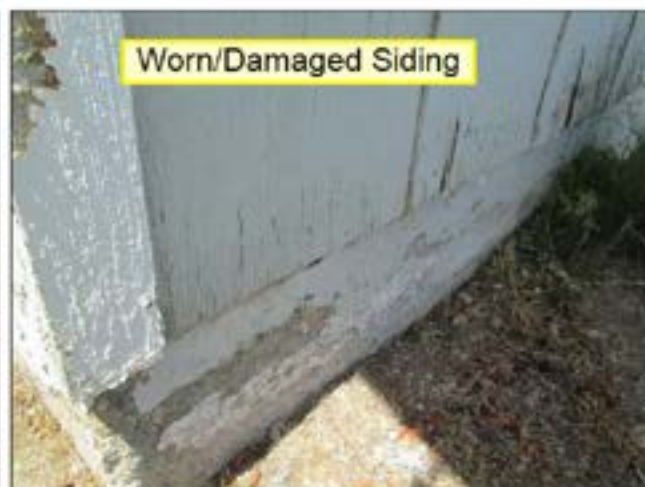
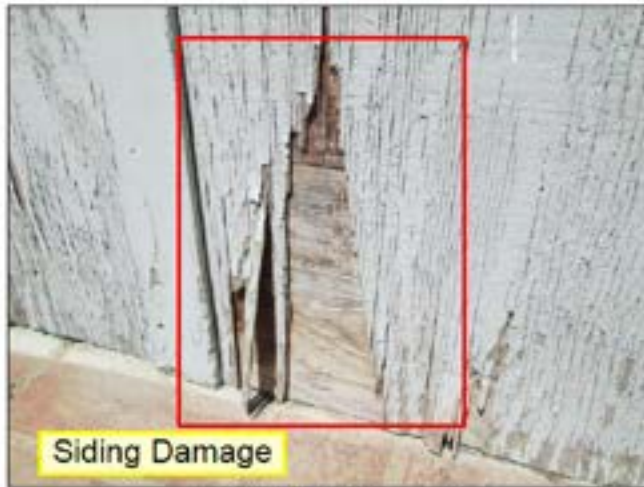
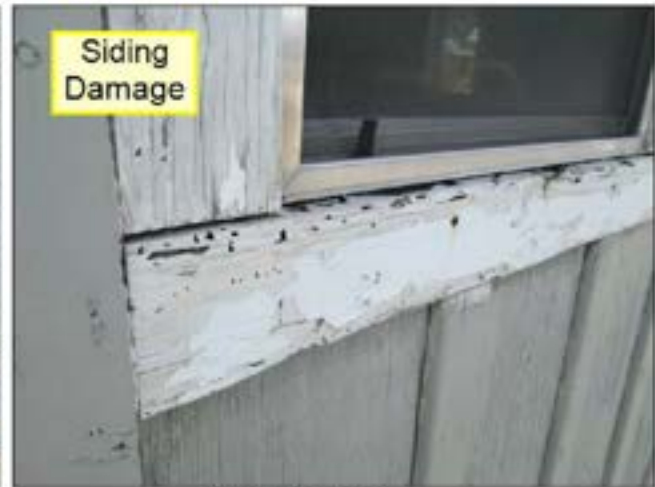
S	F	P	N	ANI	Findings
		●			2.0 SIDING Damaged/worn siding noted at all guest houses and bunk house. Anticipate repairs and painting. (Picture 2,3&4) See pest control report. Suggest changing all irrigation spray heads near all structures to drip style to prevent overspray on to siding and subsequent damage. (Picture 1)
		●			2.1 WINDOWS Older, worn and broken windows noted at guest houses and bunk house. Anticipate maintenance/repairs/replacement. Consult a window company for evaluation/cost estimate prior to close of escrow. Wood damage noted at trim of numerous windows. Anticipate repairs. See pest control report. (Picture 1)
		●			2.2 ENTRY DOORS Weather stripping gaps noted missing at majority of entry doors. Install weather stripping for energy savings and to prevent pest intrusion.
		●			2.3 SLAB FOUNDATION Foundation surfaces is not fully visible (slab on grade) therefore limited inspection noted. No significant cracking noted at exposed edge at the time of inspection.

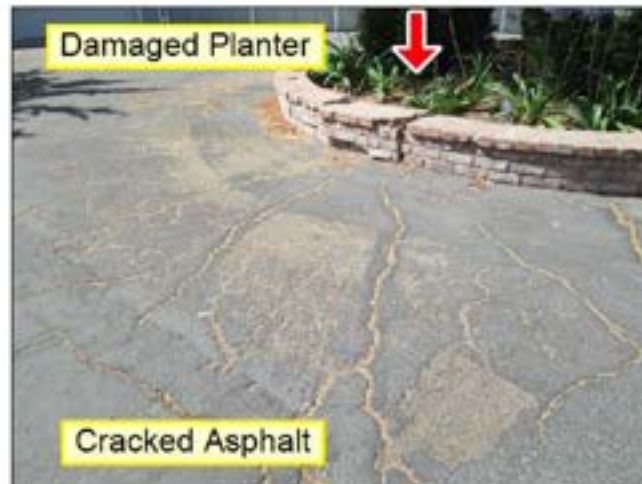
3.1 DRIVEWAY Picture 1

S	F	P	N	A	N	I	
●							3.0 WALKWAYS
		●					3.1 DRIVEWAY Cracking noted at asphalt driveway. Suggest sealing of cracks to extend service life. Anticipate repair of damaged bricks at driveway planter. (Picture 1)
●							3.2 GROUND SLOPE AT FOUNDATION
●							3.3 SITE GRADING

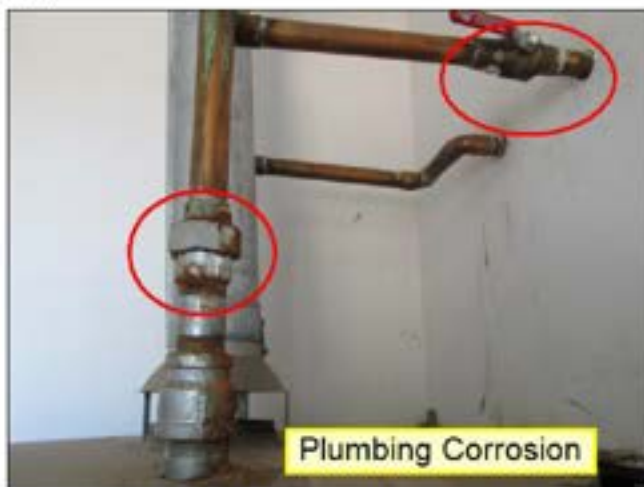
13.0.A WATER HEATER Picture 1

Plumbing Corrosion

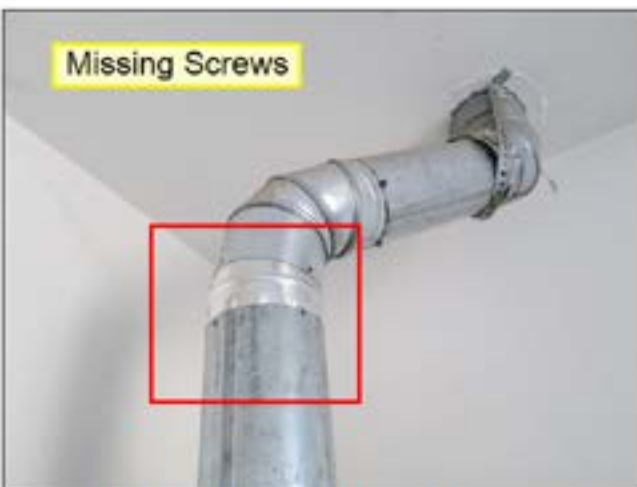
13.1.A VENT CONNECTOR Picture 1

Missing Screws

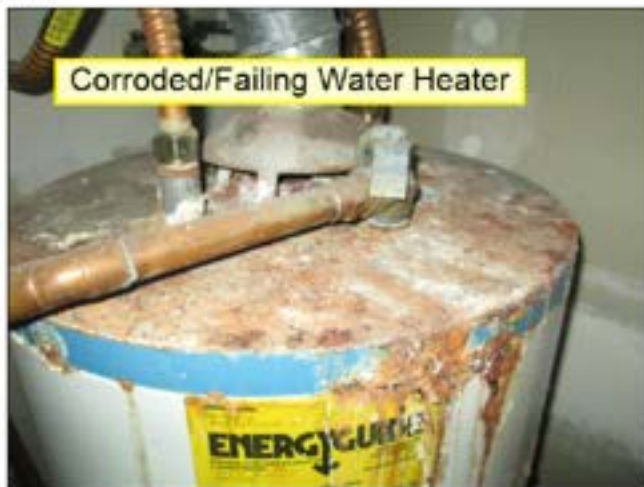
13.0.B WATER HEATER Picture 1

Corroded/Failing Water Heater

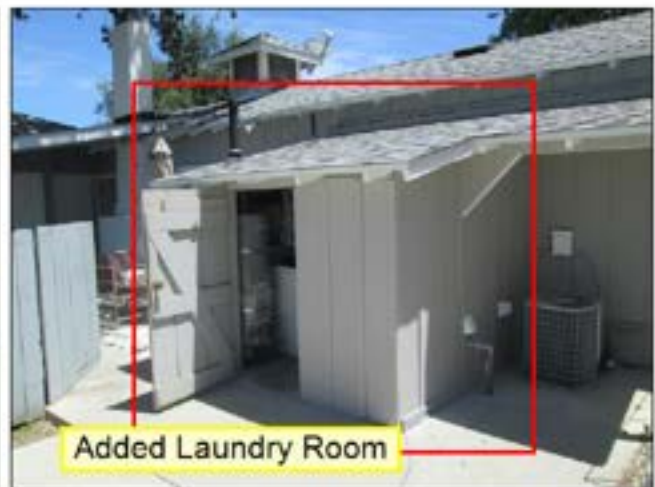
13.0.B WATER HEATER Picture 2

Added Laundry Room

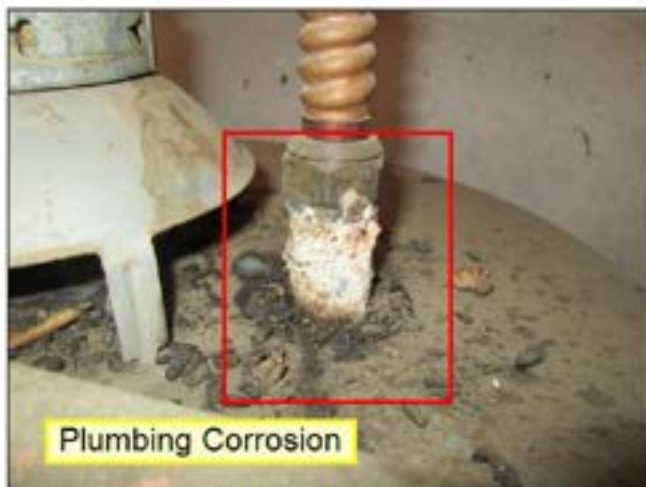
13.0.D WATER HEATER Picture 1

Plumbing Corrosion

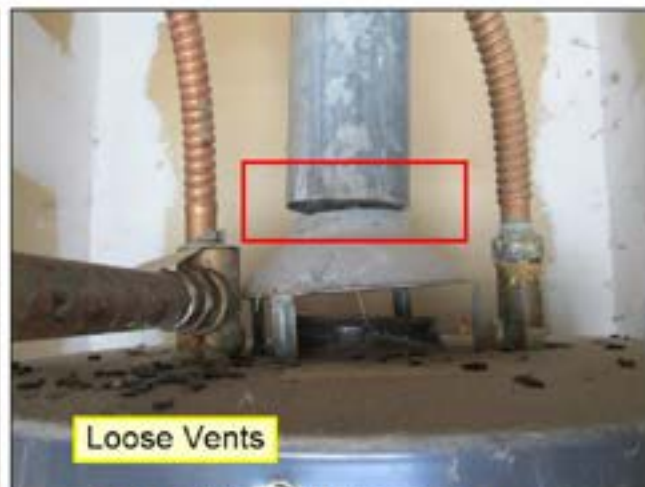
13.1.D VENT CONNECTOR Picture 1

Loose Vents
