## INSPECTION INFORMATION

123 ANY STREET  
YOUR TOWN CA 90000

2/24/2020 - 9:30 am

HouseMaster Home Inspections of Northern California  
100 Maple St #1926  
HOLLISTER CA, 95023  
800-995-4063

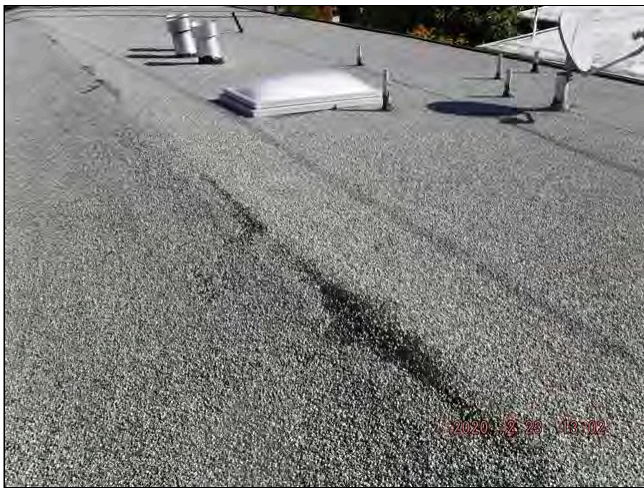
1.0 ROOF COVERING (Picture 1)

Tar and gravel roof with some bare spots showing the tar underlayment. Recommend having the gravel redistributed over the bare areas and annual inspections made.

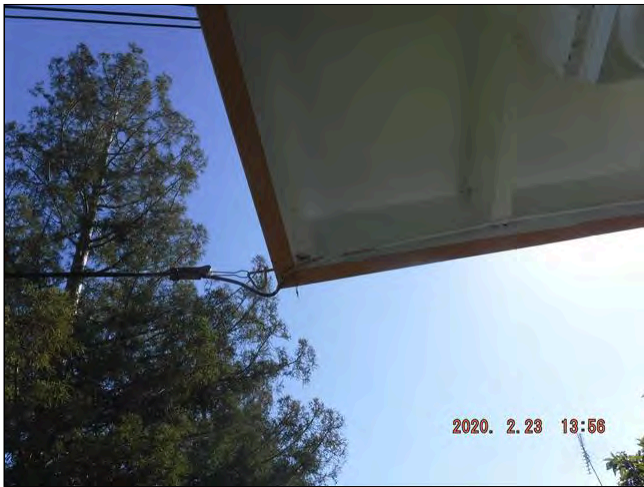
1.5(1) FASCIA / SOFFITS (Picture 1)

1.5 (1) Damages to the fascia/soffit noted at several points; check all areas and repair as required. See termite report for details on possible wood damage at the eaves/fascia/soffits.

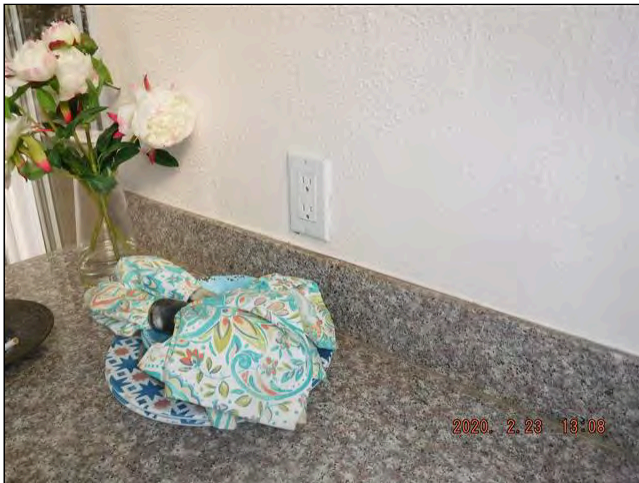
2.4 ELECTRIC / GFCI(S) (Picture 1)

No GFCI outlet at the wall near the backyard sink. Recommend adding.

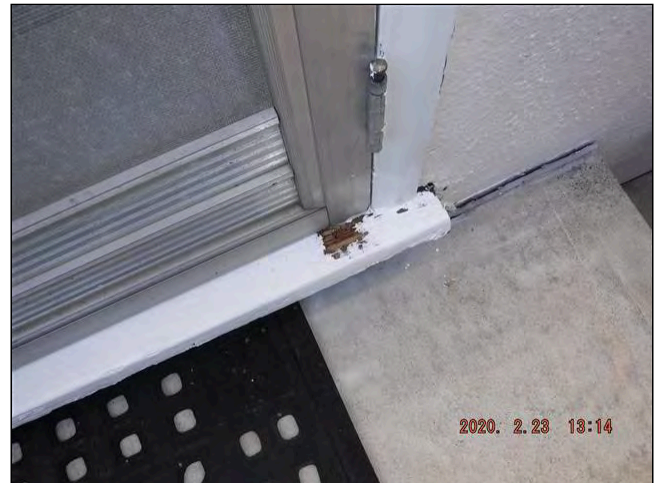
2.6 IMPORTANT NOTE (Picture 1)

Wood damage at the threshold of the side door. Repairs to the damaged wood are needed.

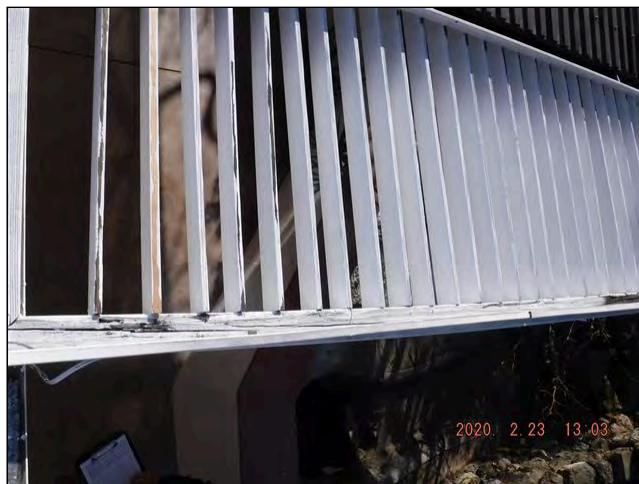
3.5 AWNING/PERGOLA/PATIO COVER (Picture 1)

Worn wood areas at the back patio cover and framing. Repairs are discretionary but area should be monitored in the future.

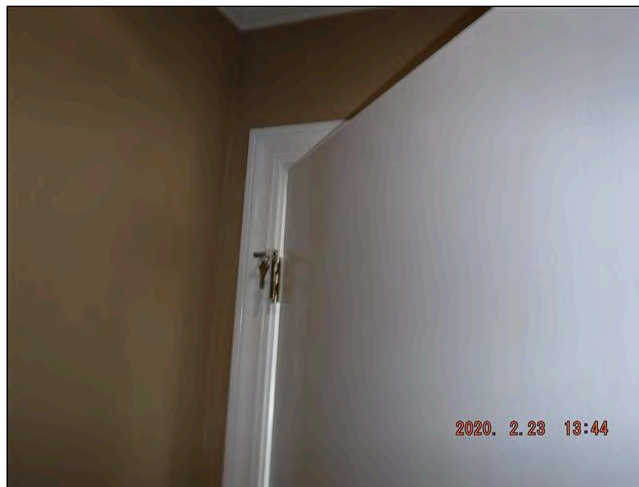
4.7 HOUSE / SERVICE DOOR(S) (Picture 1)

Door leading from the house to the garage is required to have a fire rated door with self closing capabilities. Recommend having a new hinge added to allow the door to close and a new door is needed.

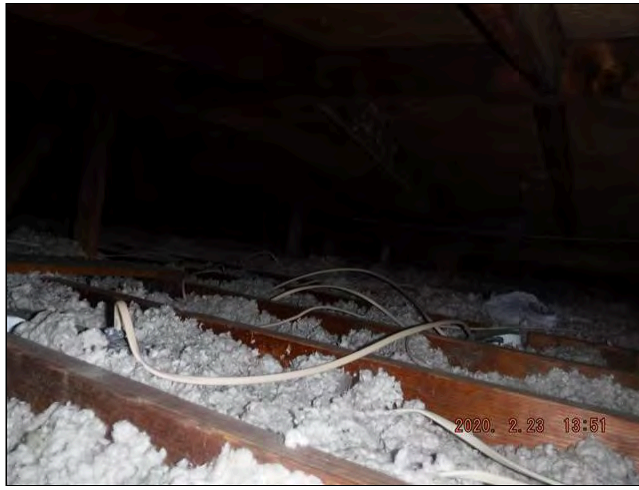
5.3(1) INSULATION (Picture 1)

5.3 (1) Insulation is near or at current minimum recommended/required levels but could be improved for energy savings.

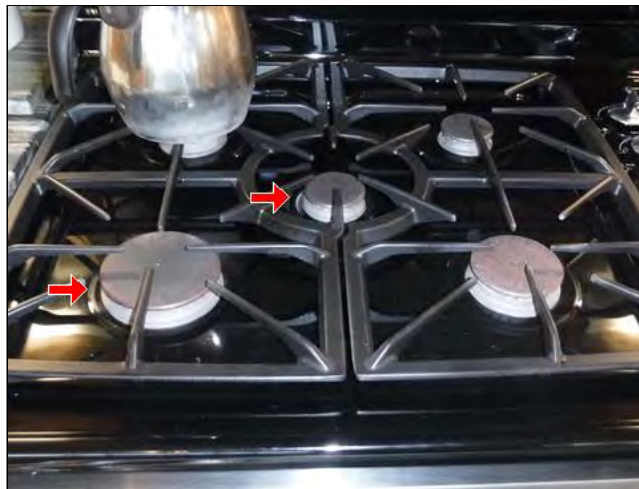
7.2(1) RANGE (Picture 1)

7.2 (1) Range is at the middle of design life with the middle and the front left burner not operating. Repairs to these two burners are needed.

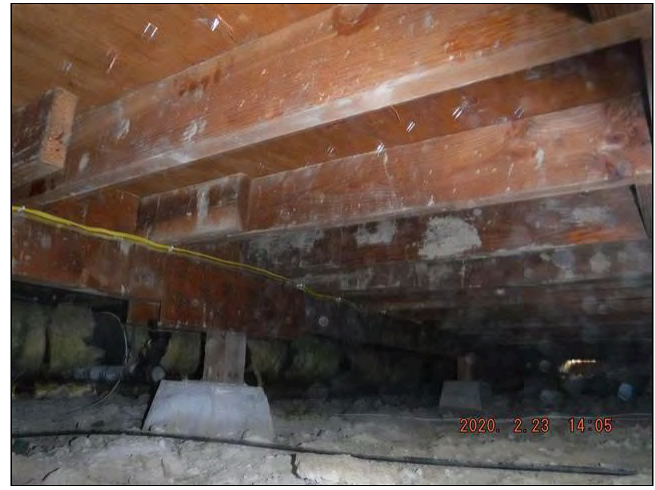
9.2 FLOOR FRAMING (Picture 1)

Stains observed at the subflooring and framing below the kitchens and bathrooms and at some area of the mud sill/foundation framing. The possibility of wood damage at these areas does exist. Due to stained conditions, recommend having additional inspections of the stains done by a licensed termite inspector or wood destroying inspector. Repairs to the damaged areas might be needed after additional inspections.

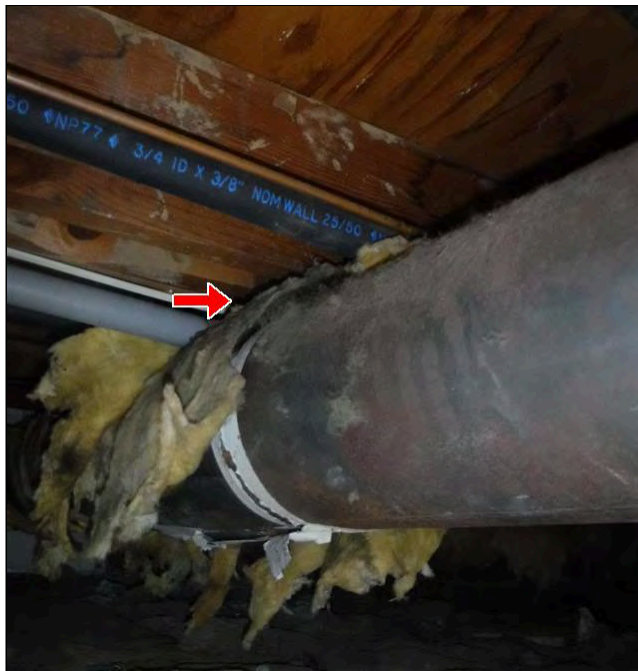
11.2 DUCTWORK (Picture 1)

Heater and A/C system share a ducting system that has a slight gap at the top of the duct at the middle of the house. Recommend having the gap at this area repaired so air does not blow on the house framing.

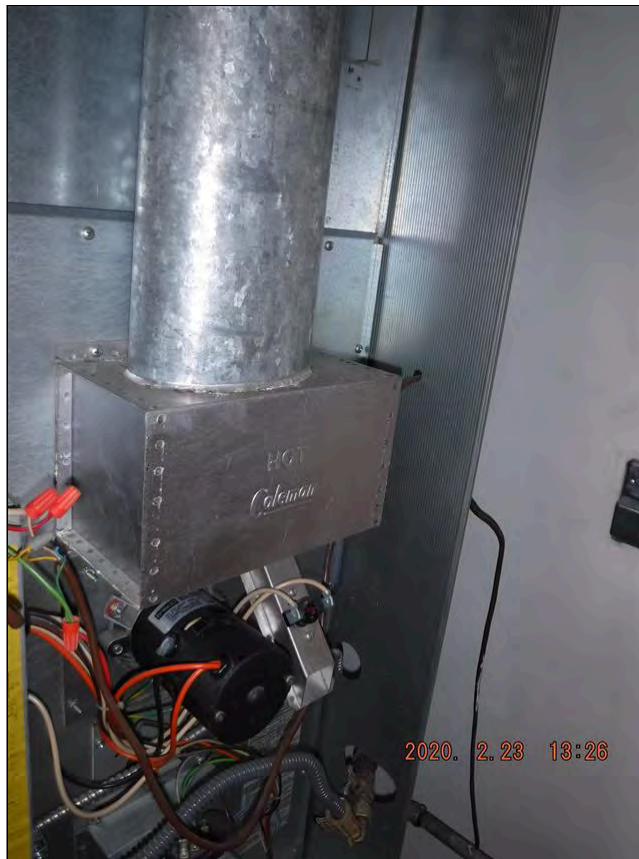
12.0 HEATING UNIT (Picture 1)

Furnace/heater is older and past design life but did operate at the time of this inspection. Heater was started and run for a limited time to determine if the system was working, provided heat at the registers, and if it started and stopped. Future service life of the heater can not be determined but due to age of the system, further evaluation should be made by a licensed heating contractor. Replacement of the heater with a new heater should also be considered.

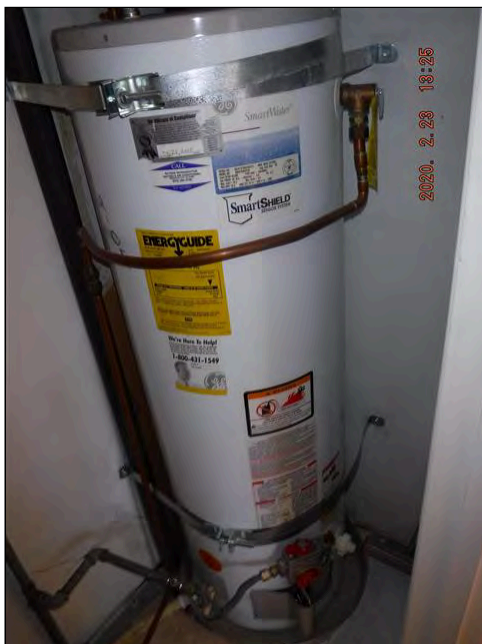
14.0 WATER HEATER (Picture 1)

The water heater was functional at the time of inspection, but is beyond normal design life; anticipate replacement needs.

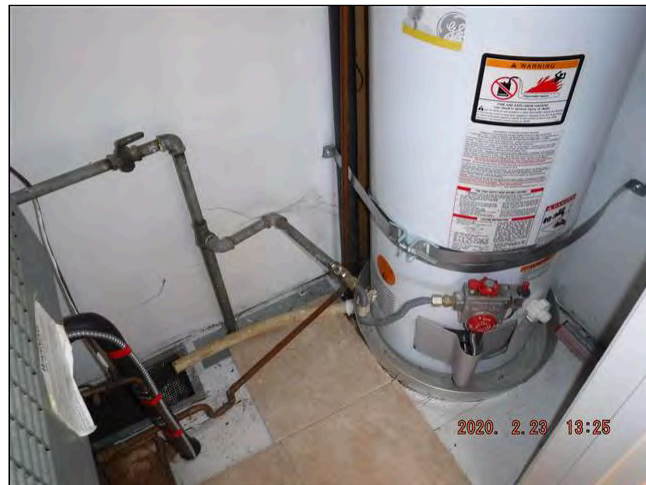
14.3 GAS / FUEL LINES AT UNIT (Picture 1)

Gas pipes leading to the water heater and the heater should have a drip leg prior to the combustion area of the items. Both water heater and house heater do not have the drip leg. Adding a drip leg should be made by an qualified contractor.

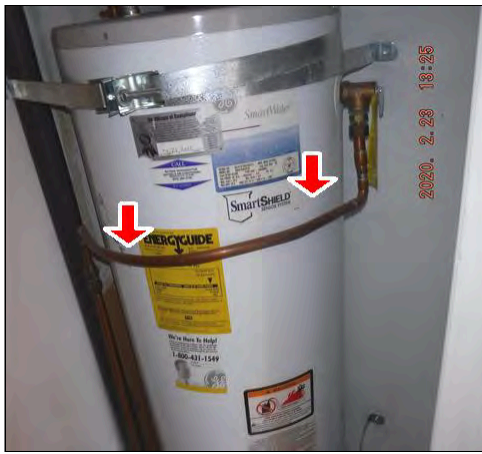
14.4(1) SAFETY VALVE PROVISIONS  
(Picture 1)

14.4 (1) TPRV on water heater relief tube should extend straight down below the water heater. Due to location of the relief valve at the heater, the tube had to be bent and run across the front of the water heater. The tube being used is also smaller than the opening from the vent drain at the heater. Replacement or re-direction of the of the vent tube at the water heater should be made if a new water heater is not installed.

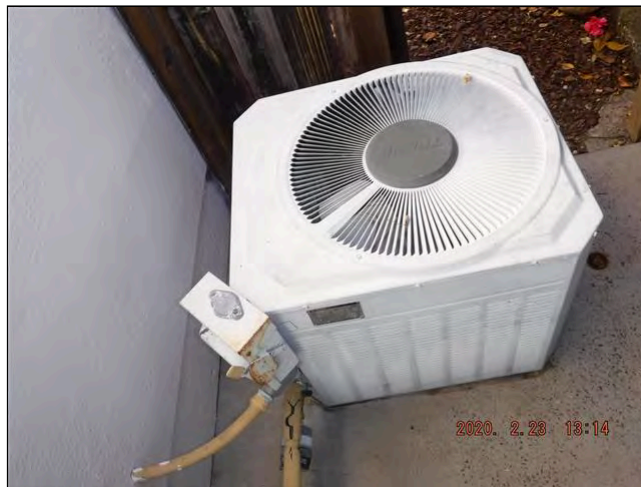
11.0 (Picture 1)

Air conditioner did operate at time of inspection. Air conditioning system appears to be approaching the end of its manufactures design life and has some rust at the top and inside the condenser system. Life expectancy can not be determined. Recommend system evaluation by a qualified HVAC contractor to determine whether repairs or upgrades are required.
