Prepared for Exclusive Use by:

Address of Inspected Property:

INSPECTION INFORMATION

MANUFACTURED

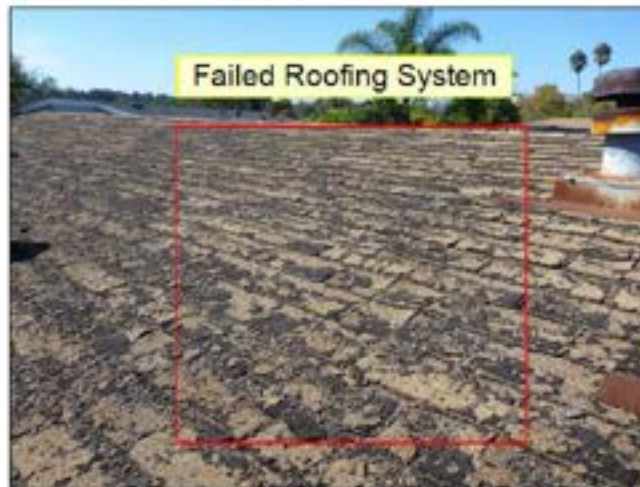
1.0 ROOFING (See Picture(s))

●					<p>1.0 ROOFING Roof coverings require periodic repairs and sealant, especially at roof penetrations. Suggest periodic evaluation and sealing/repairs as needed to aide in preventing water penetration into structure. Roof shingles have failed. Consult roofer for repair/ replacement cost estimates prior to close of escrow.(See Picture(s))</p>
●					<p>1.1 EXPOSED FLASHING Rusting noted at flashings. Suggest painting to prevent water penetration and extend service life.(See Picture(s))</p>
●					<p>1.2 PLUMBING STACKS Gaps noted at roof penetrations. Reseal roof penetrations now and on a routine basis to prevent leakage to interior of structure.</p>
●					<p>1.3 VENTILATION COVERS Rusting noted at water heater and furnace gas vent caps. Paint or replace to extend service life and prevent water penetration.(See Picture(s))</p>

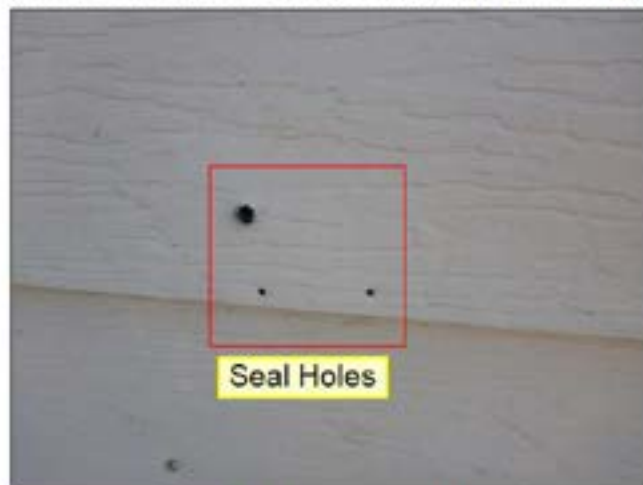
2.0 SIDING (See Picture(s))

●	●	●	●	●	<p>2.0 SIDING Damaged panels/ missing trim pieces noted at various locations. Suggest sealing at any gaps, cracks, around light fixtures, windows, doors, trim, etc...to aide in preventing water penetration and pest intrusion. Consult a contractor for evaluation/ cost estimates for repairs prior to close of escrow.(See Picture(s))</p>
●	●	●	●	●	<p>2.1 ENTRY DOORS Damaged water heater closet door noted. Anticipate replacement.(See Picture(s))</p>
●	●	●	●	●	<p>2.2 STAIRS / STOOPS Damaged landing noted at driveway steps. Weathering noted at visible portion of stairs. Suggest painting/ maintenance to stairs. anticipate replacement. Weathering noted at visible portion of stairs. Suggest painting/ maintenance to stairs.(See Picture(s))</p>
●	●	●	●	●	<p>2.3 RAILINGS Weathering/ deterioration noted at railings. Suggest routine maintenance/ repair/ replacement of railing components for enhanced life span and safe operation.</p>

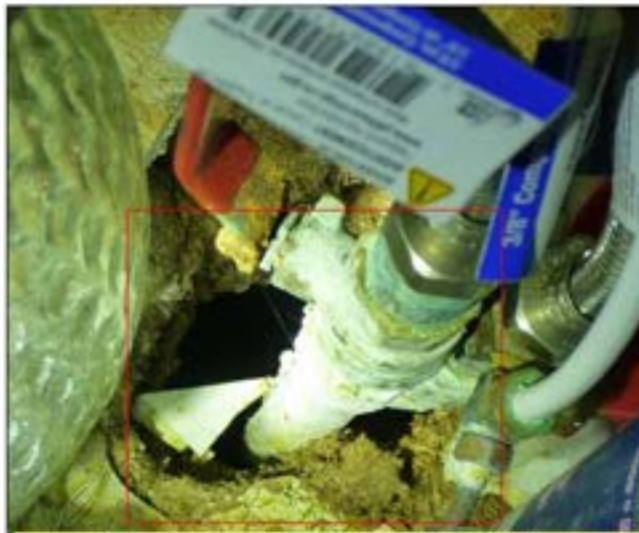
Heavy Corrosion/ Holes In Sub-Floor

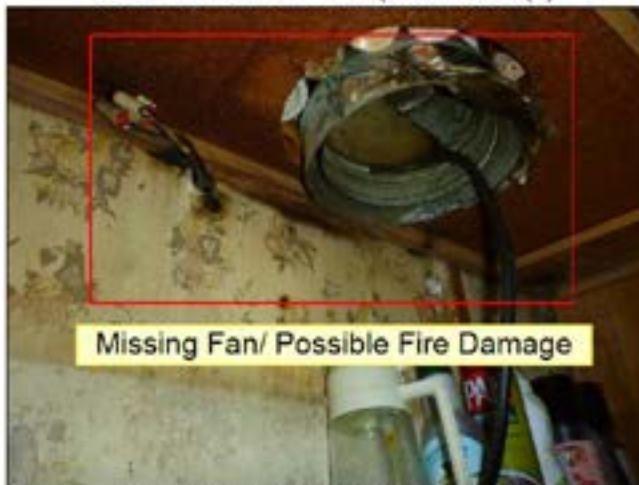
5.2 VENTILATOR (See Picture(s))

Missing Fan/ Possible Fire Damage

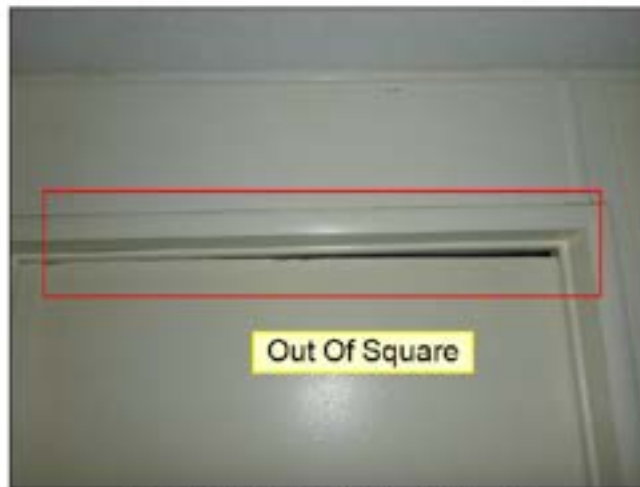
6.4 ROOM DOORS (See Picture(s))

●				6.5 PATIO / DECK DOORS(S)	Binding laundry room entry door noted. Anticipate adjustment/ replacement.
●				6.6 DETECTOR TEST	Missing smoke and carbon monoxide detectors noted. See state department of health website for required locations.

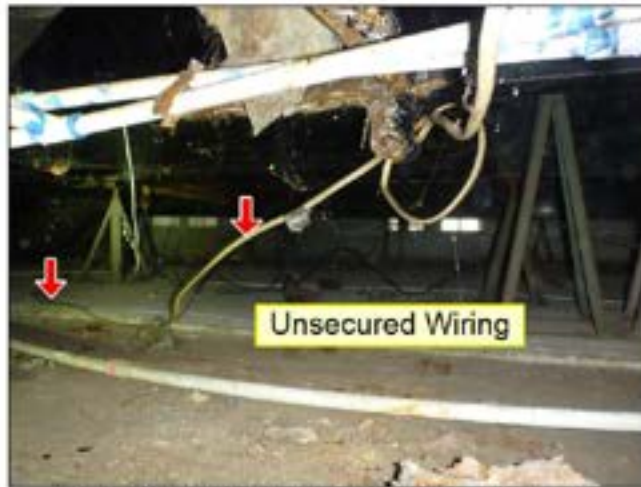
8.3 WIRING / CONDUCTORS (See Picture(s))

●	8.3 WIRING / CONDUCTORS Unsecured wiring noted in the craw/space. Consult an electrician for evaluation/ proper installation for safety prior to close of escrow.(See Picture(s))

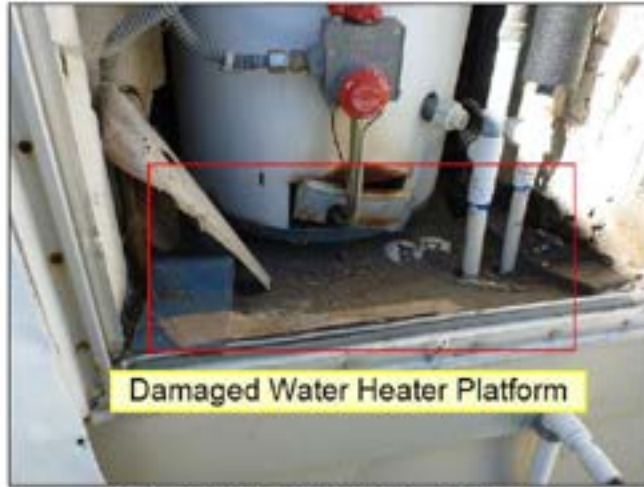
11.0 WATER HEATER (See Picture(s))

Damaged Water Heater Platform

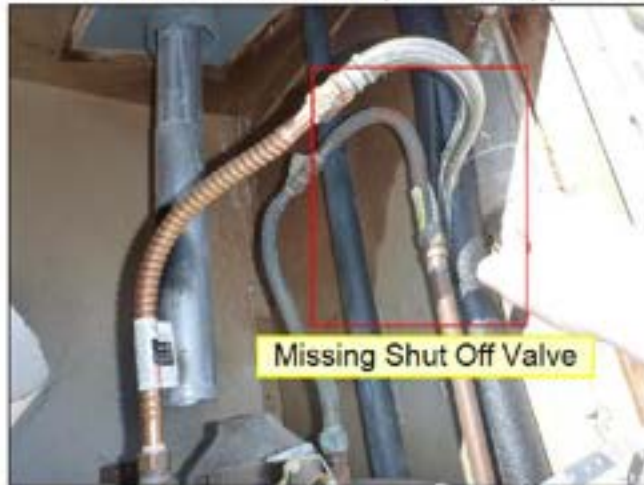
11.0 WATER HEATER (See Picture(s))

Missing Shut Off Valve

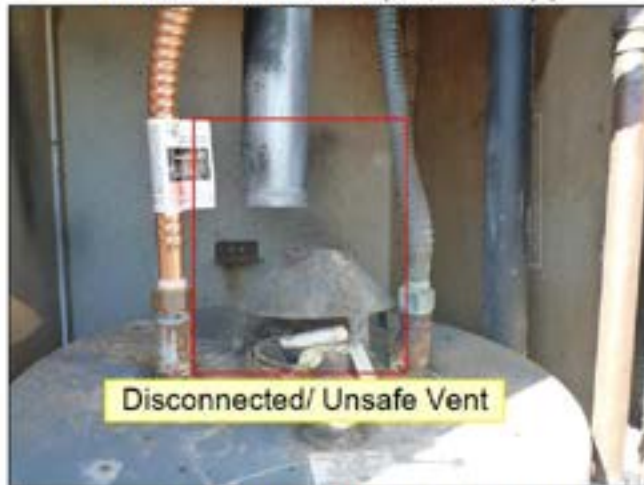
11.1 VENT CONNECTOR (See Picture(s))

Disconnected/ Unsafe Vent

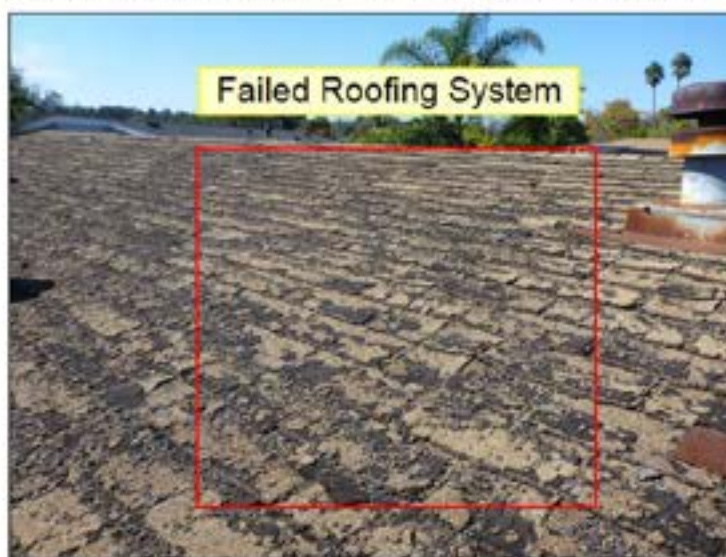
1.0 (See Picture(s))

Roof shingles have failed. Consult roofer for repair/ replacement cost estimates prior to close of escrow.(See Picture(s))

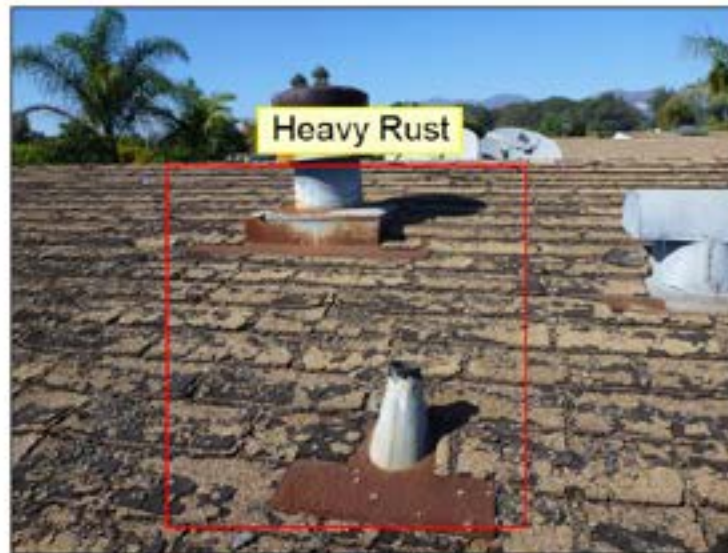
1.1 (See Picture(s))

Rusting noted at flashings. Suggest painting to prevent water penetration and extend service life.(See Picture(s))

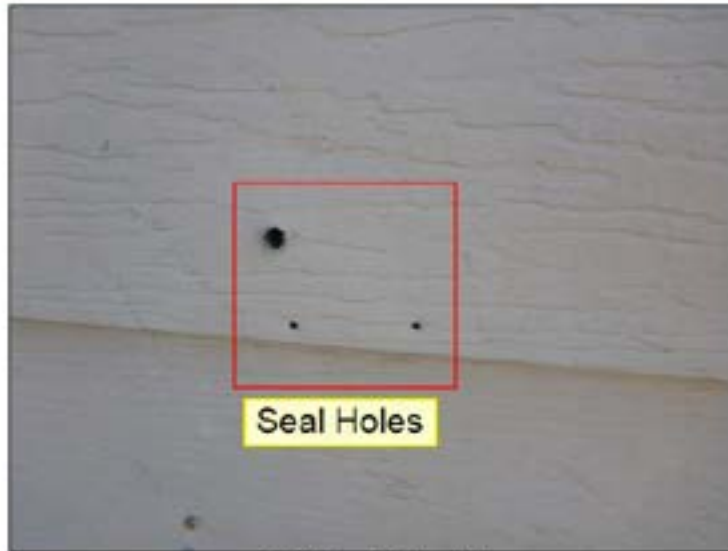
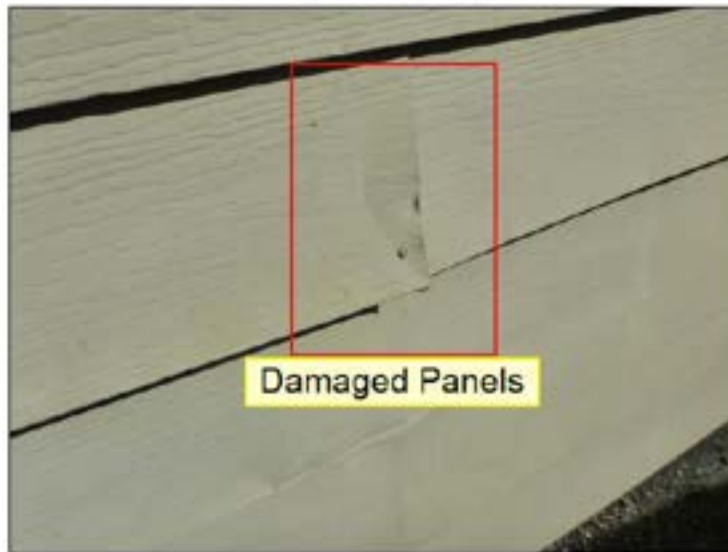
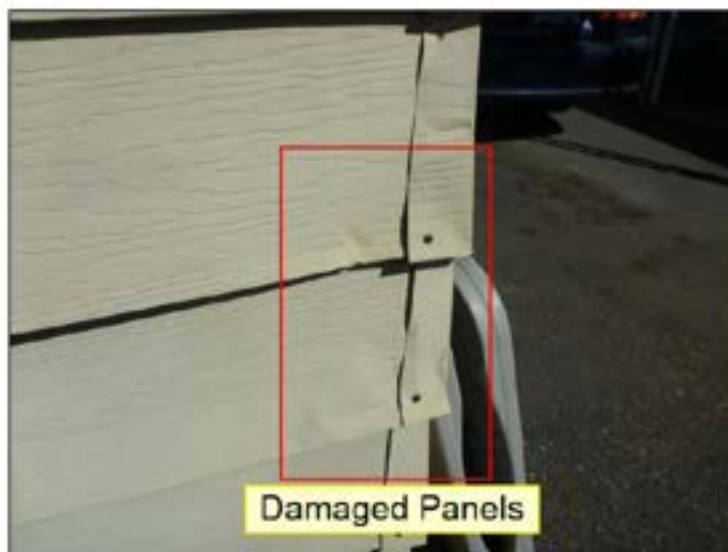
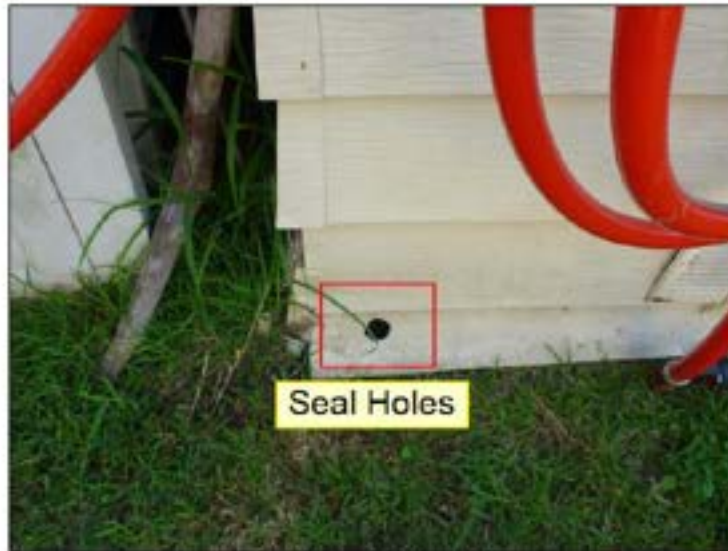
Damaged panels/ missing trim pieces noted at various locations. Suggest sealing at any gaps, cracks, around light fixtures, windows, doors, trim, etc....to aide in preventing water penetration and pest intrusion. Consult a contractor for evaluation/ cost estimates for repairs prior to close of escrow.(See Picture(s))

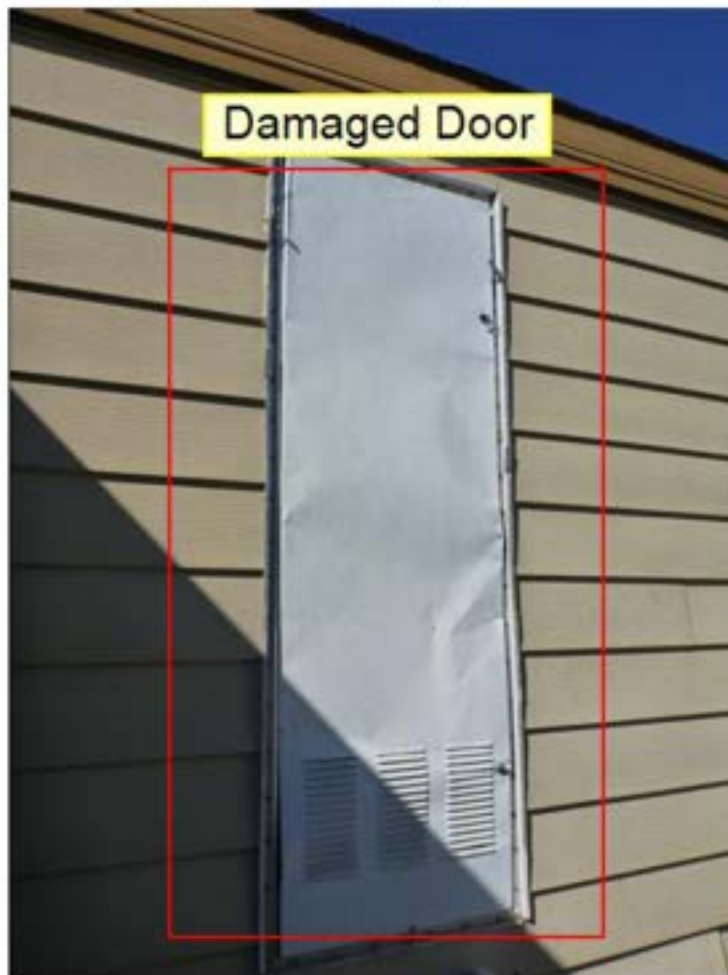
2.1 (See Picture(s))

Damaged water heater closet door noted. Anticipate replacement.(See Picture(s))

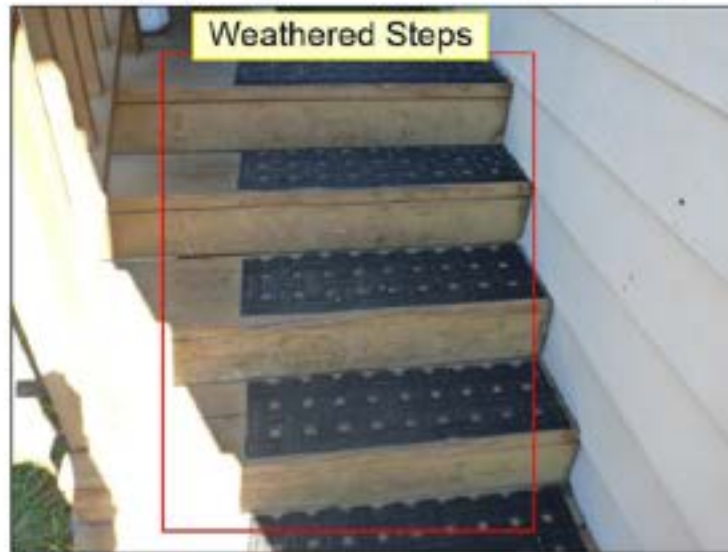
2.2 (See Picture(s))

Weathering noted at visible portion of stairs. Suggest painting/ maintenance to stairs.(See Picture(s))

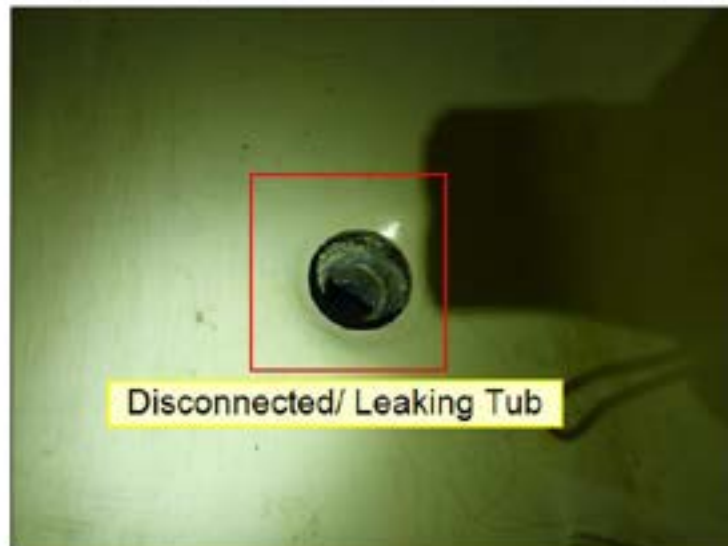
4.2 (See Picture(s))

Drainline at Tub is disconnected and leaking into crawlspace. Consult a plumber for evaluation/ repairs prior to close of escrow.

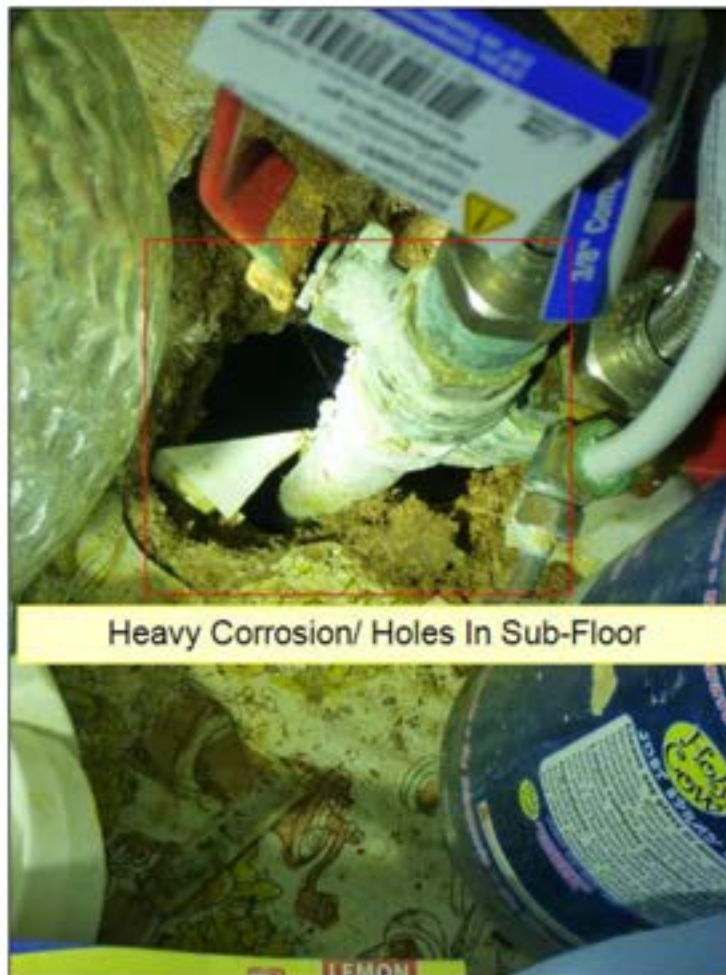
5.0 (See Picture(s))

Stains/moisture damage noted under kitchen sink. Consult seller on history of water leaks. Unable to determine condition behind concealed areas. Look for hidden damage behind materials prior to close of escrow.

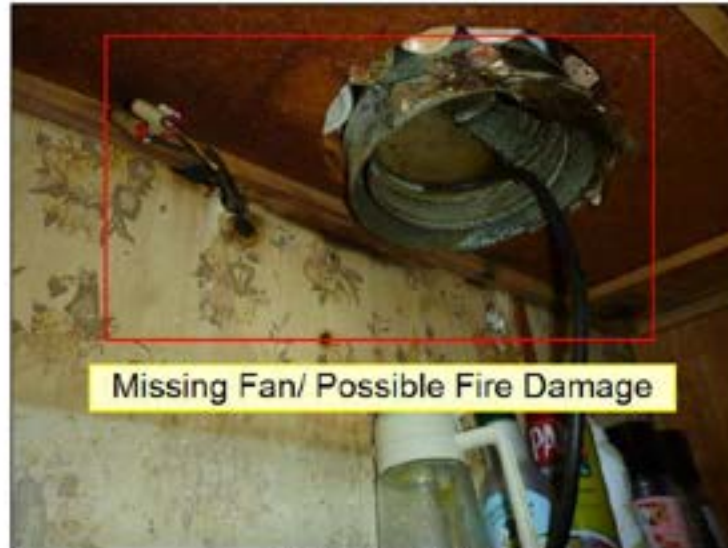
5.2 (See Picture(s))

possible fire damage noted at exhaust hood. Consult seller regarding the history of fires/ damage. Anticipate repairs.

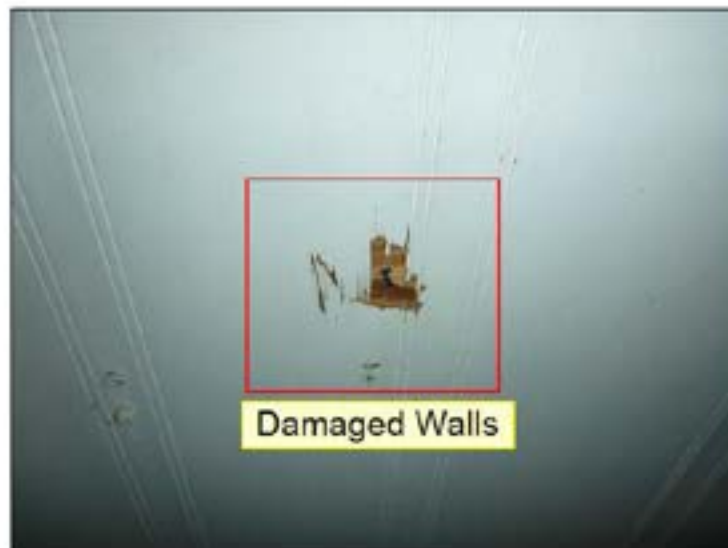
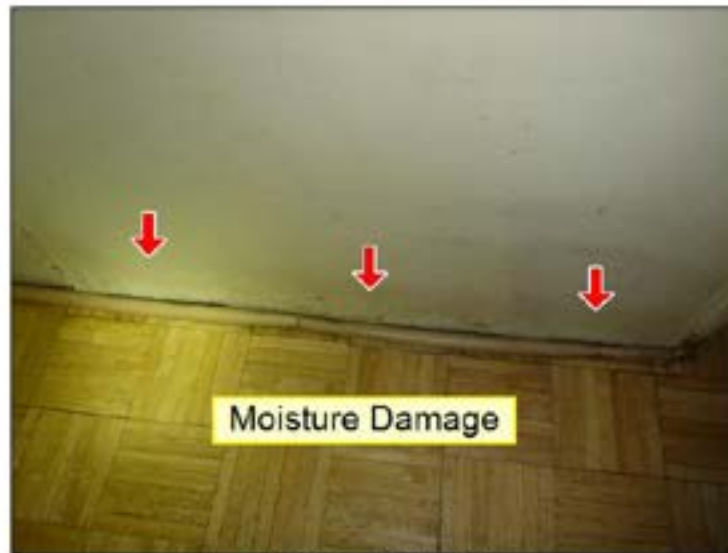
6.0 (See Picture(s))

Moisture damage noted at hallway walls. Consult the seller regarding the history of water leaks. Consult a contractor for evaluation/ repairs as needed.(See Picture(s))

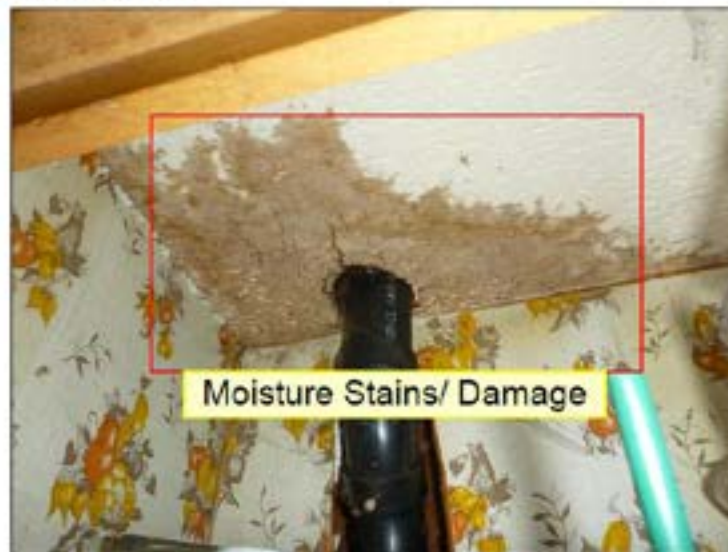
6.1 (See Picture(s))

Staining and discoloration noted at ceiling(s). Possible leakage from exterior and/or roof cover. Consult seller regarding prior water penetration. Check for hidden damage.(See Picture(s))

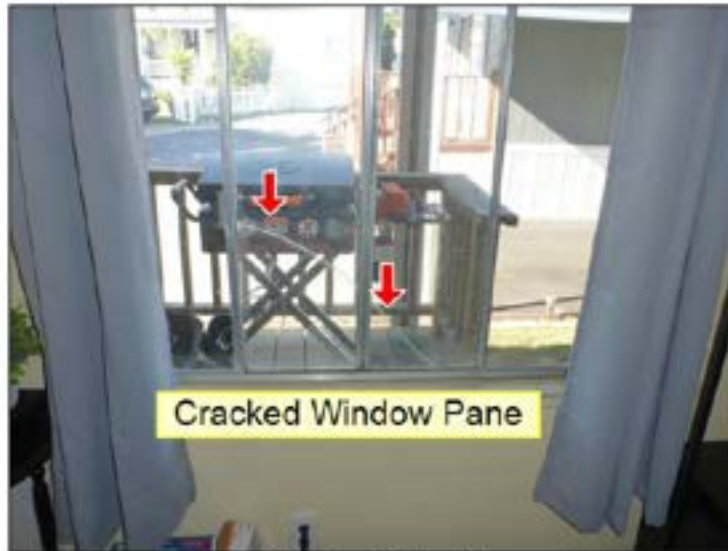
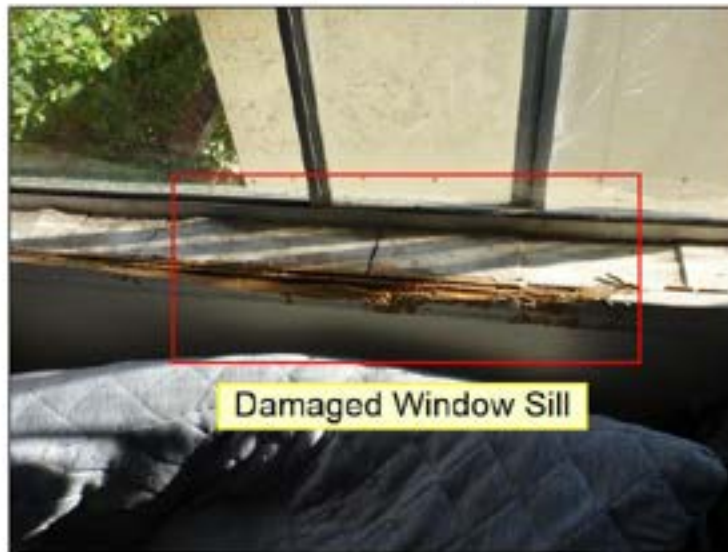
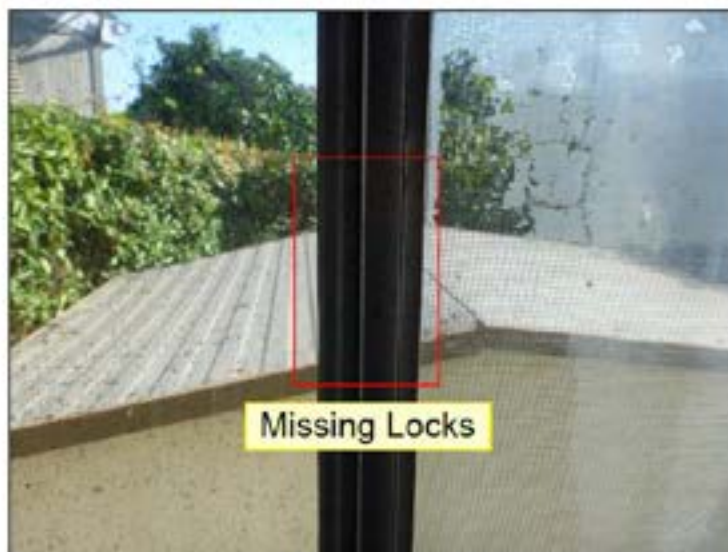
6.3 (See Picture(s))

Moisture/ pet damage noted at window and/or sill near window. Consult seller as to history and contractor for repairs. Unable to determine if any hidden damage exists.(See Picture(s))

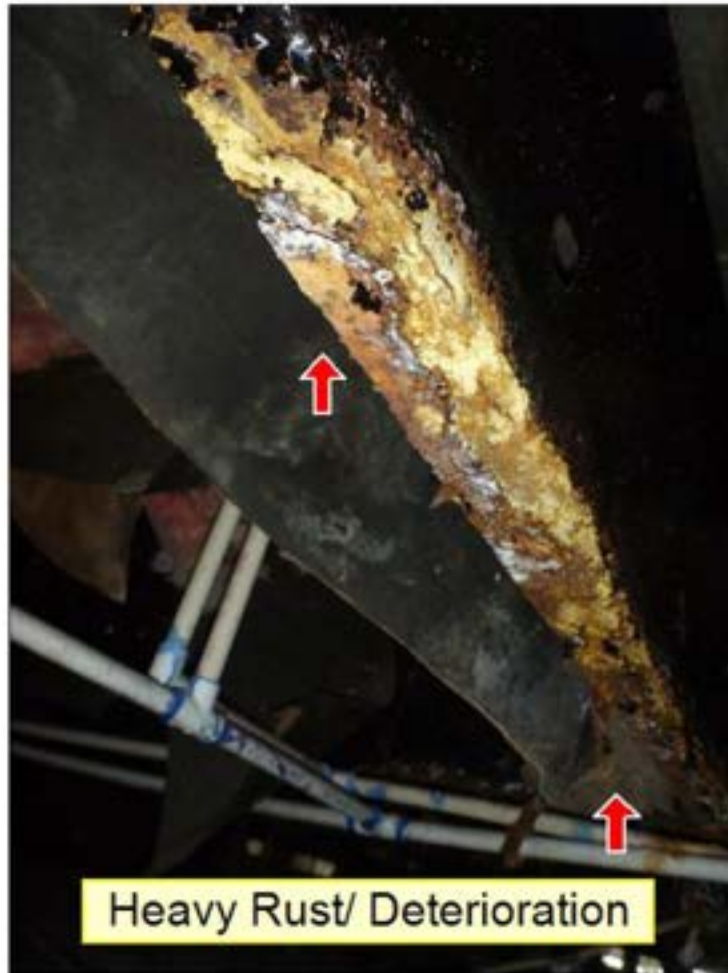
7.0 (See Picture(s))

Heavy rust/ deterioration noted to steel beam in crawlspace. Consult a contractor for evaluation/ repairs/ servicing to prevent further damage to steel framing prior to close of escrow.(See Picture(s))

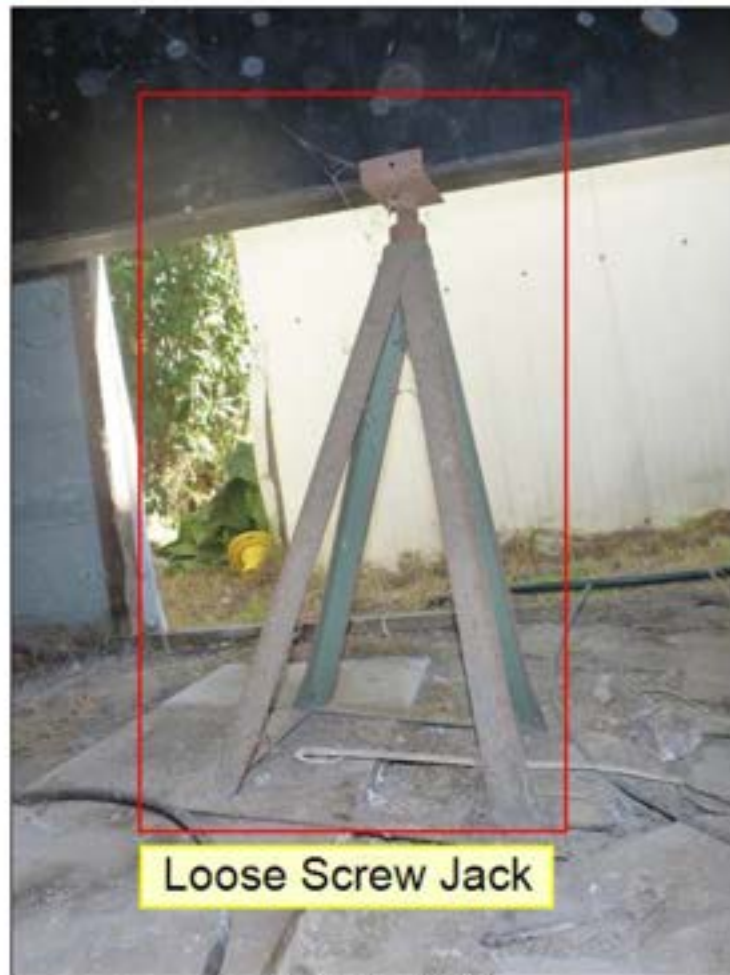
7.1 (See Picture(s))

Loose screw jack noted at crawlspace entry. Consult a contractor for evaluation/ proper installation to prevent movement/ settlement in the structure.(See Picture(s))

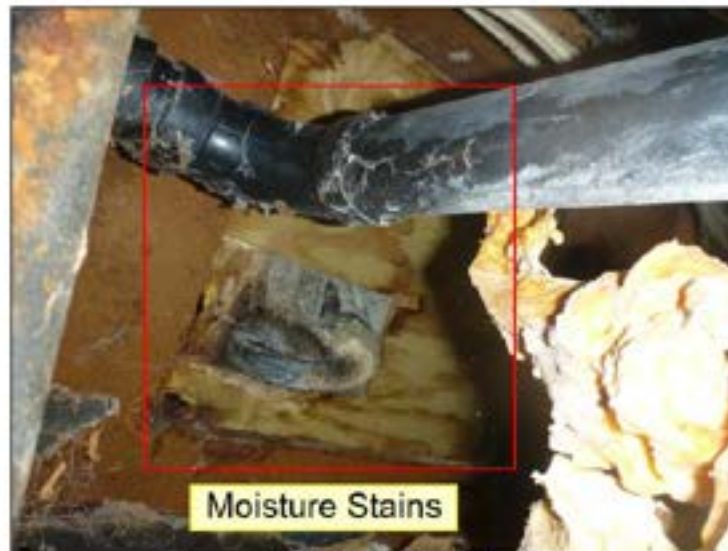
7.2 (See Picture(s))

Damaged belly tarp noted at various locations. Wood rot noted at various locations of sub-flooring. Consult a contractor for evaluation/ repair prior to close of escrow. (See Picture(s))

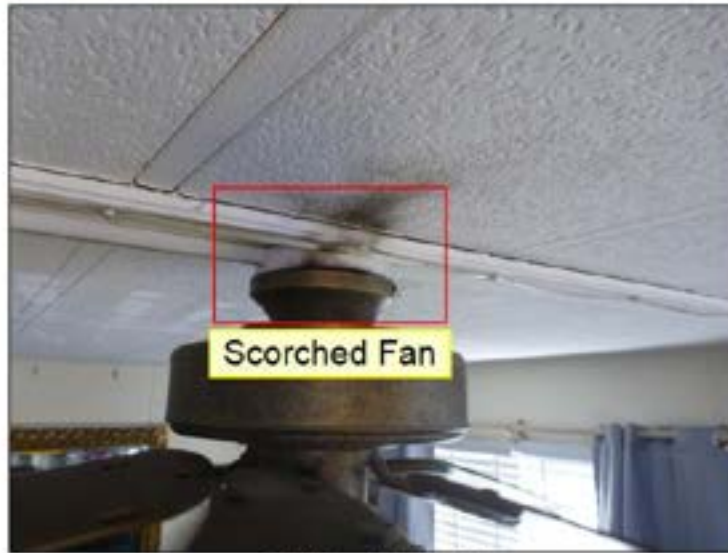
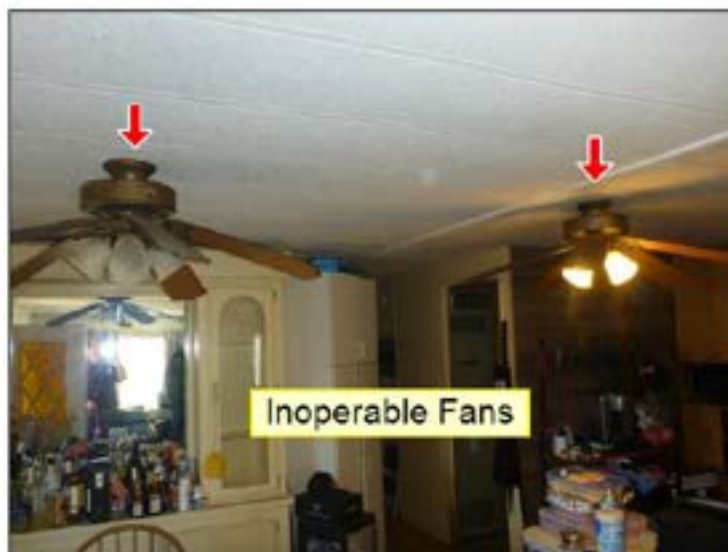
8.2 (See Picture(s))

Inoperable ceiling fans noted in dining/ kitchen area. Consult an electrician for evaluation/ replacement as needed for proper operation.(See Picture(s))

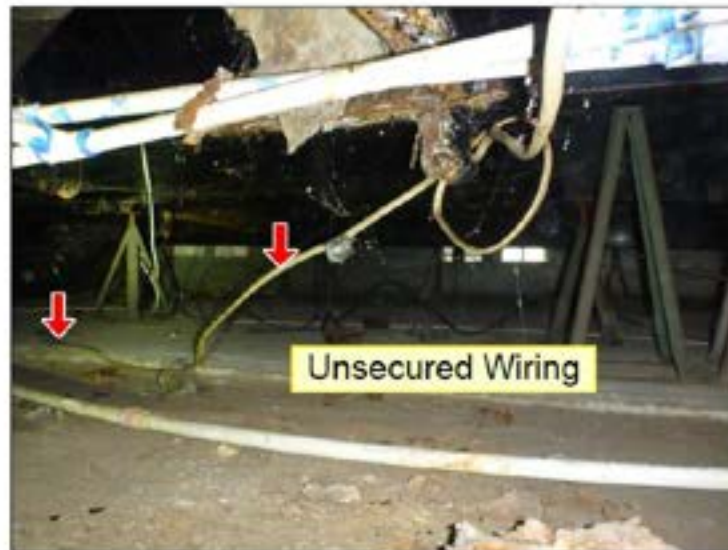
8.3 (See Picture(s))

Unsecured wiring noted in the crawlspace. Consult an electrician for evaluation/ proper installation for safety prior to close of escrow.(See Picture(s))

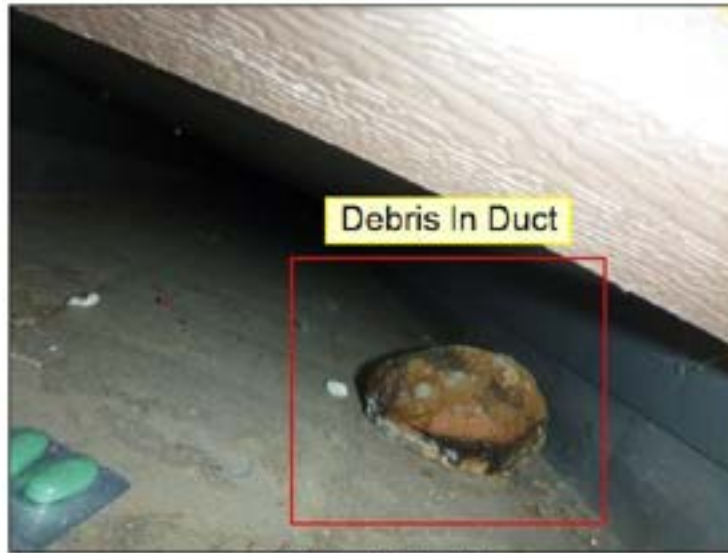
9.5 (See Picture(s))

Dirty ducts noted at registers. Suggest evaluation and cleaning of system by an HVAC contractor.(See Picture(s))

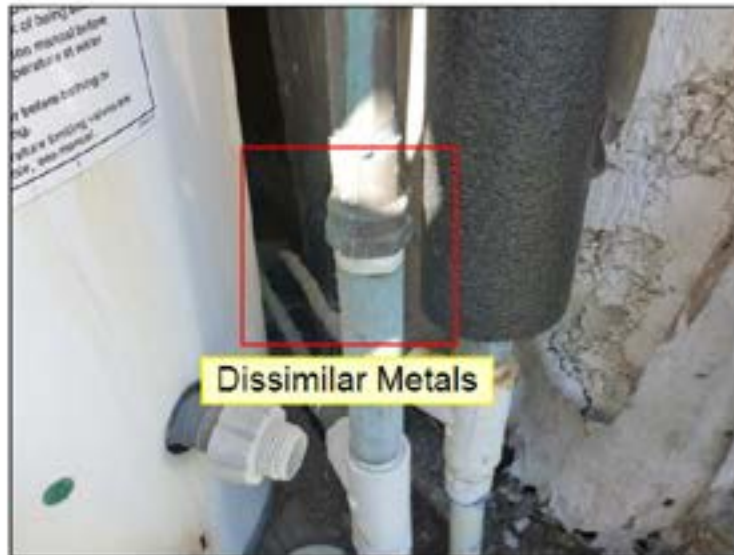
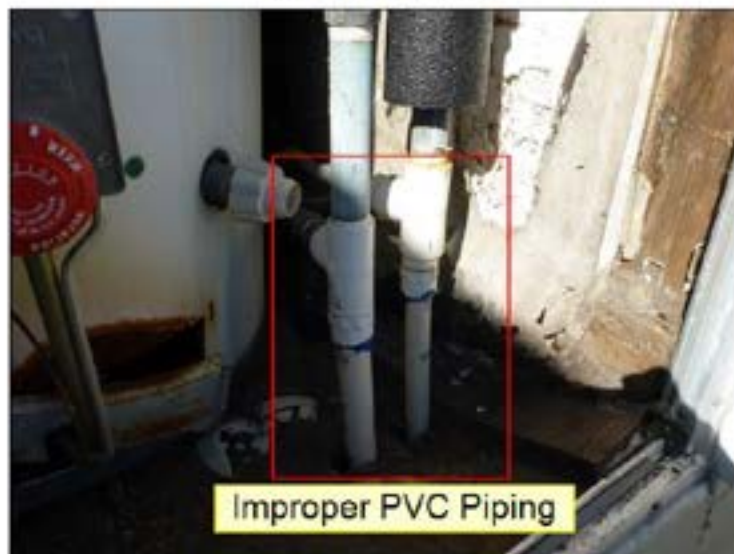
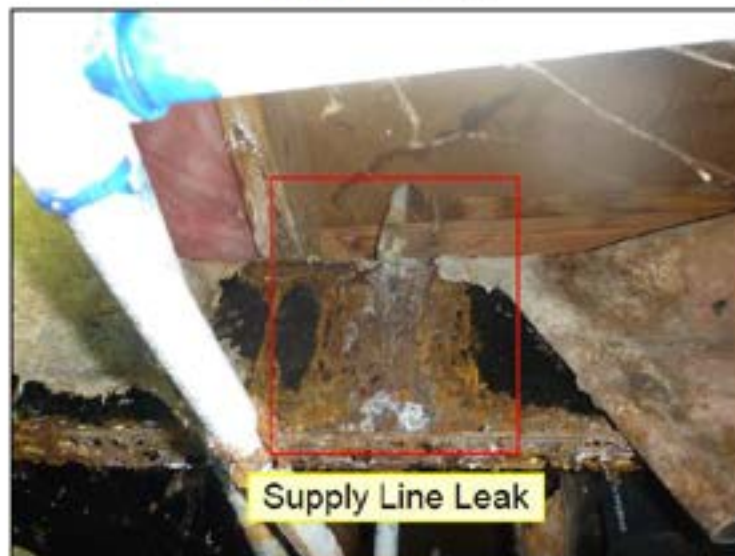
10.0 (See Picture(s))

Mixed (Galvanized to Copper) water piping noted. Anticipate replacement of remaining galvanized piping. Consult plumber for evaluation and repairs as required.(See Picture(s))

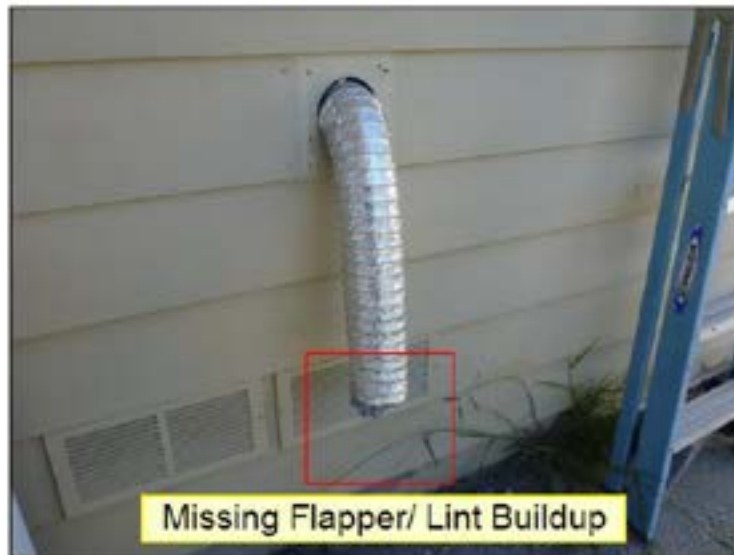
10.3 (See Picture(s))

Suggest regular cleaning of clothes dryer vent for fire safety and energy efficiency.

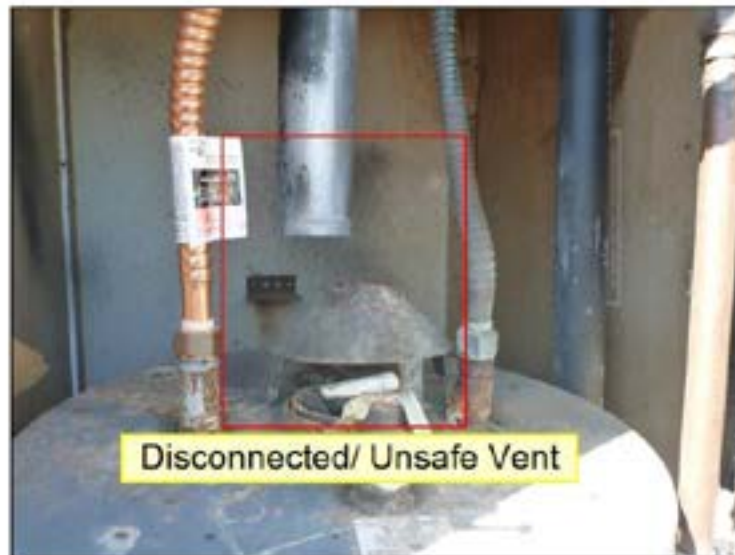
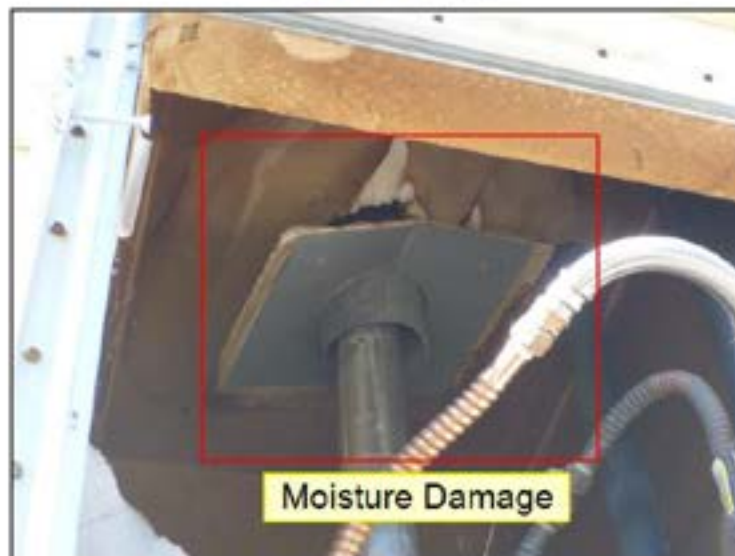
11.1 (See Picture(s))

Draft hood/ Vent pipe is not properly installed and poses a safety concern. Consult a plumber for proper installation of vent pipe prior to lighting water heater for occupant safety.(See Picture(s))

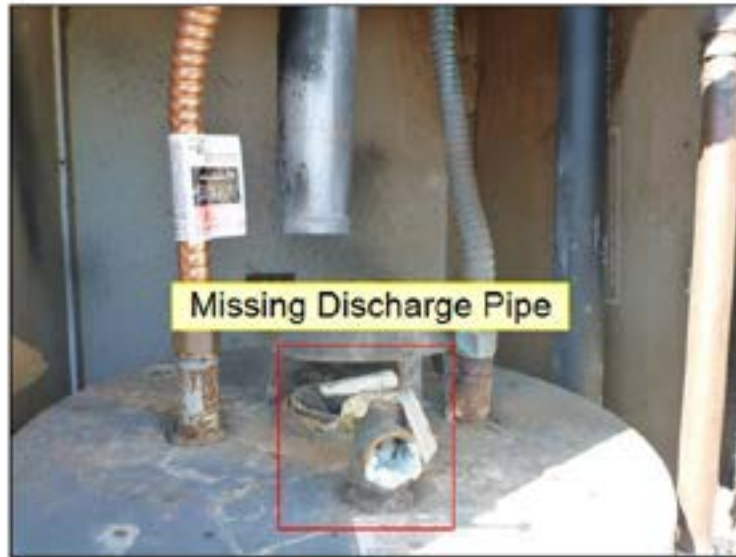
11.3 (See Picture(s))

No TPRV discharge pipe noted at water heater. Install correct size drain pipe and properly terminate to an approved location for safety. Consult a plumber for correct installation.(See Picture(s))
