1234 Main Street
Anytown OH 00000

10/23/2017

Kreps Home Inspection dba HouseMaster

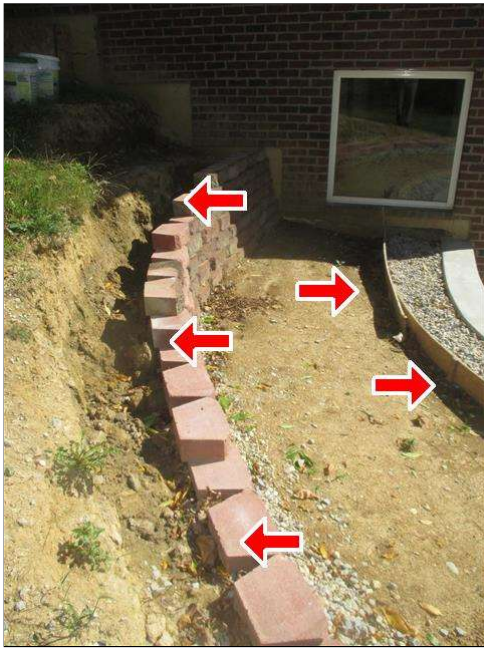
3.3 RETAINING WALL(S) Picture 1

Retaining wall at right rear corner of house is not complete Item 1(Picture) . This retaining wall rated Poor and advise completion by the appropriate professional.

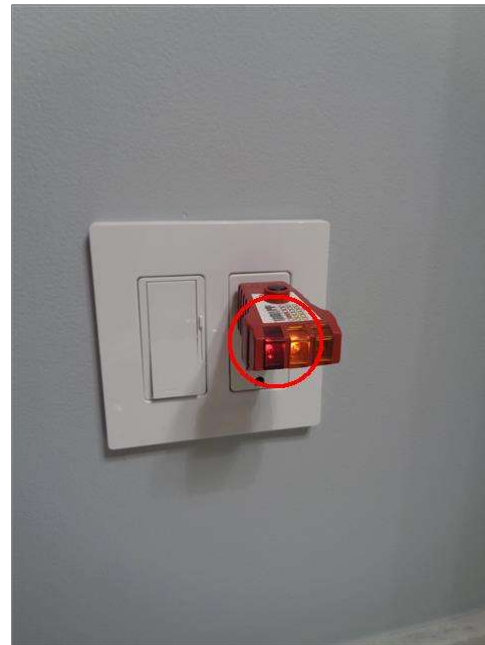
6.7.A ELECTRIC / GFCI Picture 1

Receptacle indicates reverse polarity, meaning the hot and neutral wiring has been reversed Item 1(Picture). Advise correction and verify proper operation before closing.
