Prepared for Exclusive Use by:

Address of Property:

Shelby Hendrix

Multi-Unit Property

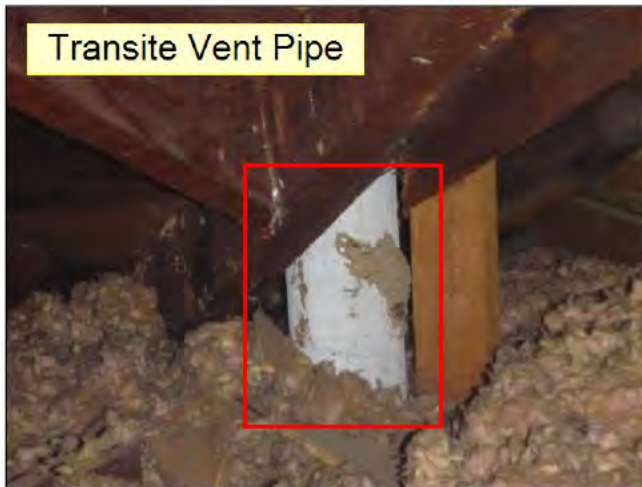
1.3 VENTILATION COVERS (See Picture(s))

Transite Vent Pipe

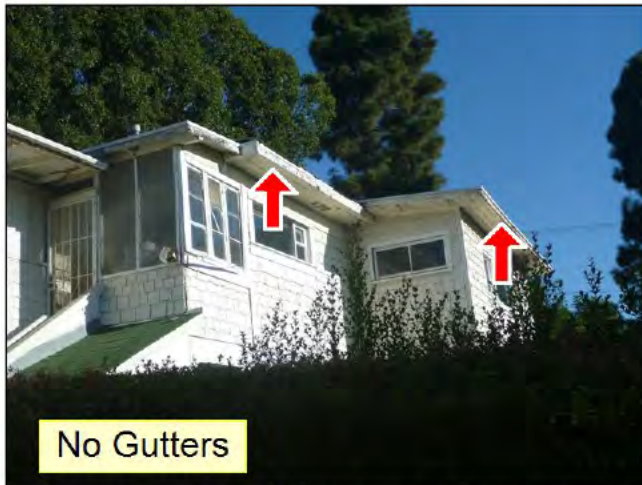
1.4 RAIN GUTTERS / EAVETROUGHES (See Picture(s))

No Gutters

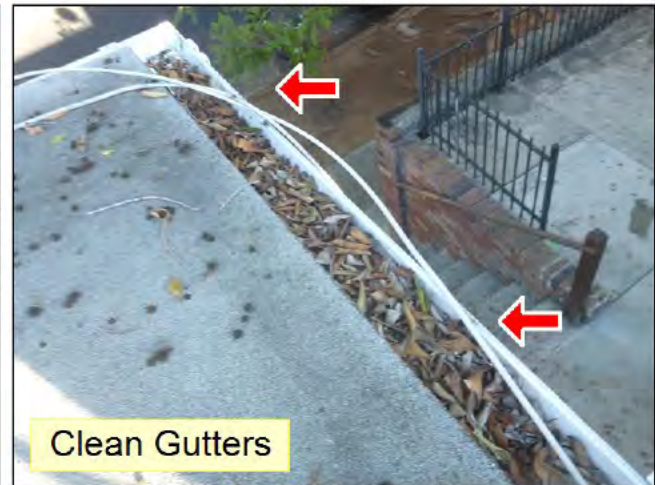
1.4 RAIN GUTTERS / EAVETROUGHES (See Picture(s))

Clean Gutters

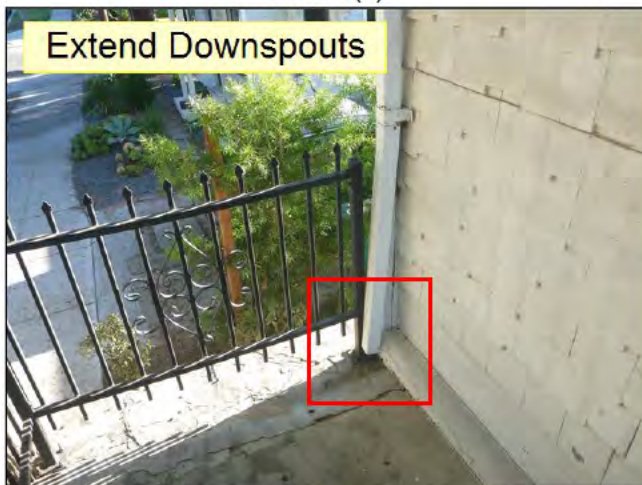
1.5 DOWNSPOUTS / ROOF DRAINS (See Picture(s))

Extend Downspouts

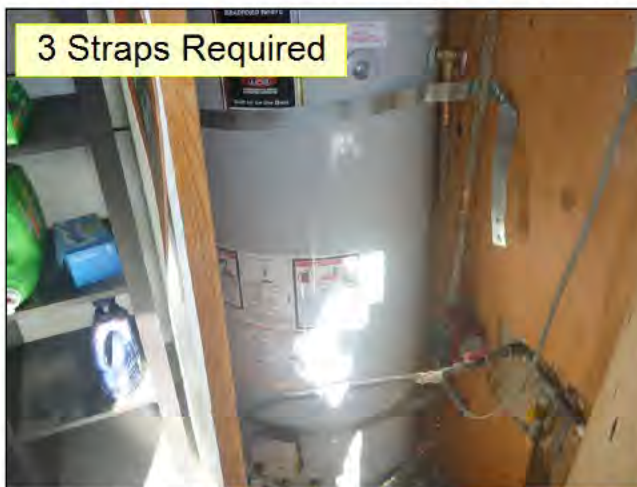
#### 4.0 WATER HEATER (See Picture(s))

●			<p><b>4.0 WATER HEATER</b></p> <p>Three seismic straps are required on a 75 gallon water heater as per California State Architect requirements. Consult a licensed plumbing contractor for proper installation. (See Picture(s))</p> <p>Corrosion noted at plumbing of water heater. Replace components as needed to prevent leaks and moisture damage. (See Picture(s))</p> <p>Water heater operated properly at the time of inspection. It is 1 year old with a manufacturers design life of 8 - 12 years. Suggest annual flushing to remove sediment and extend service life.</p>
		●			<p><b>4.1 VENT CONNECTOR</b></p> <p>Vent pipe disconnected at water heater. Contact a plumber for repair to prevent carbon monoxide from entering units. (See Picture(s))</p>
●					<b>4.2 GAS / FUEL LINES AT UNIT</b>
		●			<p><b>4.3 SAFETY VALVE PROVISIONS</b></p> <p>The drain pipe for the Temperature Pressure Relief Valve is not installed within 6 to 24 inches off of ground. Contact a plumber for correct installation. See supplemental information for additional comments. (See Picture(s))</p>

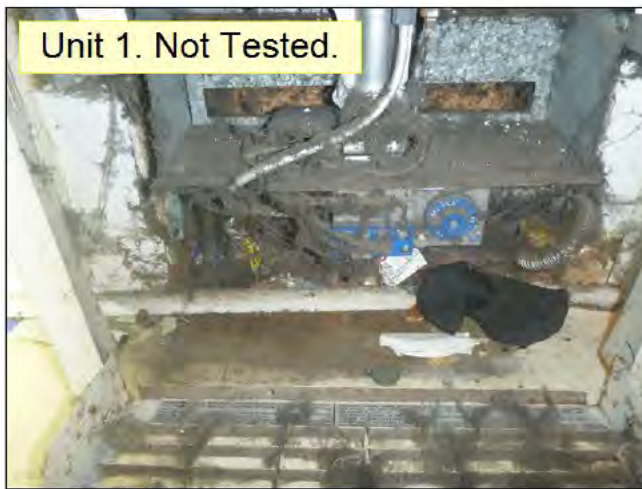
6.0 HEATING UNIT (See Picture(s))

<b>6.0 HEATING UNIT</b>
					Unit 1: Estimated 25-30 years old. Not tested due to significant lint buildup fire hazard. Have unit cleaned and tested. Unit is nearing/has reached end of design life. Anticipate future repair/replacement.
					Unit 2: 13 years old. Operated properly.
					Unit 3: 21 years old. Operated properly.
					Unit 4: 34 years old. Pilot light not lit and ignitor inoperable. Unit is past design life. Contact HVAC contractor to evaluate and determine repair or replacement cost estimate.
					Unit 5: 13 years old. Burners did not light when thermostat was turned up. Have unit/thermostat evaluated/ repaired by an HVAC contractor and cleaned for fire safety.
					Suggest annual servicing/evaluation of all units by a heating, ventilation and air conditioning (HVAC) contractor to extend service life and for proper and safe operation.
					<b>6.1 BURNERS</b>
					Heat exchanger is not fully visible due to design of system. Therefore not inspected. Recommend annual evaluation and repairs and service of unit to ensure proper and safe operation. Burner assembly was not removed during inspection to determine condition of heat exchanger. This is not performed during a standard inspection.

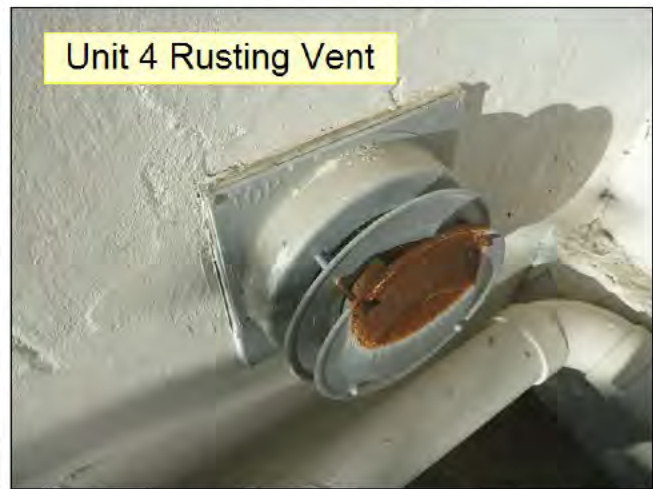
6.2 VENT CONNECTOR (See Picture(s))

<b>6.2 VENT CONNECTOR</b>
					Disconnected vent at unit 1 balcony/laundry area. Have vent connected to prevent carbon monoxide from entering home. (See Picture(s))
					Unit 4 rusting vent at wall. Anticipate painting or replacement. (See Picture(s))
					See roofing section of report regarding rusting vents on roof.
					<b>6.3 GAS / FUEL LINES AT UNIT</b>
					<b>6.4 COMBUSTION AIR PROVISIONS</b>
					<b>6.5 THERMOSTAT</b>
					See comments above regarding unit 5.
					Units 1 and 4 not tested. See comments above.

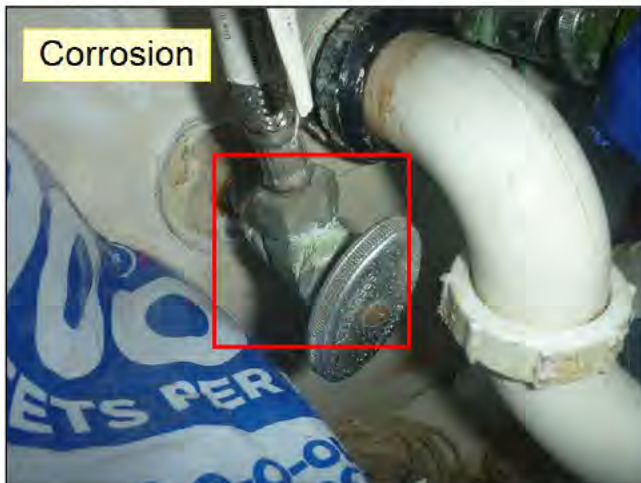
7.0.A SINK(S) (See Picture(s))

●					<b>7.0.A SINK(S)</b> Corrosion noted at shutoff valves beneath sinks. Replace components as needed to prevent leaks and moisture damage. (See Picture(s))
	●				<b>7.1.A TOILET</b> Loose toilet at floor connection noted. Pull toilet, check for damage/water penetration. Re-secure/reset toilet to prevent moisture damage. Consult a plumber for correction.
	●				<b>7.2.A BATHTUB</b> Drain stopper at tub did not work properly. Repairs, adjustments or cleaning may correct many drain defects, however, drain mechanism repairs or replacement may be difficult depending on accessibility. Consult plumber for repairs and/or replacement.  Older/worn bathtub and fixtures. Anticipate repair/replacement. See supplemental information regarding older/worn fixtures/faucets. (See Picture(s))
●					<b>7.3.A ELECTRIC / GFCI</b>
	●				<b>7.4.A VENTILATION</b> Window is low in tub/shower which may allow water into wall. Suggest use of water proof curtain at window while showering. (See Picture(s))  Consider installation of exhaust fans for improved ventilation over windows.

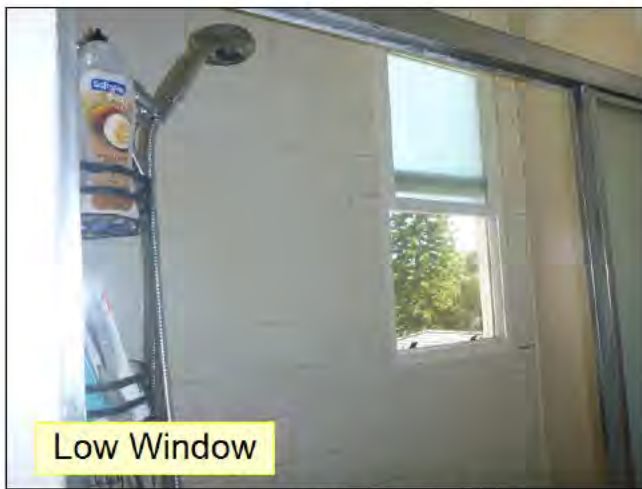
#### 7.4.A VENTILATION (See Picture(s))

Low Window

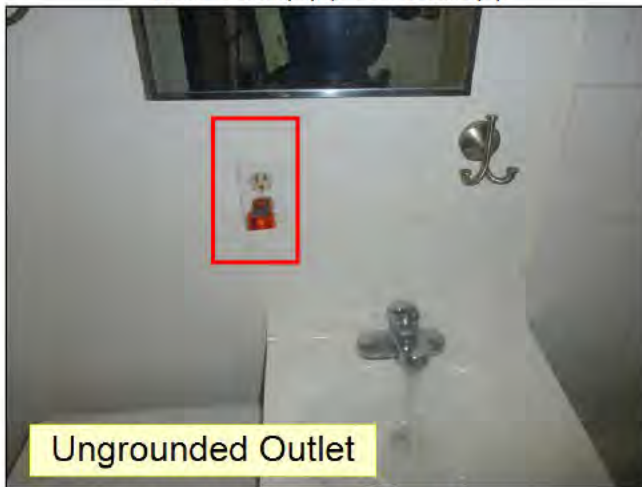
7.3.C ELECTRIC / GFCI (See Picture(s))

Ungrounded Outlet

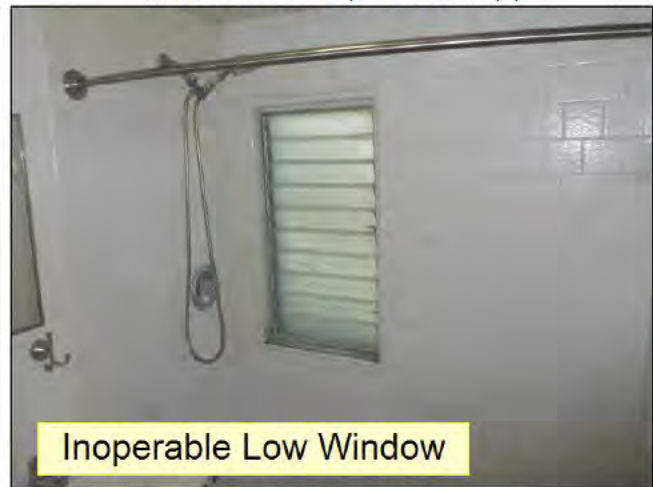
7.4.C VENTILATION (See Picture(s))

Inoperable Low Window

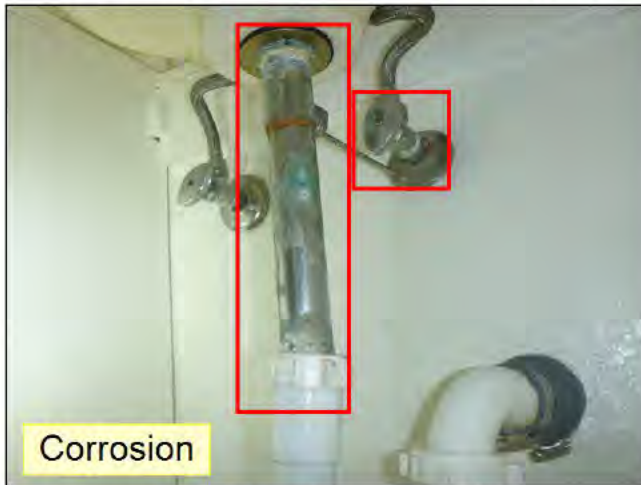
7.0.D SINK(S) (See Picture(s))

Corrosion

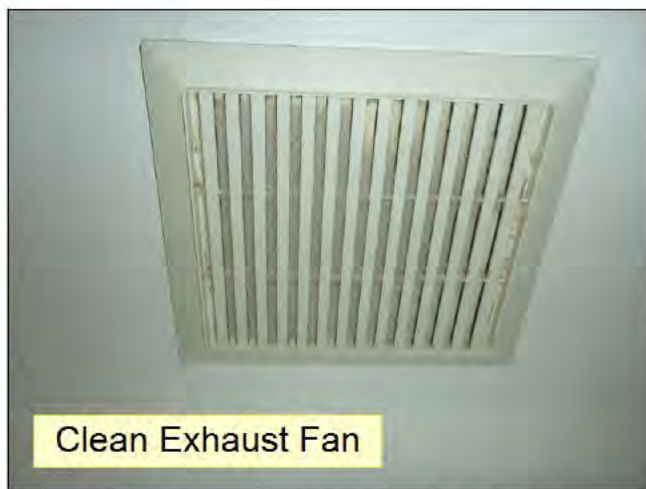
#### 7.4.D VENTILATION (See Picture(s))

Clean Exhaust Fan

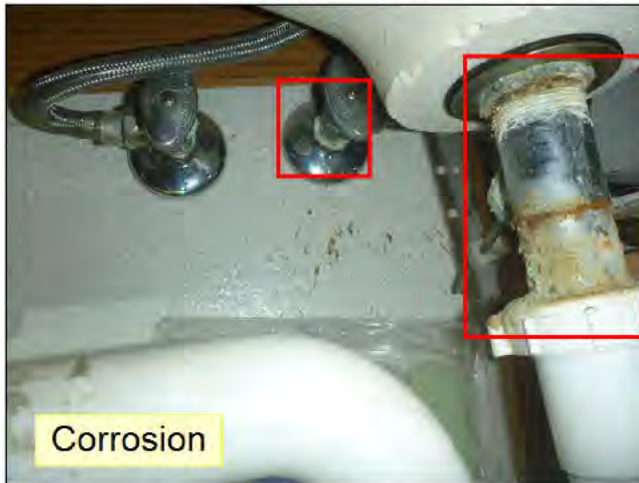
7.0.E SINK(S) (See Picture(s))

Corrosion

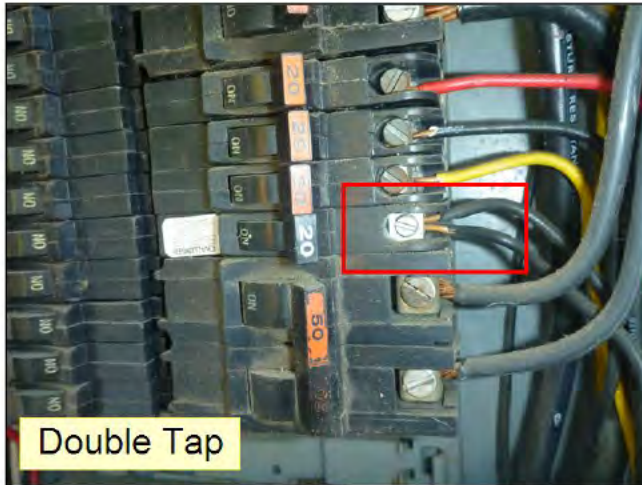
10.2 DISTRIBUTION PANEL (See Picture(s))

●						<b>10.0 SERVICE / ENTRANCE LINE</b> Note: Units are not individually metered. Anticipate installing individual meters and house meter if planning to charge tenants for electricity.
●						<b>10.1 SERVICE GROUNDING PROVISIONS</b>
		●				<b>10.2 DISTRIBUTION PANEL</b> Doubled up circuit noted in panel. Circuit tapping although common is not allowed. Suggest consulting electrician to evaluate and make repairs. See supplemental comments for additional information. (See Picture(s)) "Stab-Loc" circuit breaker panel manufactured by Federal Pacific Electric (FPE) is installed as main distribution panel and has been known to present a latent hazard by failing to trip under load, causing arcing which can result in an electrical fire. Recommend contacting a licensed electrical contractor to determine replacement cost estimate prior to close of escrow. (See Picture(s))  Labelling of service panel breakers is required for safe operation. (See Picture(s))

Double Tap

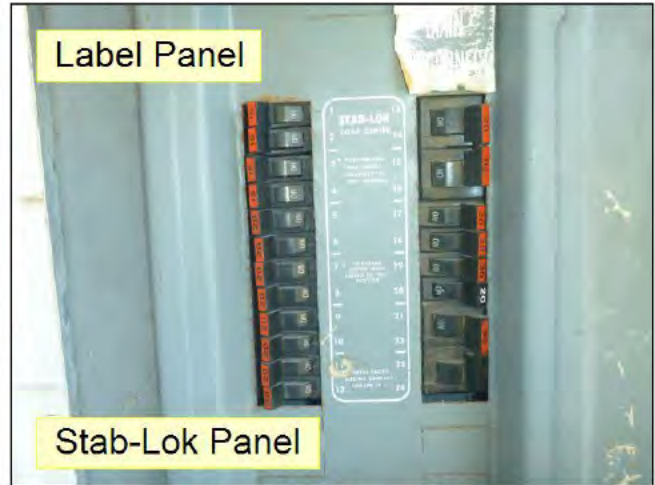
10.2 DISTRIBUTION PANEL (See Picture(s))

Label Panel

Stab-Lok Panel

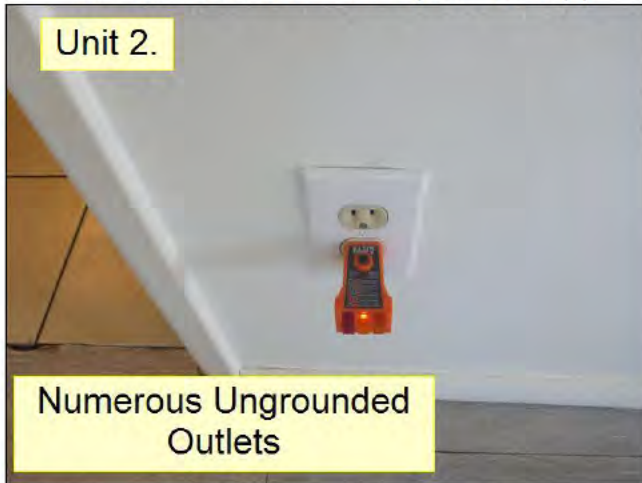
10.5 DEVICES (See Picture(s))

Unit 2.

Numerous Ungrounded Outlets

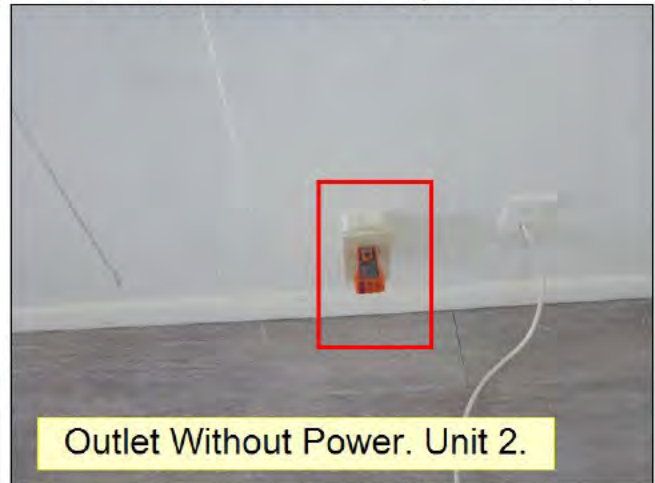
10.5 DEVICES (See Picture(s))

Outlet Without Power. Unit 2.

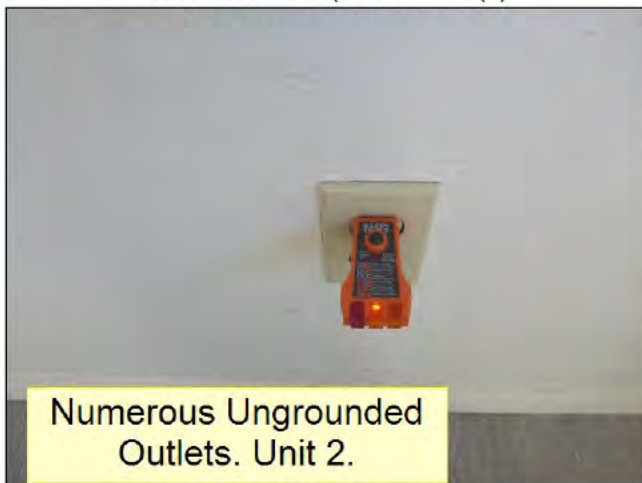
10.5 DEVICES (See Picture(s))

Numerous Ungrounded Outlets. Unit 2.

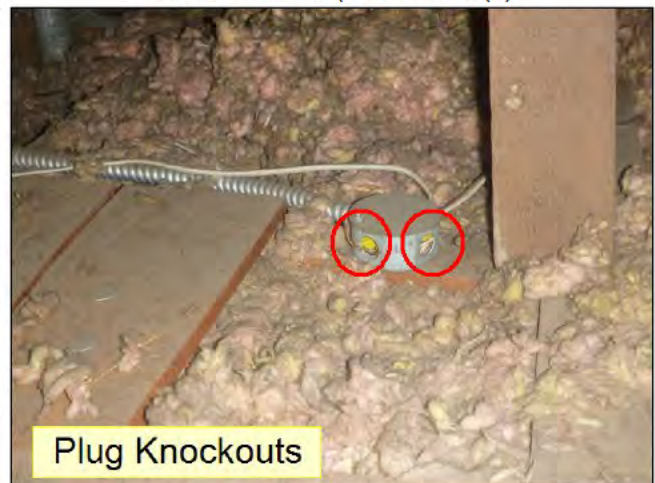
10.5 DEVICES (See Picture(s))

Plug Knockouts

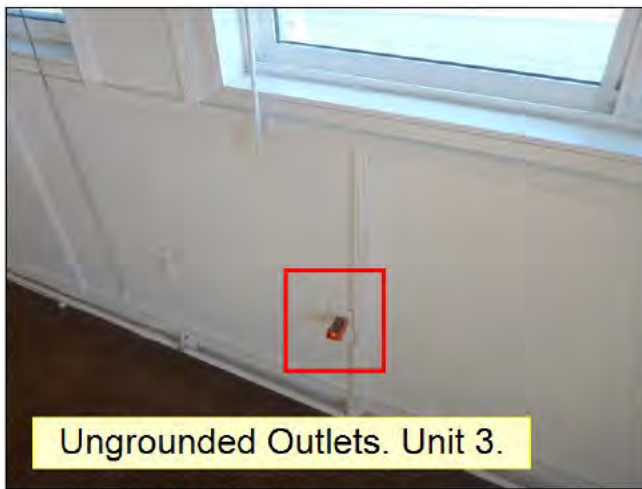
10.5 DEVICES (See Picture(s))

Ungrounded Outlets. Unit 3.

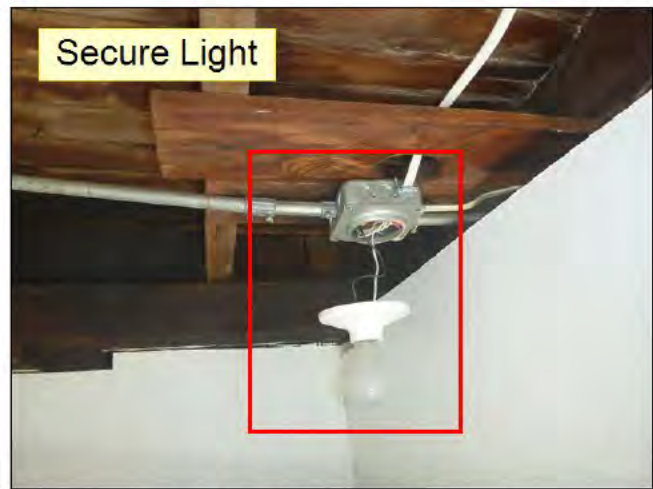
10.5 DEVICES (See Picture(s))

Secure Light

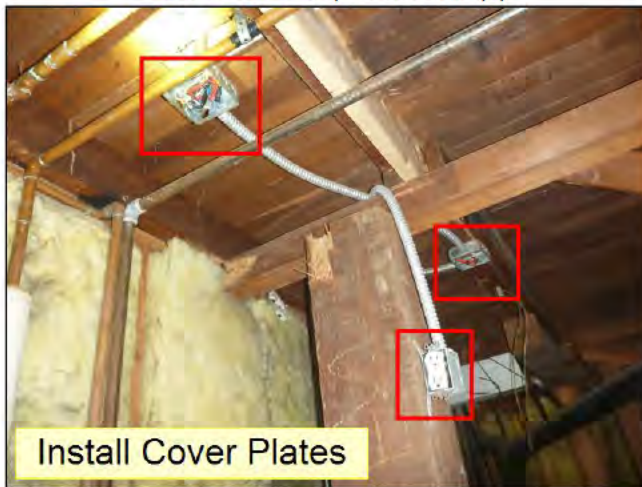
10.5 DEVICES (See Picture(s))

Install Cover Plates

●				<b>10.3 MAIN DISCONNECT(S)</b> Electric panel will be undersized for today's needs. Recommend consulting with an electrical contractor for panel upgrade options/cost prior to close of escrow. See supplemental comments for additional information.  Consider installation of a whole house surge protector as an upgrade (not required by code) in main panel to protect sensitive electrical components. Consult an electrician for installation if desired.
●						<b>10.4 SUBPANEL</b> No subpanels in units 1, 2, 3, and 5. Anticipate installation of sub panels. Unit 4 subpanel: Satisfactory
		●				<b>10.5 DEVICES</b> Numerous ungrounded outlets observed. Ungrounded outlets pose a shock risk. Consult an electrician for options for upgrade (ask about using GFCI outlets or breakers as a possible solution) and to determine repair cost estimate prior to close of escrow. See Non-Grounded Receptacles in Supplemental Information.  See comments in kitchen, bath, and exterior sections of report regarding GFCI outlet upgrades. Plug open knockouts at junction boxes in attic for electrical safety. (See Picture(s)) Hanging light in laundry room. Secure for electrical safety. (See Picture(s))  Missing cover plates noted. Install covers at all outlets and switches for safety.

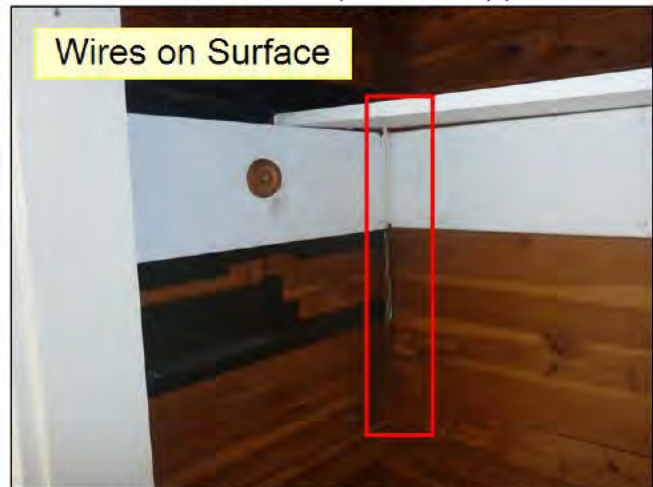
10.6 WIRING / CONDUCTORS (See Picture(s))

Wires on Surface

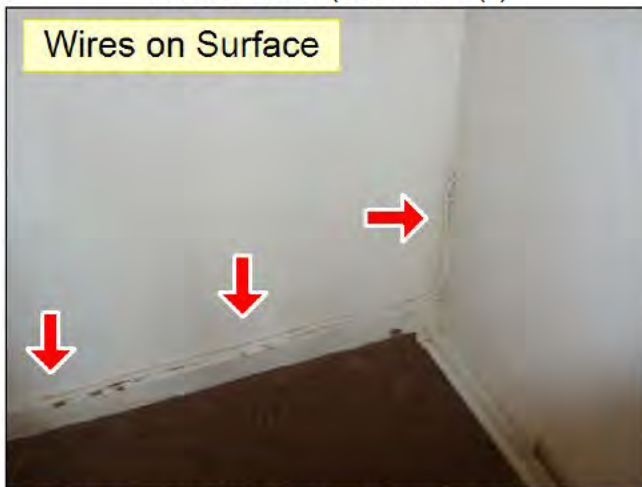
10.6 WIRING / CONDUCTORS (See Picture(s))

Wires on Surface

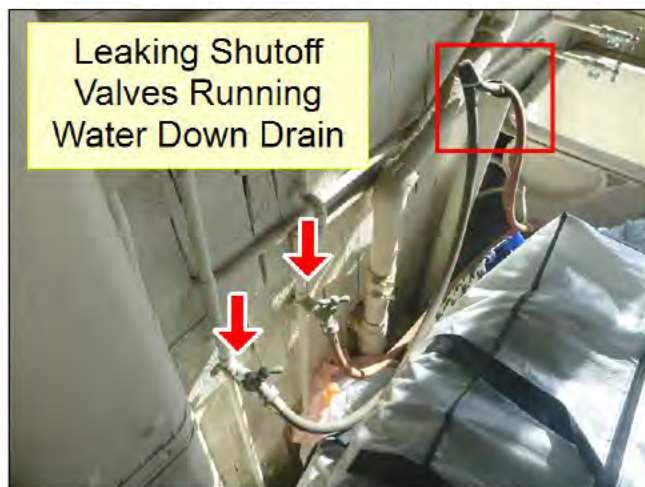
11.0 WATER PIPING (See Picture(s))

●	<b>11.0 WATER PIPING</b> Angle stops at upstairs laundry are running water down laundry drain and cannot be shutoff. Contact a plumber to replace shutoff valves. (See Picture(s)) Plumbing corrosion noted at numerous shutoff valves. See bath and kitchen sections of report. Consult a plumber for repair. Evaluation of the plumbing system is limited to permanently connected fixtures and readily visible pipe condition. The function and effectiveness of angle stop shut offs, laundry standpipes, vent pipes, anti-siphon devices, floor drains and similar items generally cannot be evaluated. Conditions are subject to unpredictable change, e.g. leaks may develop, water flow may drop, drains may become blocked. etc. The detection of sewer gases and the conditions of sub-slab or inground piping is excluded from a standard inspection.
		●	<b>11.1 WATER FLOW AT FIXTURES</b> The water pressure was 20 psi at the time of inspection which is below the normal range of 40 to 80 psi. Consult a plumber for evaluation and pressure regulator adjustment/replacement prior to close of escrow. See supplemental comments below for additional information. (See Picture(s))

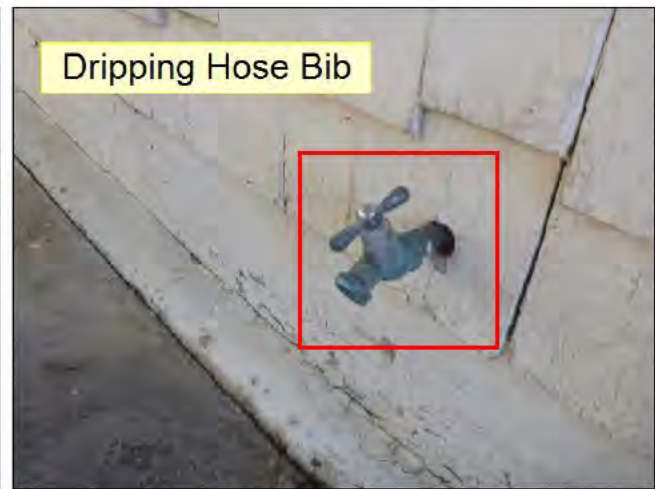
11.4 EXTERIOR FAUCET(S) (See Picture(s))

●	<b>11.4 EXTERIOR FAUCET(S)</b> Dripping hose bib at front of building. Anticipate replacement. (See Picture(s)) Lack of anti-siphon valves noted at hose bibs. Suggest installing as an upgrade to keep water/contaminants in hose from entering back into the potable water supply.

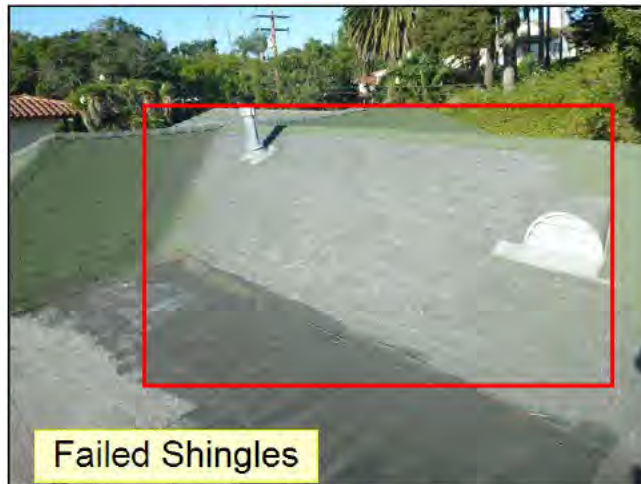
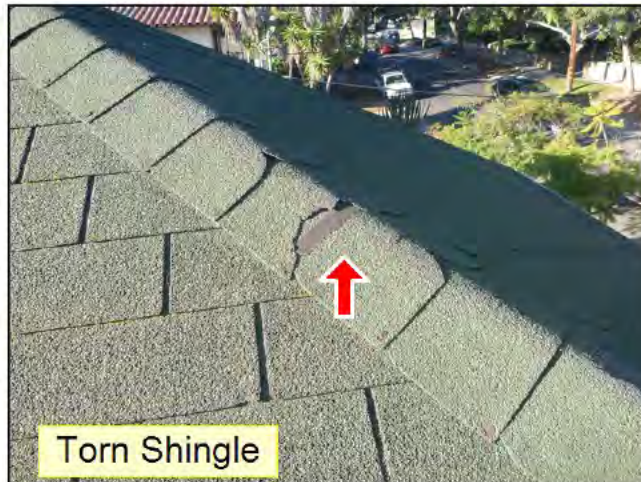
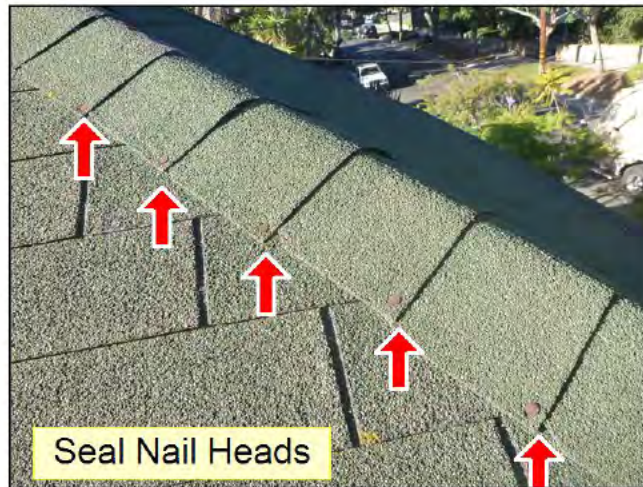
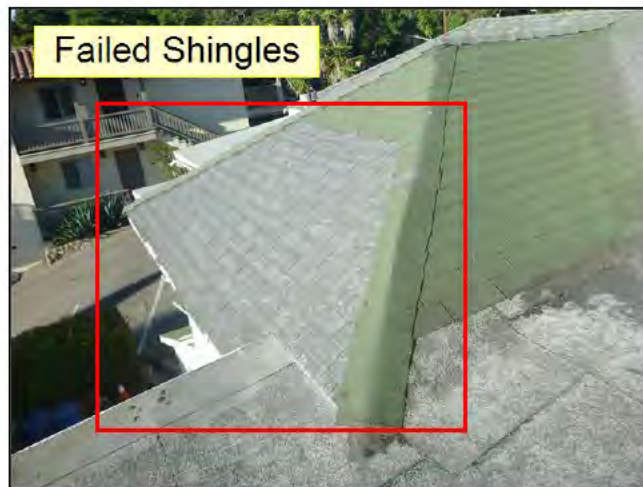
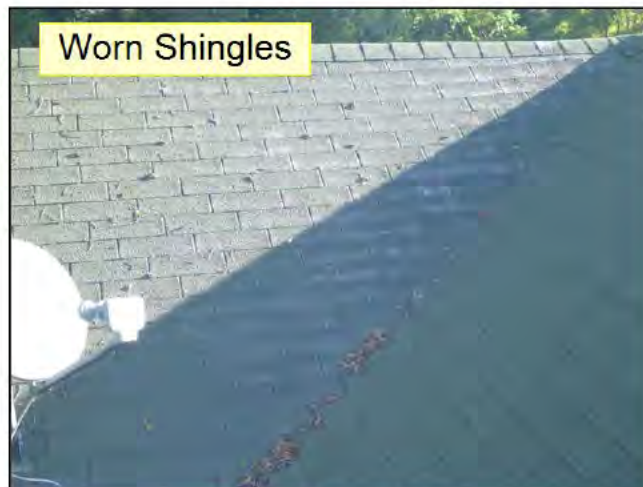
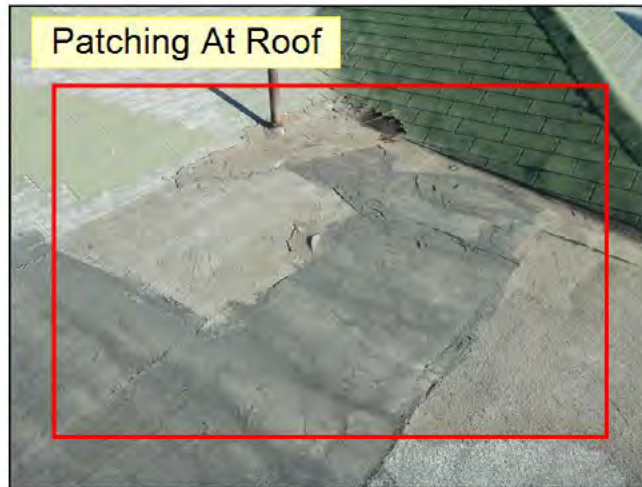
1.0 (See Picture(s))

Roof shingles are failing with granule loss and exposed fiberglass with areas of previous patching observed on roof. Consult a roofing contractor to determine roof replacement cost estimates prior to close of escrow. (See Picture(s))

Exposed nailheads at ridge caps. Suggest sealing to extend service life and prevent water penetration. (See Picture(s))

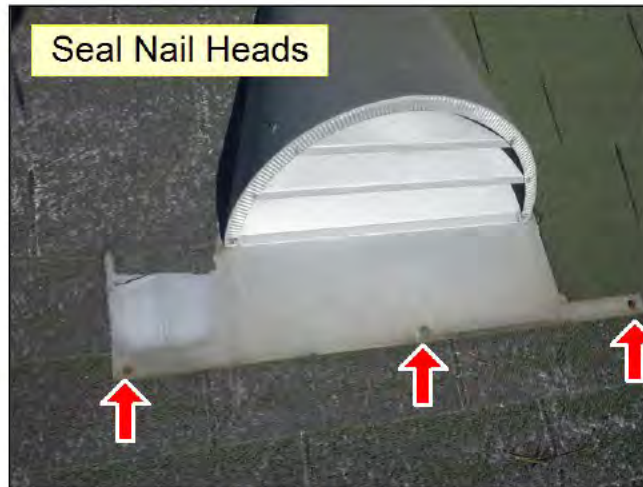
1.1 (See Picture(s))

Exposed nailheads at flashings observed on roof. Seal nailheads as required to prevent water penetration and extend service life. (See Picture(s))

Anticipate replacing flashing when reroofing.

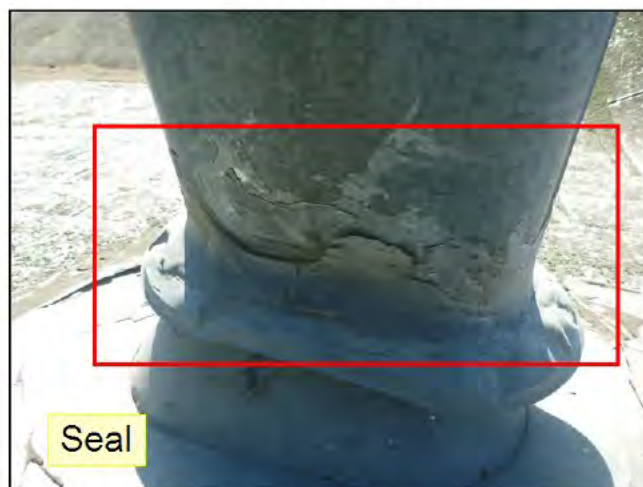
1.2 (See Picture(s))

Gaps noted at roof penetrations. Reseal roof penetrations now and on a routine basis to prevent leakage to interior of structure. (See Picture(s))

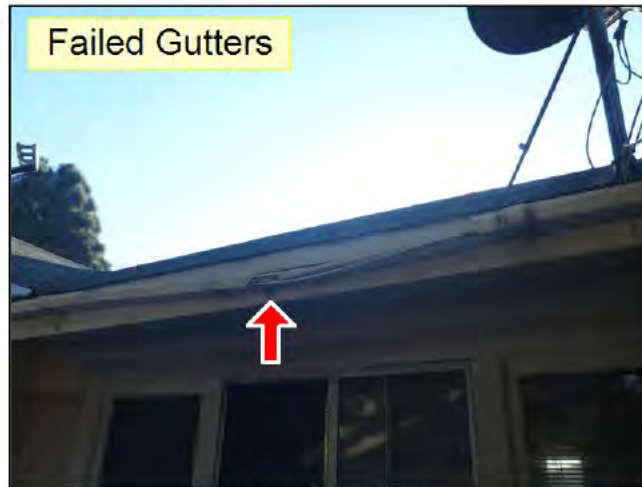
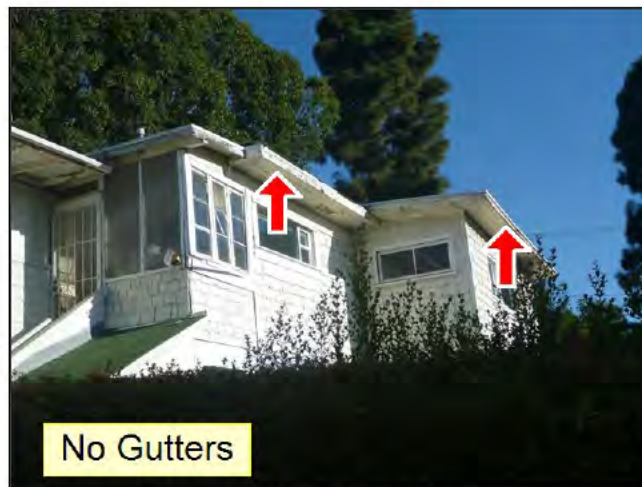
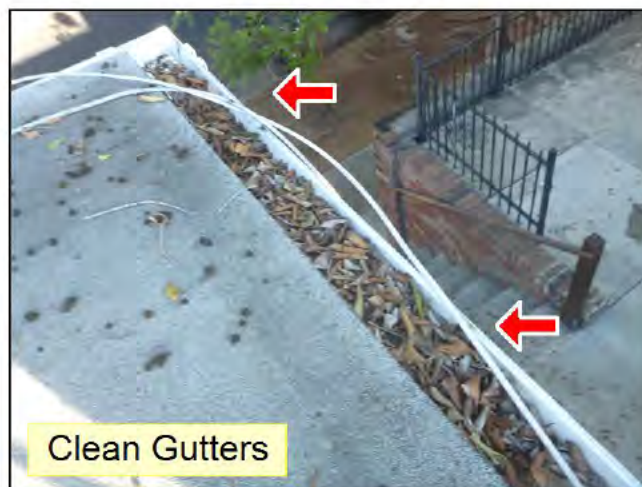
Multiple failed gutters observed. Anticipate replacement. (See Picture(s))

Buildup in rain gutters. Suggest cleaning and flushing now and on an annual basis for proper drainage. Consider upgrade of gutter guards to prevent leaf buildup. (See Picture(s))

Suggest installation of rain gutters and downspouts at all pitched roof edges to aide in controlling water run off away from structure and hardscaping. Gutters and downspouts help aide in reducing water runoff from splashing onto/penetrating into structure. Consider adding built in drains/subsurface drains and connecting downspouts into drain system. (See Picture(s))

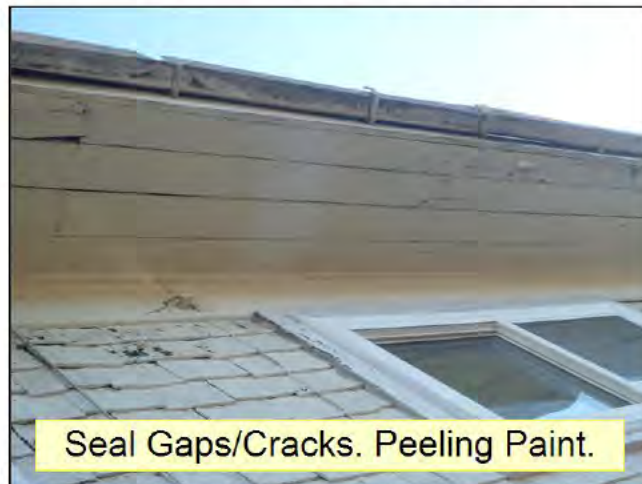
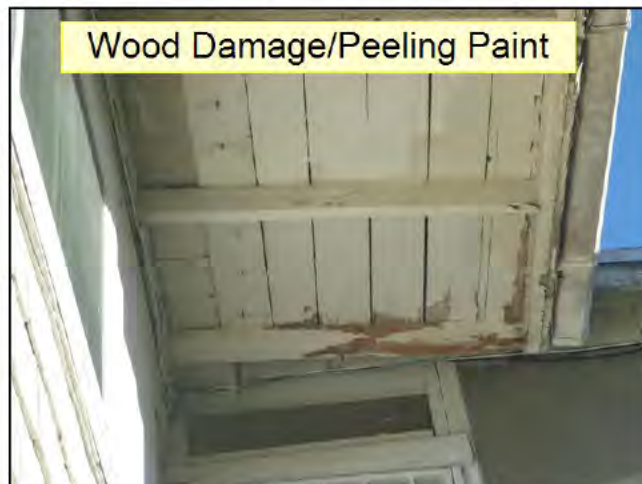
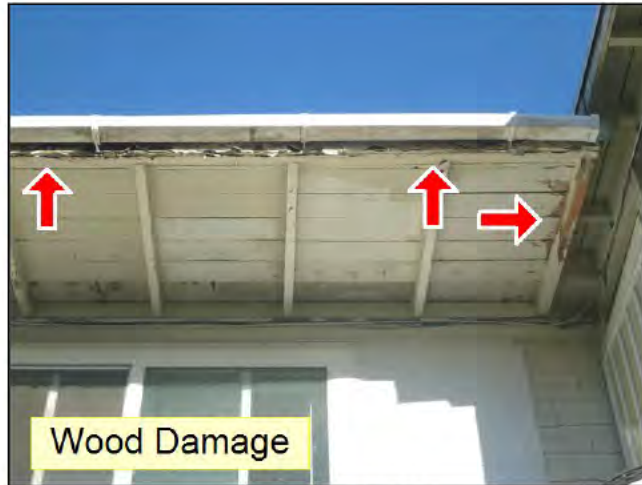
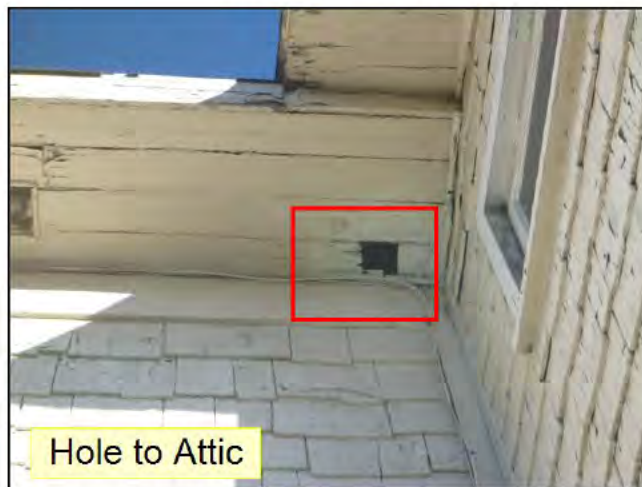
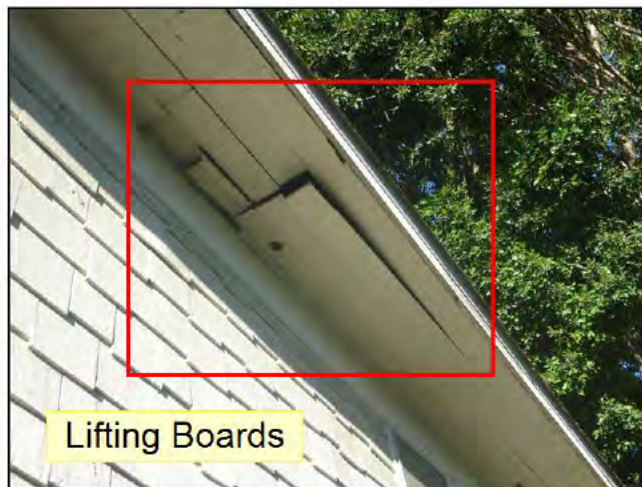
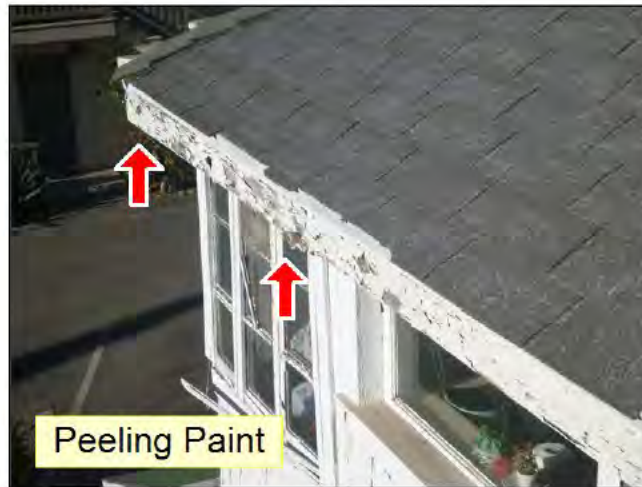
Wood damage noted at fascia/eaves/soffit members. Anticipate repairs. Consult pest control company for evaluation and repair/treatment cost estimate. (See Picture(s))

Peeling/loose paint observed at fascia/eaves. Due to the age of the home (1978 and older), the paint may contain lead. Suggest repainting to preserve wood. Use care when working with old materials, especially with paint. Have tested prior to disturbing. (See Picture(s))

Suggest consultation with a licensed painting contractor certified in lead paint testing/removal prior to close of escrow.

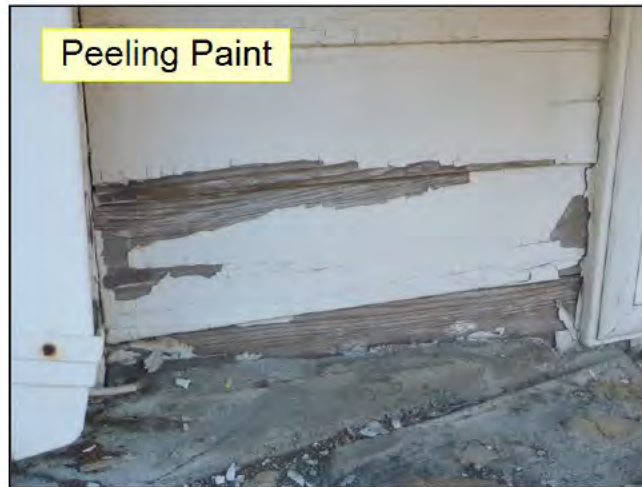
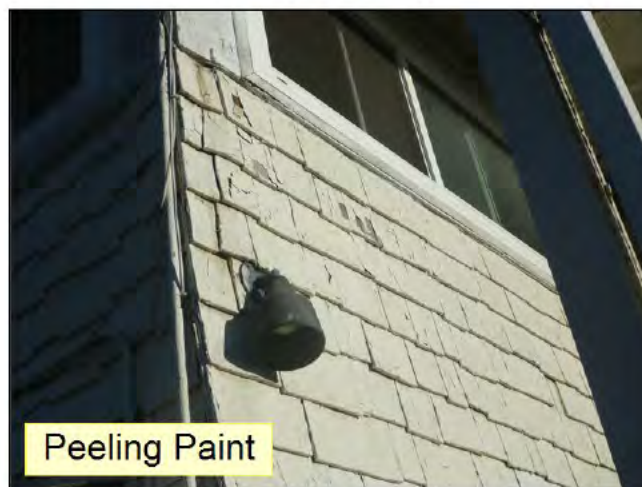
Paint is peeling/loose. Due to the age of the home (1978 and older), the paint may contain lead. Suggest repainting to preserve wood. Use care when working with old materials, especially with paint. Have tested prior to disturbing. (See Picture(s))

Peeling Paint

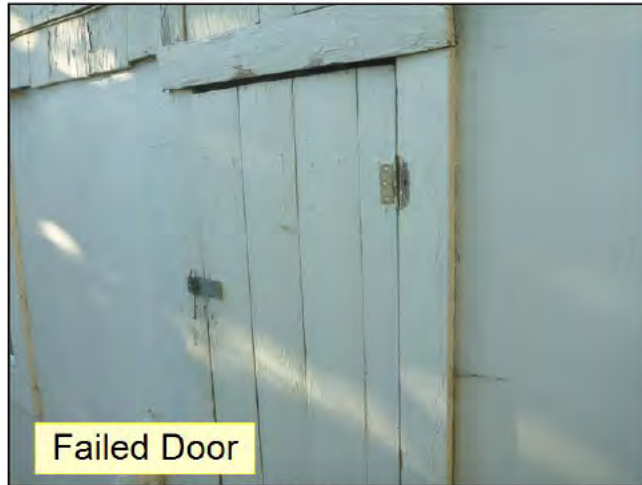
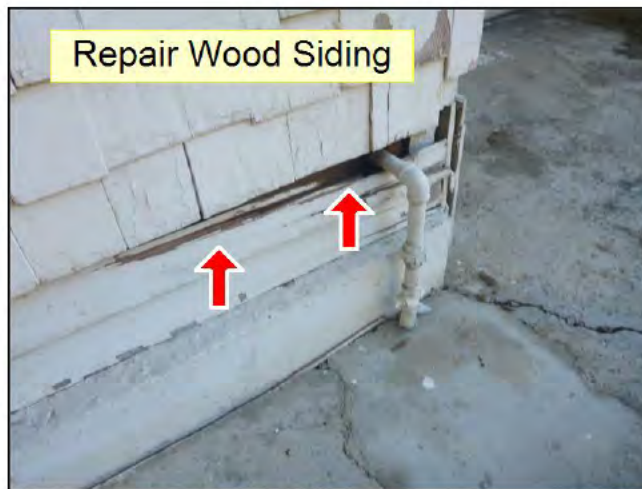
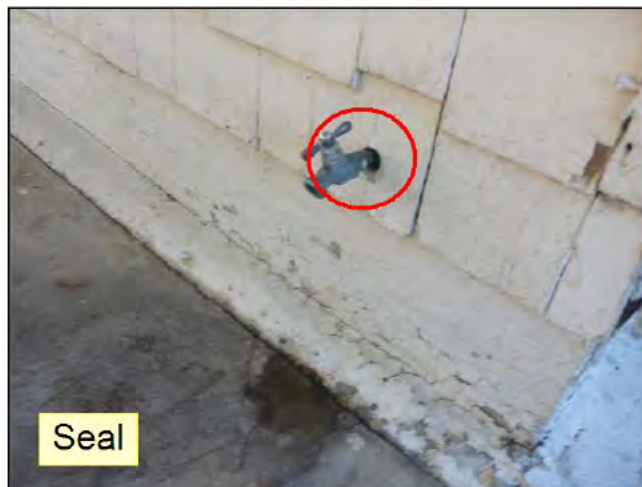
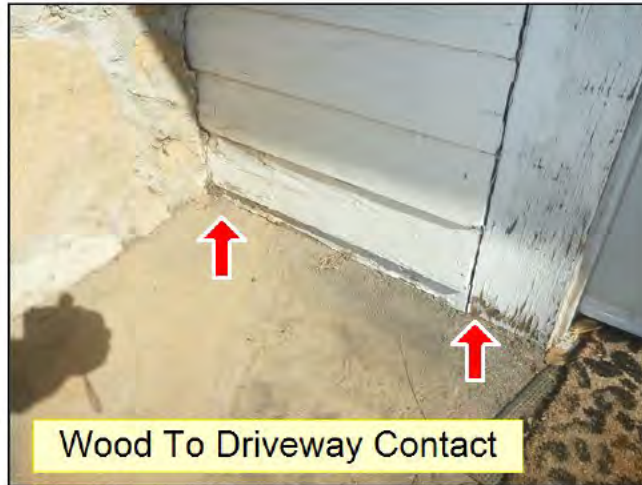
Wood rot observed at exterior wood siding. See pest control report for conditions related to wood siding, trim and framing members. (See Picture(s))

Failed door at crawlspace access. Anticipate repair. (See Picture(s))

Suggest sealing now and annually at any holes, gaps, cracks, around light fixtures, windows, doors, trim, etc...to aide in preventing water penetration and pest intrusion. (See Picture(s))

Recommend raising wood siding and installing flashing where wood siding meets driveway to prevent further wood deterioration. (See Picture(s))

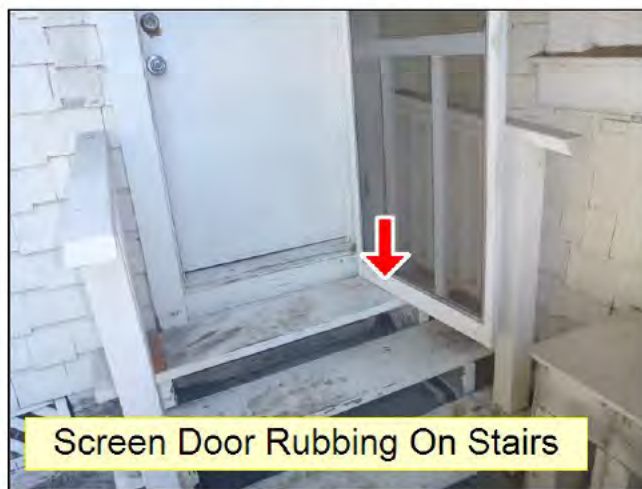
2.1 (See Picture(s))

Multiple weathered front doors and screen doors. Anticipate refinishing, repair, or replacement as desired. (See Picture(s))

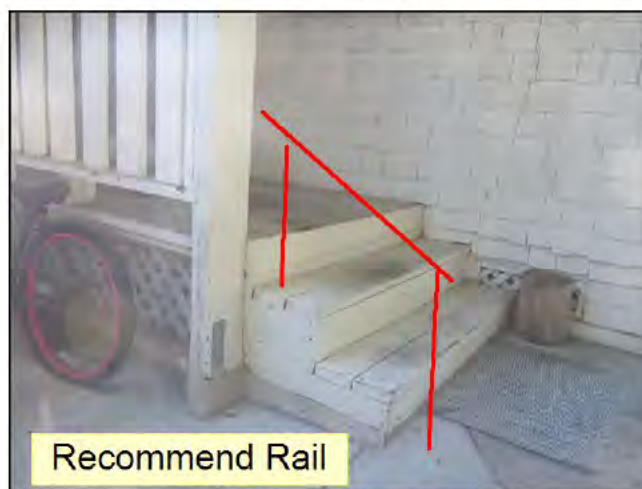
2.3 (See Picture(s))

Loose rail at rear stairs. Anticipate repair/replacement. (See Picture(s))

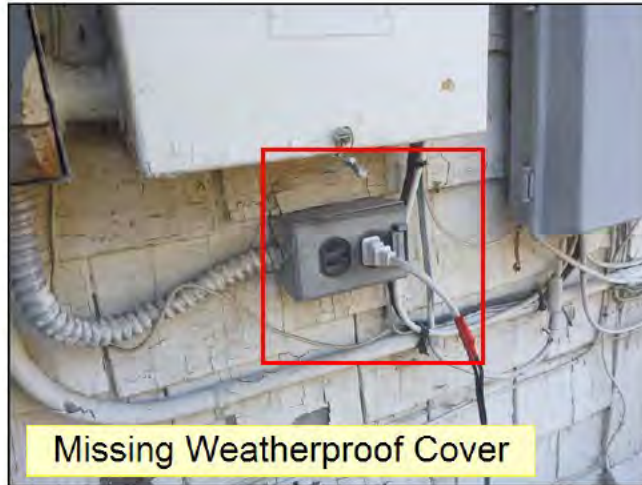
2.4 (See Picture(s))

Missing weatherproof covers noted at exterior wall outlets. Installation required to prevent moisture and pest intrusion. (See Picture(s))

Suggest upgrades to Ground Fault Circuit Interrupters (GFCI) outlets at all exterior outlets for added safety. Consult licensed electrical contractor for installation.

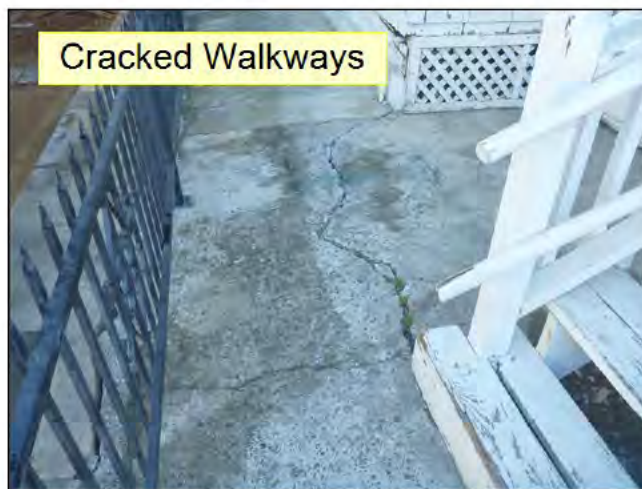
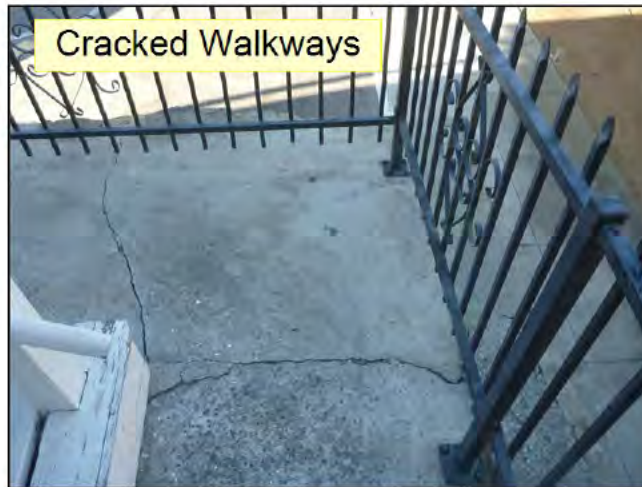
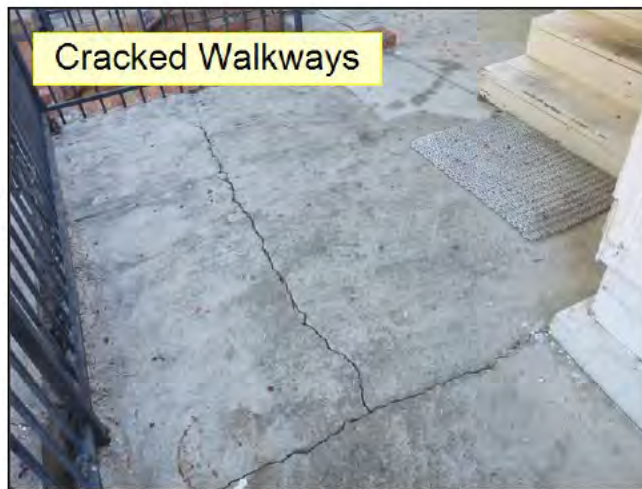
Numerous cracks at front entry walkways at units 1, 2, and 3. See retaining wall section of report. See rain gutter and downspout comments in roofing section of report. (See Picture(s))

Suggest sealing at any hardscaping (walks, patios & driveways) cracks for enhanced life span of material.

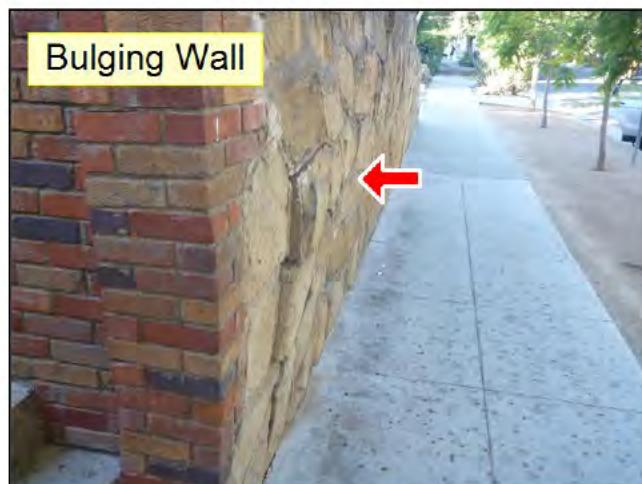
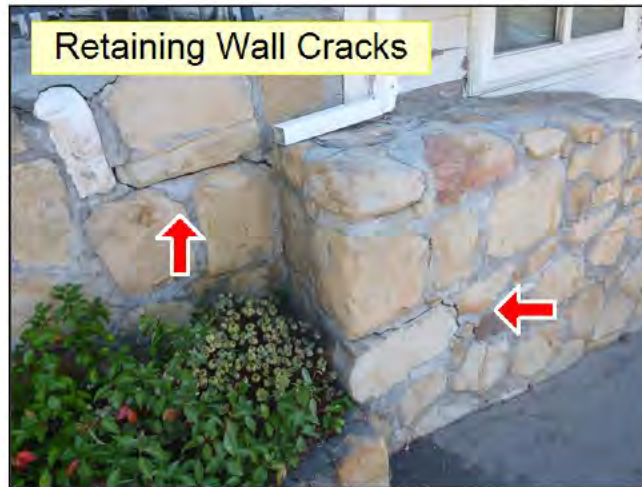
Cracking/displacement observed at front retaining wall. Consult a contractor for further evaluation and repairs. (See Picture(s))

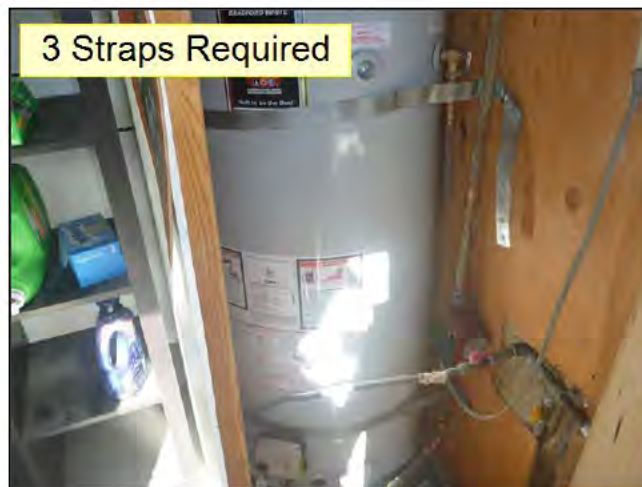
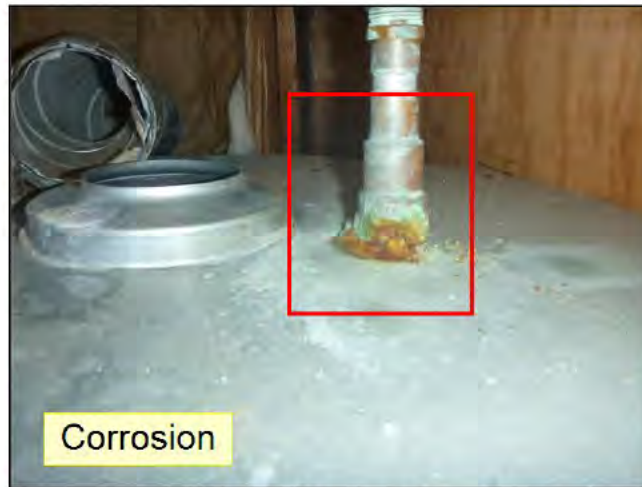
Corrosion noted at plumbing of water heater. Replace components as needed to prevent leaks and moisture damage. (See Picture(s))

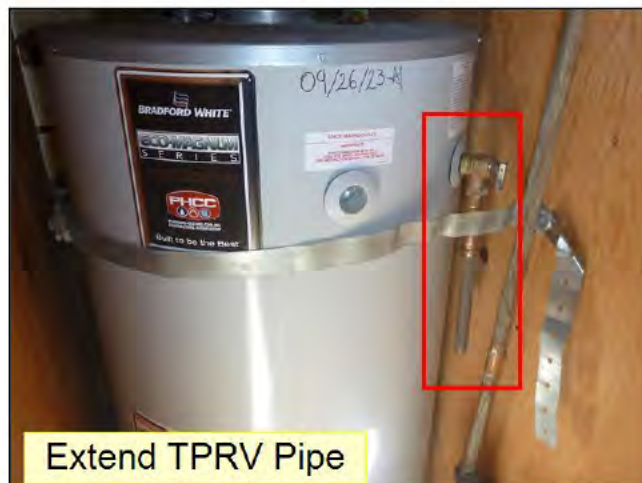
4.3 (See Picture(s))

The drain pipe for the Temperature Pressure Relief Valve is not installed within 6 to 24 inches off of ground. Contact a plumber for correct installation. See supplemental information for additional comments. (See Picture(s))
