Prepared for Exclusive Use by:

Address of Property:

Shelby Hendrix

Multi-Unit Property

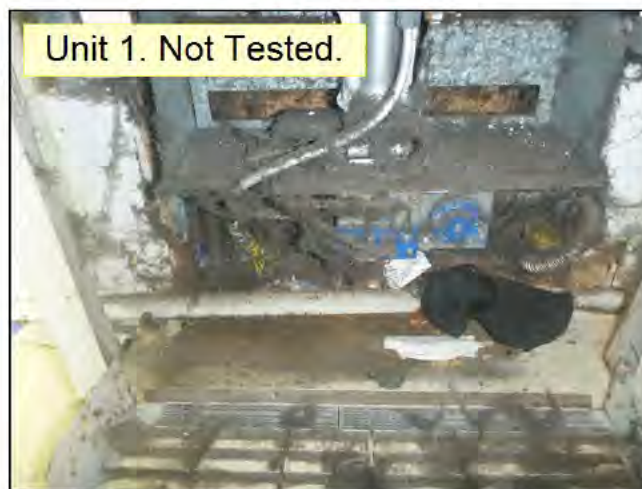
6.0 (See Picture(s))

Unit 1: Estimated 25-30 years old. Not tested due to significant lint buildup fire hazard. Have unit cleaned and tested. Unit is nearing/has reached end of design life. Anticipate future repair/replacement.

Unit 4: 34 years old. Pilot light not lit and ignitor inoperable. Unit is past design life. Contact HVAC contractor to evaluate and determine repair or replacement cost estimate.

Unit 5: 13 years old. Burners did not light when thermostat was turned up. Have unit/thermostat evaluated/repared by an HVAC contractor and cleaned for fire safety.

Suggest annual servicing/evaluation of all units by a heating, ventilation and air conditioning (HVAC) contractor to extend service life and for proper and safe operation.

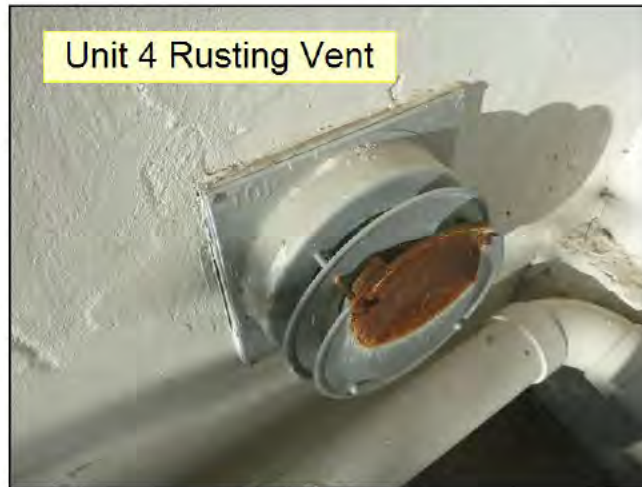
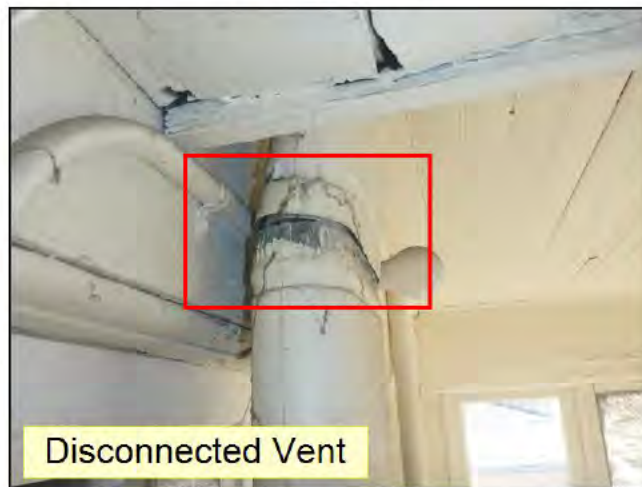
Unit 4 rusting vent at wall. Anticipate painting or replacement. (See Picture(s))

See roofing section of report regarding rusting vents on roof.

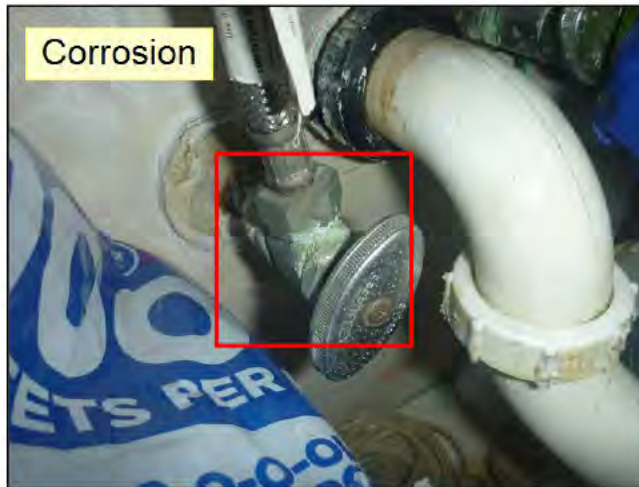
7.0.A (See Picture(s))

Corrosion noted at shutoff valves beneath sinks. Replace components as needed to prevent leaks and moisture damage. (See Picture(s))

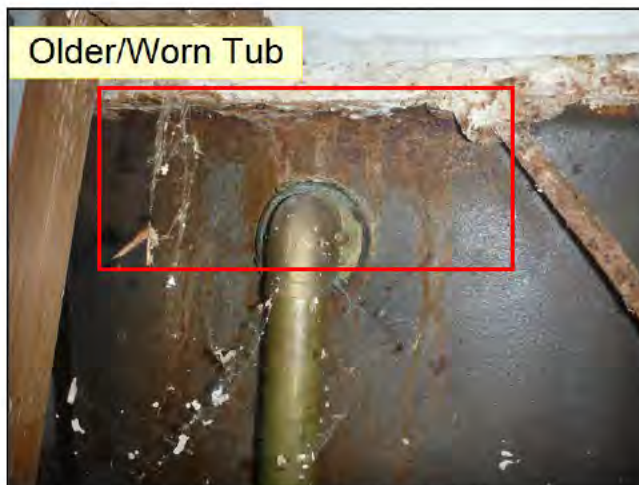
7.2.A (See Picture(s))

Older/worn bathtub and fixtures. Anticipate repair/replacement. See supplemental information regarding older/worn fixtures/faucets. (See Picture(s))

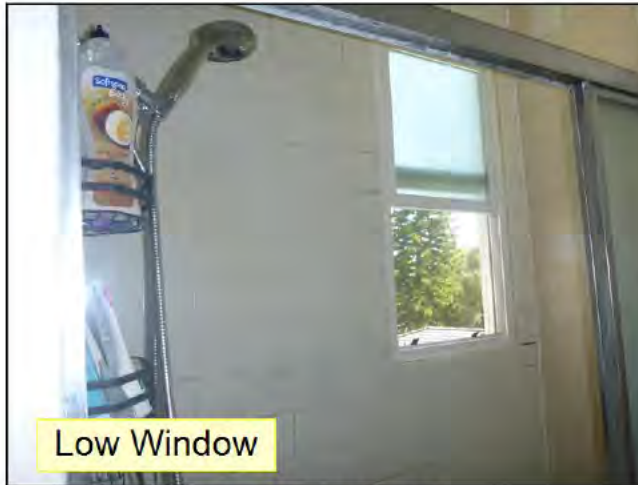
7.4.A (See Picture(s))

Window is low in tub/shower which may allow water into wall. Suggest use of water proof curtain at window while showering. (See Picture(s))

Consider installation of exhaust fans for improved ventilation over windows.

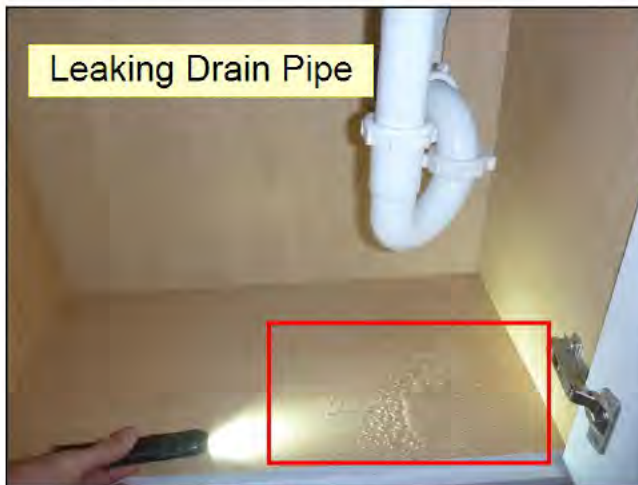
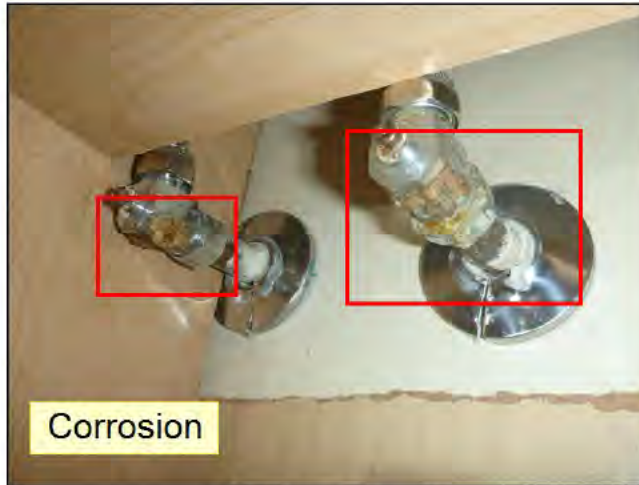
Active water leak at drain piping under sink. Contact a plumber for repair. (See Picture(s))

Corrosion noted at shutoff valves beneath sinks. Replace components as needed to prevent leaks and moisture damage. (See Picture(s))

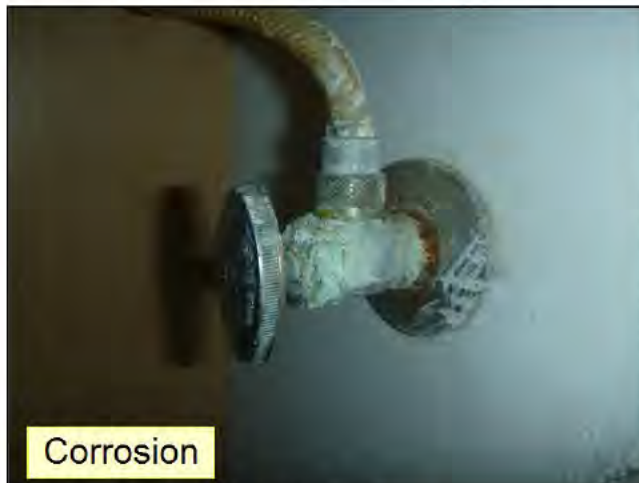
7.0.C (See Picture(s))

Corrosion noted at shutoff valves beneath sinks. Replace components as needed to prevent leaks and moisture damage. (See Picture(s))

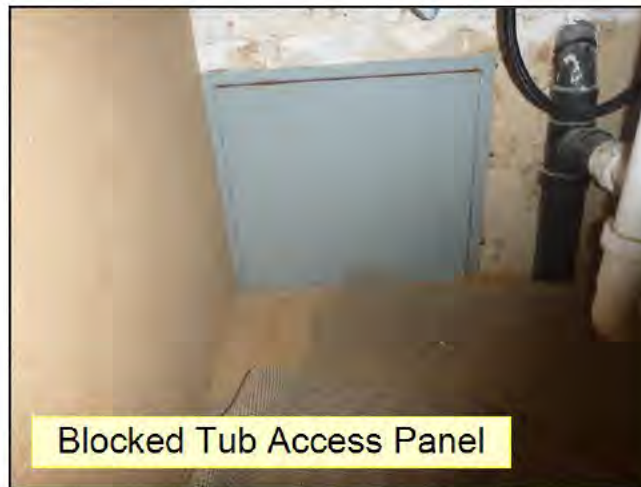
7.2.C (See Picture(s))

Tub access panel is blocked by kitchen cabinet base. Reconfigure access panel to allow access for repairs and inspection. (See Picture(s))

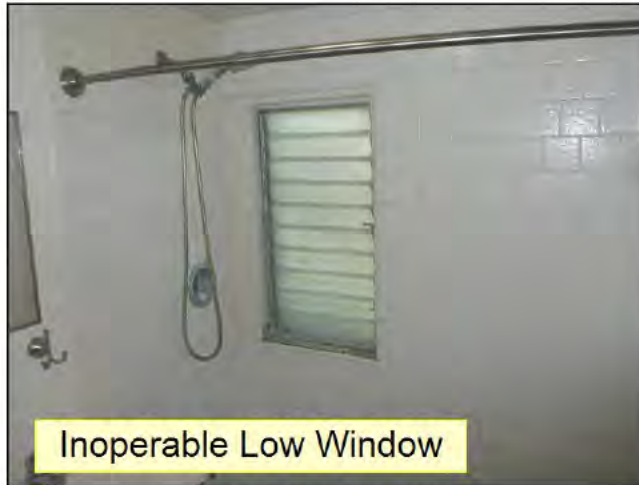
7.4.C (See Picture(s))

Jalousie window is inoperable and is low in tub/shower which may allow water into wall. Suggest use of water proof curtain at window while showering, moving window, or removing window and installing fan. (See Picture(s))

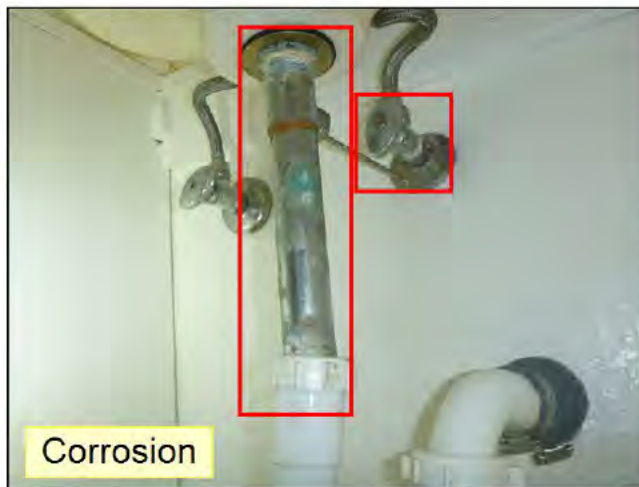
7.0.D (See Picture(s))

Corrosion noted at plumbing beneath sinks. Replace components as needed to prevent leaks and moisture damage.

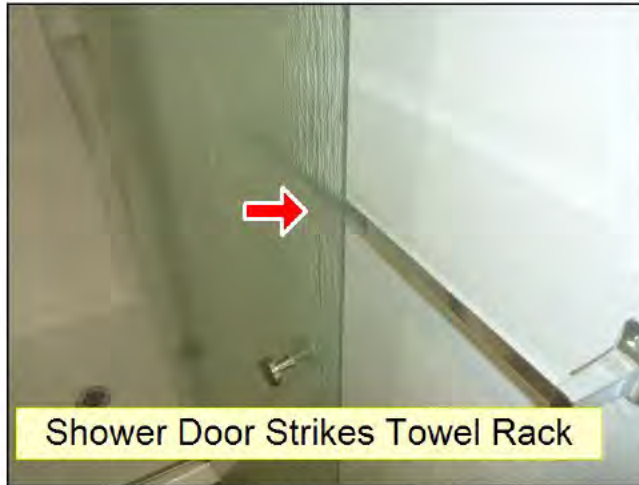
7.2.D (See Picture(s))

Glass shower door strikes towel rack. Consider moving towel rack and using caution with frameless glass shower door. (See Picture(s))

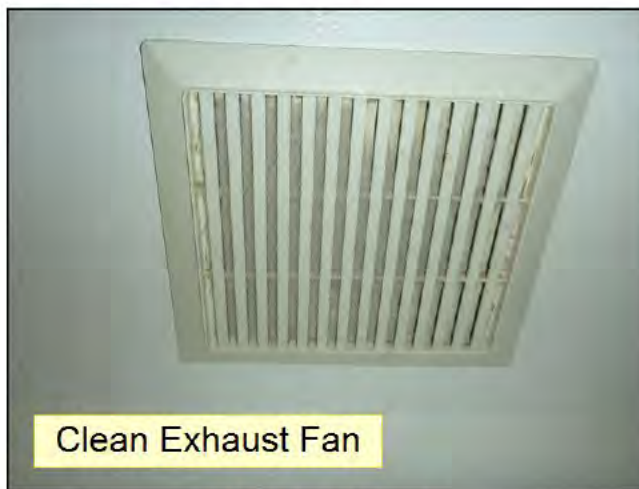
7.4.D (See Picture(s))

Dirty exhaust fan noted. Suggest cleaning for proper venting and fire safety.

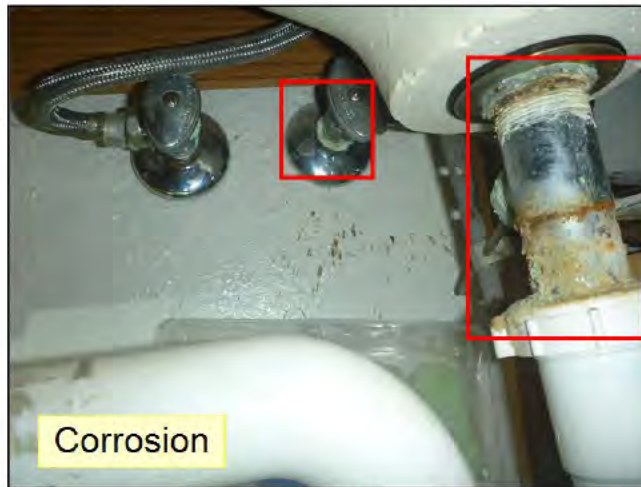
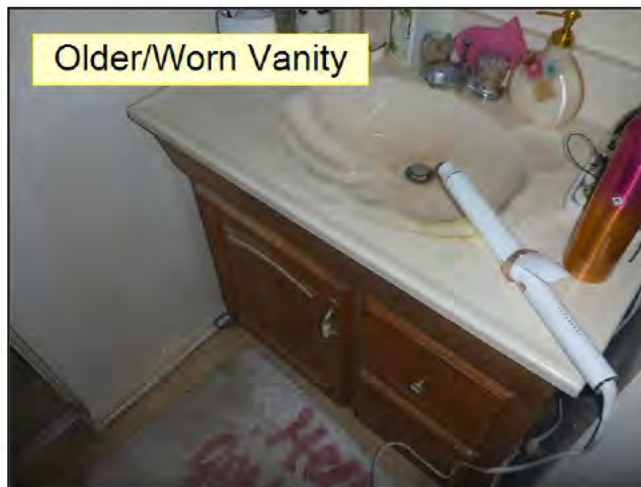
7.0.E (See Picture(s))

Corrosion noted at shutoff valves beneath sinks. Replace components as needed to prevent leaks and moisture damage.

Older and worn sink, faucet, and vanity. Refinish/replace as desired.

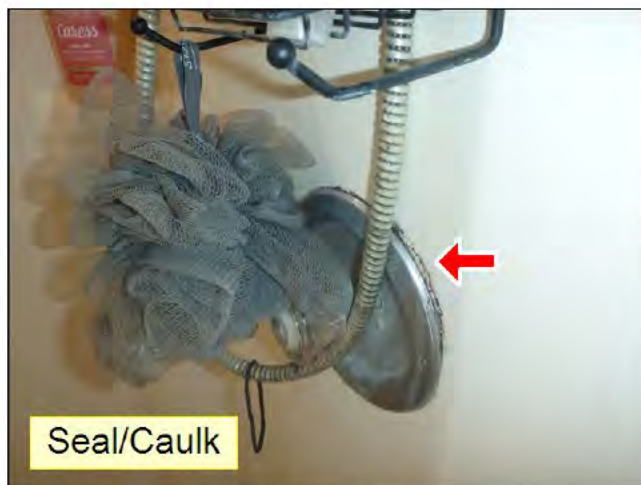
7.2.E (See Picture(s))

Shower head is leaking. Have connection of shower head re-taped and re secured.

Seal/caulk around escutcheon plate to prevent moisture behind finish materials.

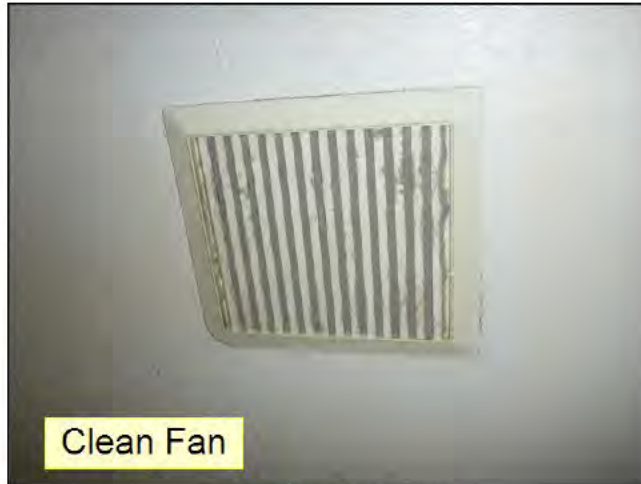
7.4.E (See Picture(s))

Dirty exhaust fan noted. Suggest cleaning for proper venting and fire safety.

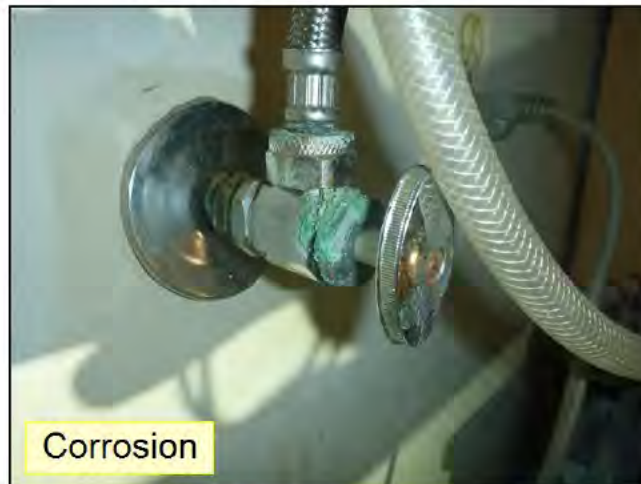
8.0.A (See Picture(s))

Corrosion observed on plumbing beneath kitchen sink. Contact plumber for repair/replacement. (See Picture(s))

Stains/moisture damage noted under kitchen sink. Consult seller on history of water leaks. Unable to determine condition behind concealed areas. Look for/anticipate hidden damage behind materials. (See Picture(s))

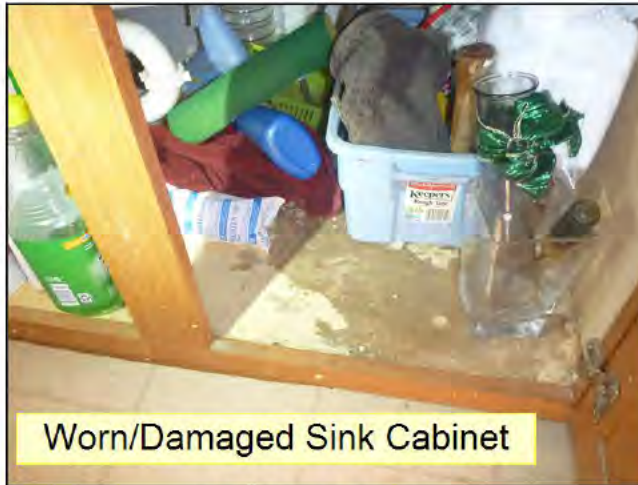
8.0.A (See Picture(s))

Worn/Damaged Sink Cabinet

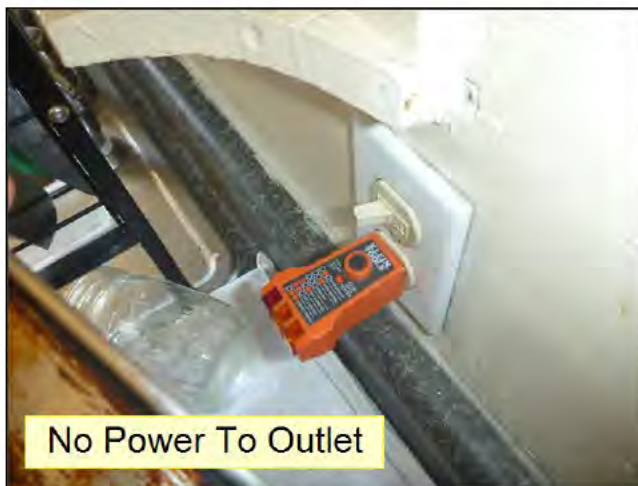
8.6.A (See Picture(s))

No power to outlet to right side of sink or to disposal. Contact an electrician for evaluation and repair.(See Picture(s))

No Power To Outlet

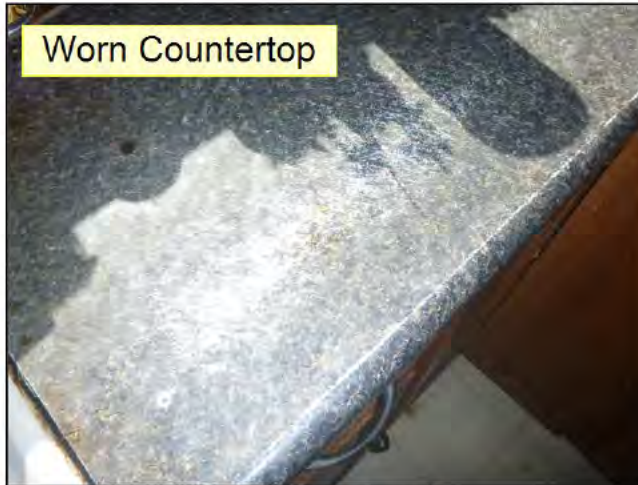
8.7.A (See Picture(s))

Older and worn countertop noted. Formica damaged at several locations. Anticipate replacement. (See Picture(s))

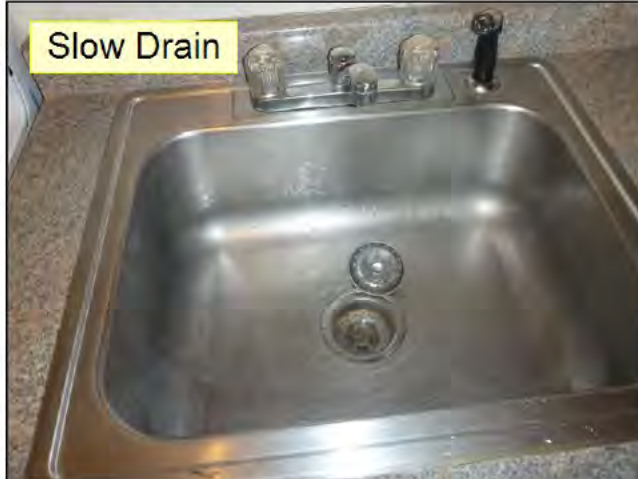
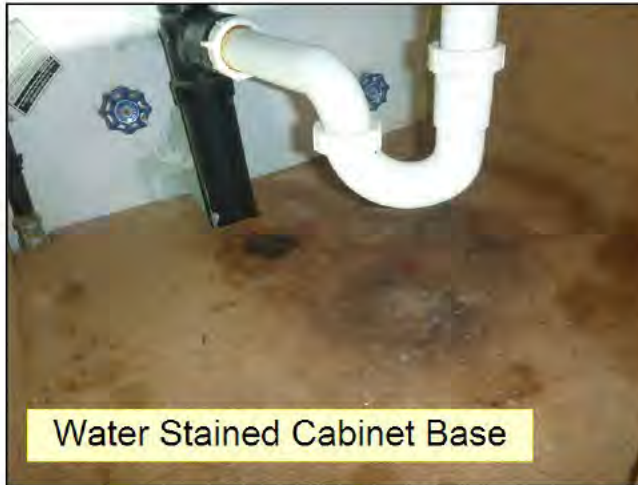
8.0.B (See Picture(s))

Slow drain noted at kitchen sink. Consult a plumber for evaluation/repair as required for proper drainage. (See Picture(s))

Stains/moisture damage noted under kitchen sink. Consult seller on history of water leaks. Unable to determine condition behind concealed areas. Look for/anticipate hidden damage behind materials. (See Picture(s))

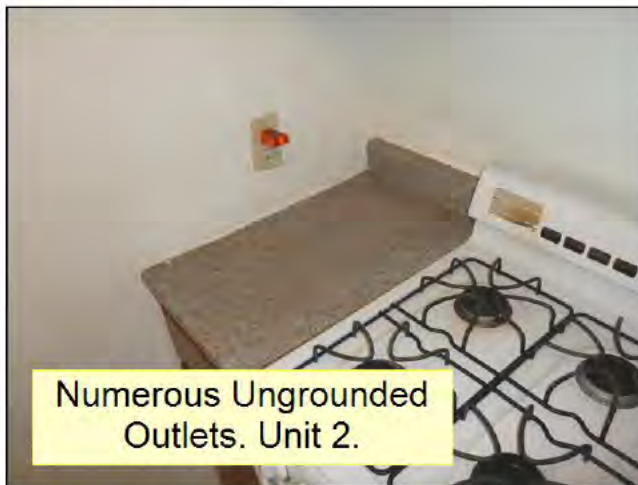
8.6.B (See Picture(s))

Ungrounded at electrical outlets observed in kitchen. Consult an electrician for correction. Suggest upgrade to GFCI (Ground Fault Circuit Interrupter) type outlets for added safety. (See Picture(s))

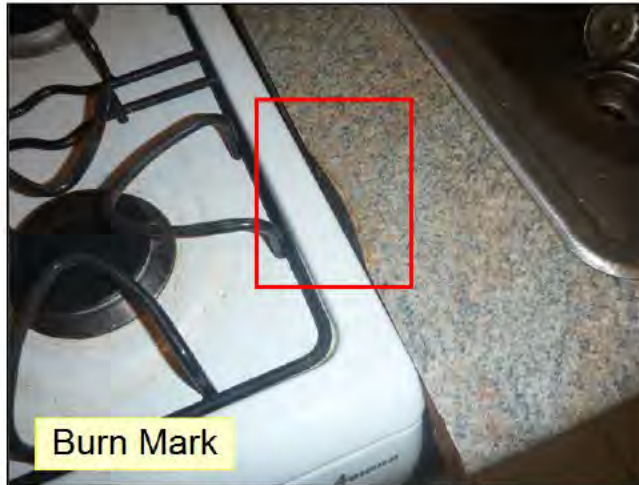
8.7.B (See Picture(s))

Burned countertop edge near range. Repair/replace as desired. (See Picture(s))

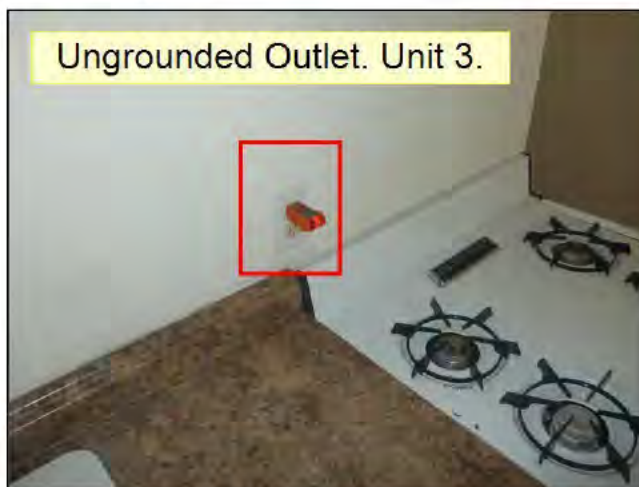
8.6.C (See Picture(s))

Ungrounded at electrical outlets observed in kitchen. Consult an electrician for correction. Suggest upgrade to GFCI (Ground Fault Circuit Interrupter) type outlets for added safety. (See Picture(s))

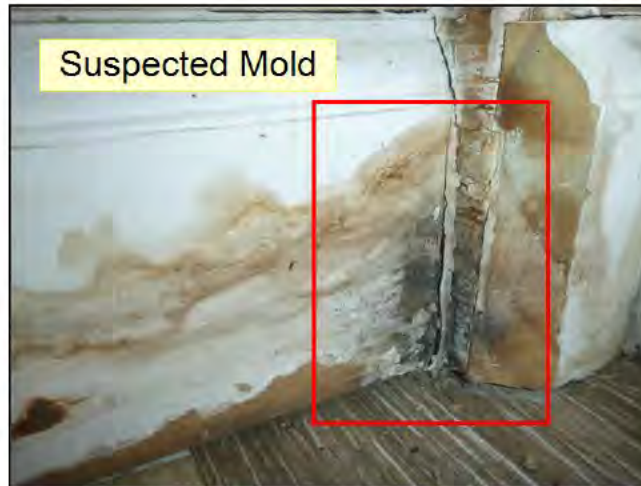
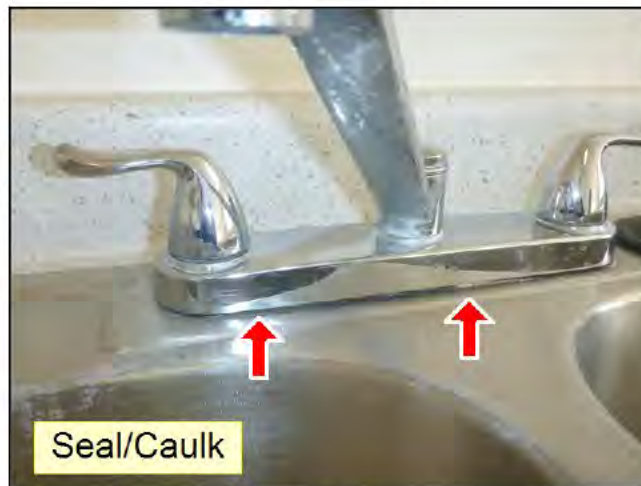
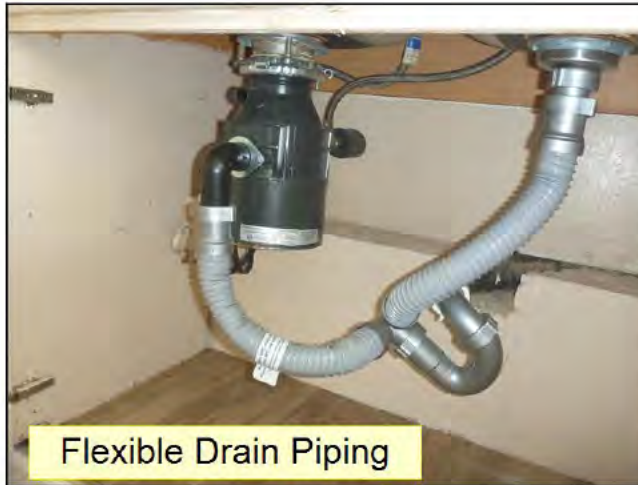
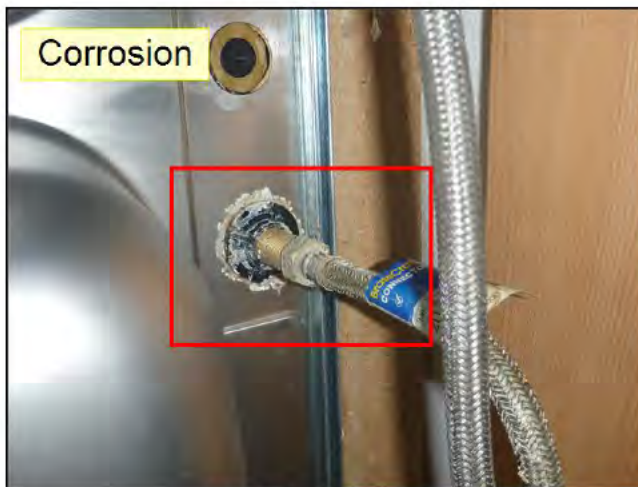
8.0.D (See Picture(s))

Corrosion observed on plumbing beneath kitchen sink. Contact plumber for repair/replacement. (See Picture(s))

Stains/moisture damage and suspected mold/mildew beneath kitchen sink at baseboard. Consult seller on history of water leaks. Unable to determine condition behind concealed areas. Look for/anticipate hidden damage behind materials prior to close of escrow. (See Picture(s))

Caulk/seal around faucet to prevent water penetration. (See Picture(s))

Flexible drain piping under kitchen sink and crooked p trap is not approved per the plumbing code. Consult a licensed plumber for correction. (See Picture(s))

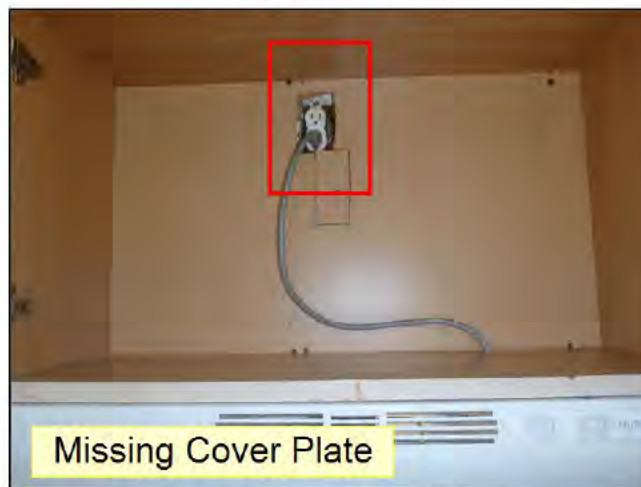
8.6.D (See Picture(s))

Missing cover plate at outlet above hood. Install covers at all outlets and switches for safety. (See Picture(s))

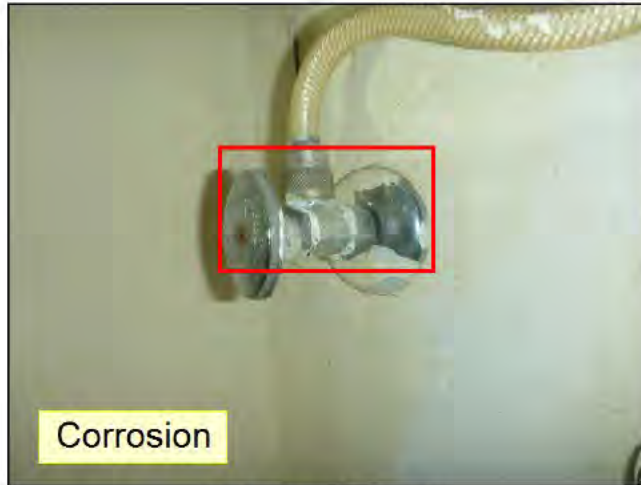
8.0.E (See Picture(s))

Corrosion observed on plumbing beneath kitchen sink. Contact plumber for repair/replacement.

Older/worn sink fixtures. Anticipate repair or replacement.

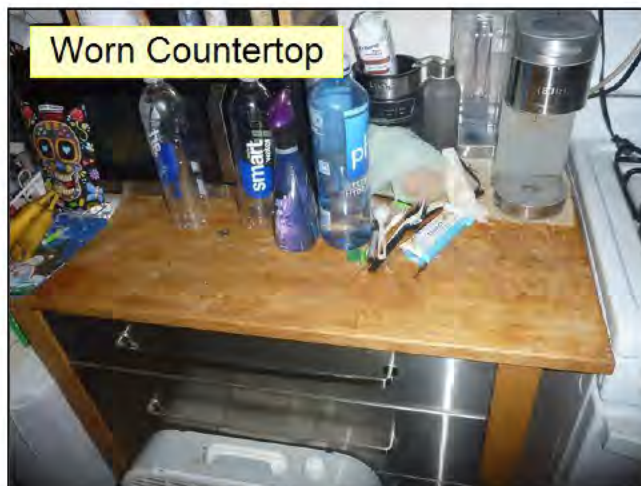
8.7.E (See Picture(s))

Worn wood countertop. Refinish as desired. (See Picture(s))

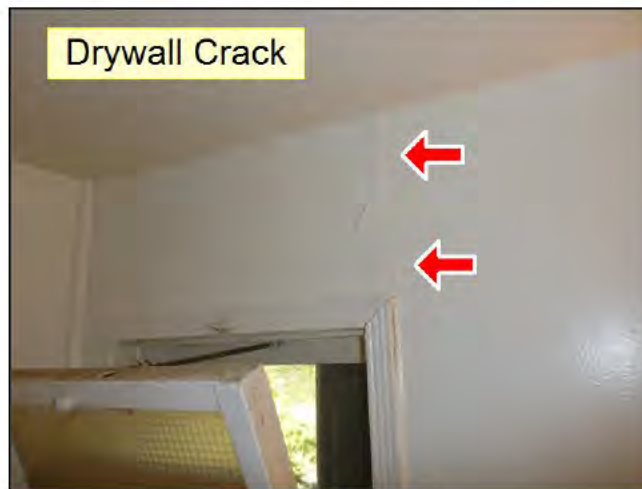
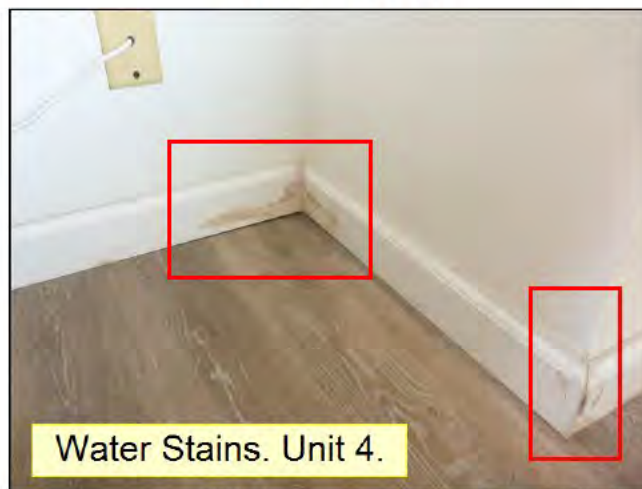
9.0 (See Picture(s))

Water stains at unit 4 baseboard was dry at time of inspection. Look for/anticipate hidden damage behind finish materials. (See Picture(s))

Anticipate repairs (patching & painting) of cracks, scuffs, scrapes and nail holes in walls.

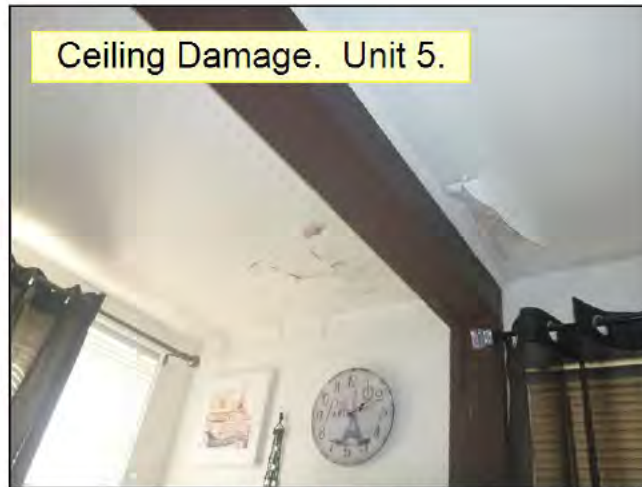
9.1 (See Picture(s))

Damaged ceilings and patching observed at units 4 and 5 were dry at time of inspection. Consult seller on history. Monitor conditions and make repairs as needed. (See Picture(s))

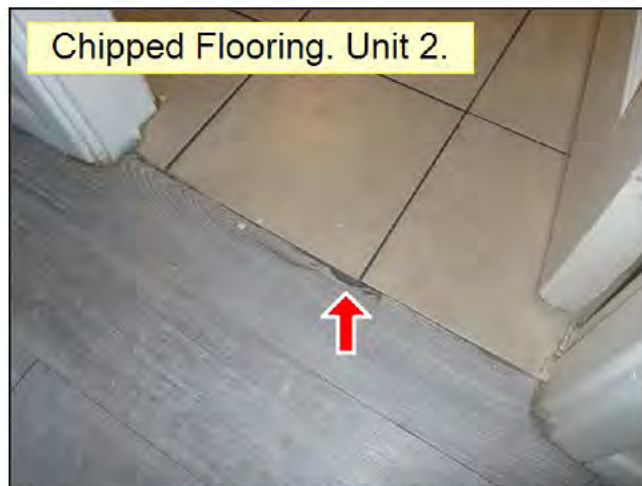
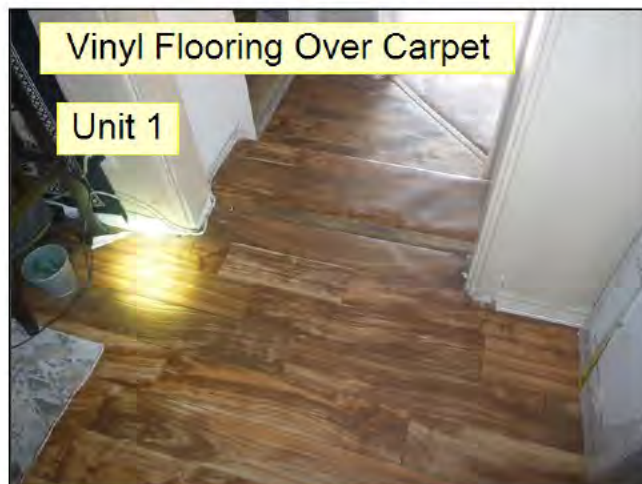
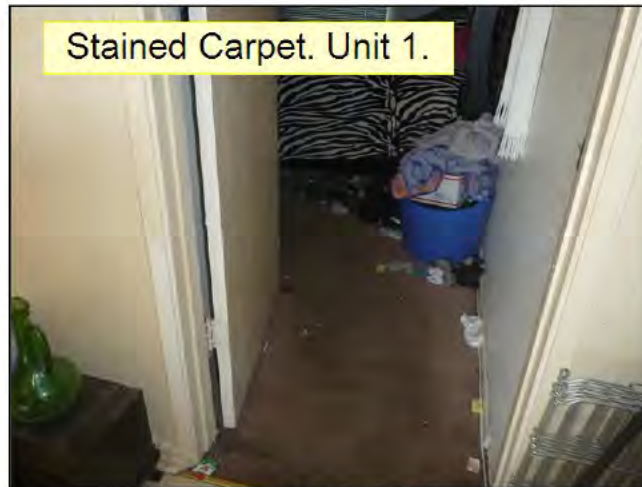
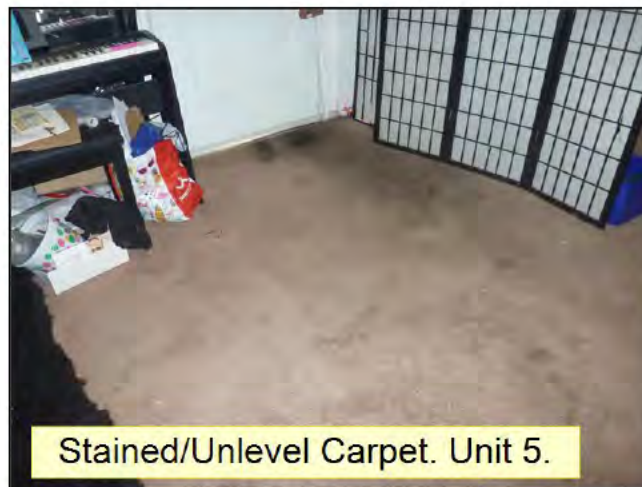
9.2 (See Picture(s))

Worn/stained carpeting, chipped flooring, and vinyl flooring over carpet observed. Anticipate replacement. (See Picture(s))

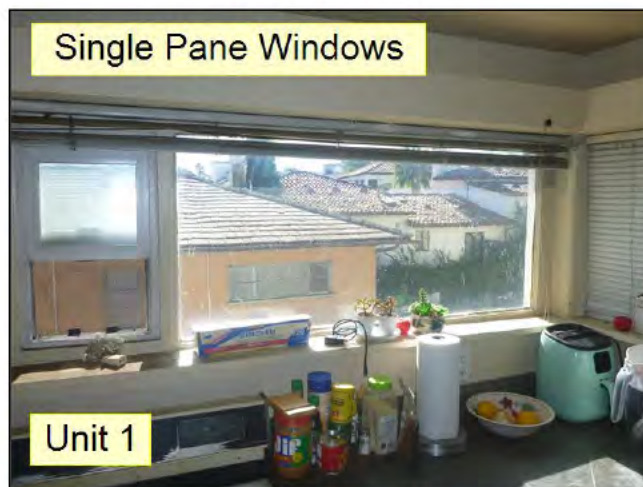
9.3 (See Picture(s))

Numerous older/worn single pane windows observed.. Consider upgrade to dual pane tempered glass windows for energy savings and added safety. (See Picture(s))

Single Pane Windows

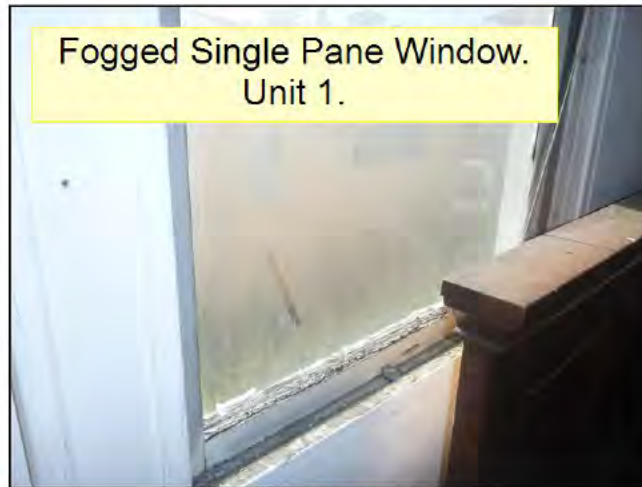
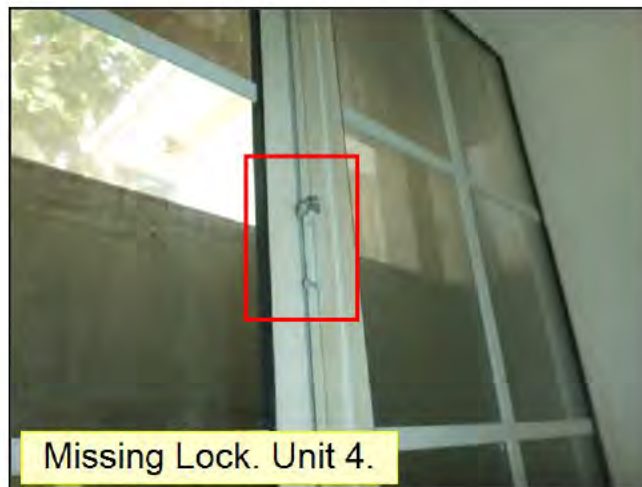
9.3 (See Picture(s))

Damaged hardware/locks and torn screens at multiple windows. Repair/replace as desired. (See Picture(s))

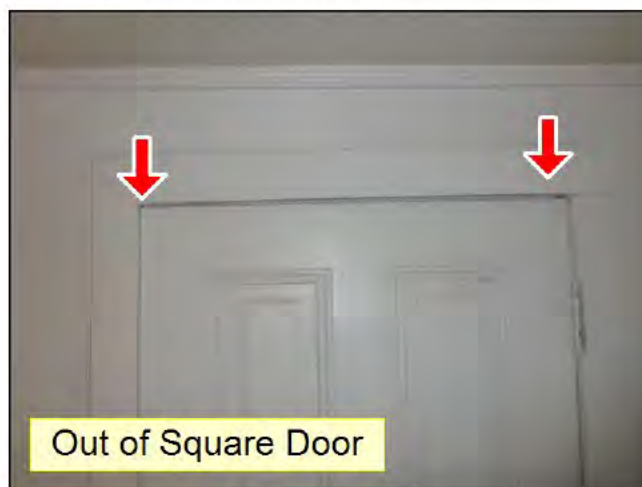
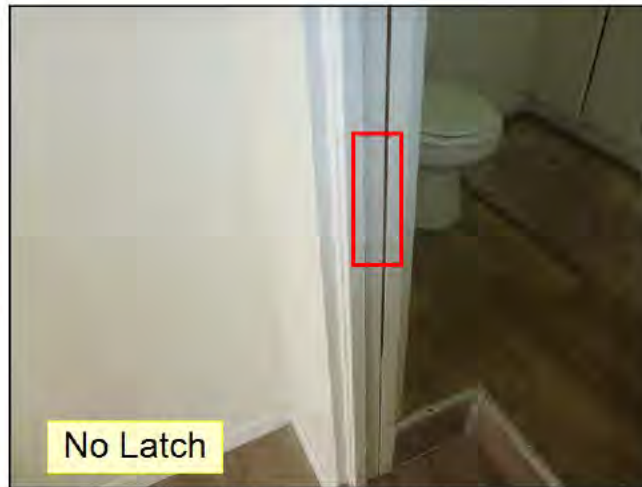
9.4 (See Picture(s))

Multiple older/worn interior doors out of square and rubbing against frame. Adjust/repair/replace as required for smooth and proper operation. (See Picture(s))

No latch to open pocket door at unit 4 bathroom. Install as desired. (See Picture(s))

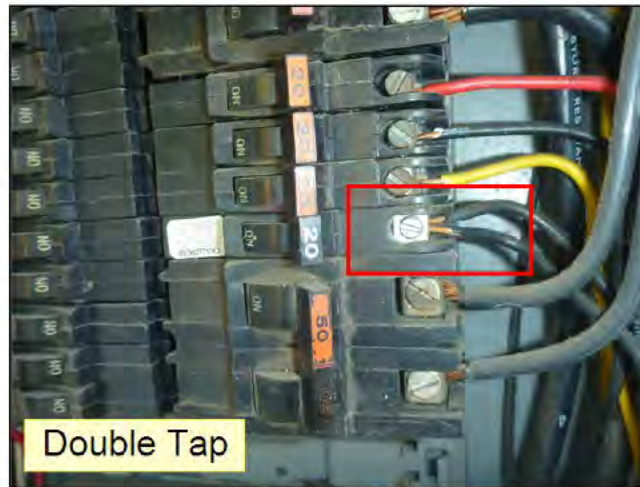
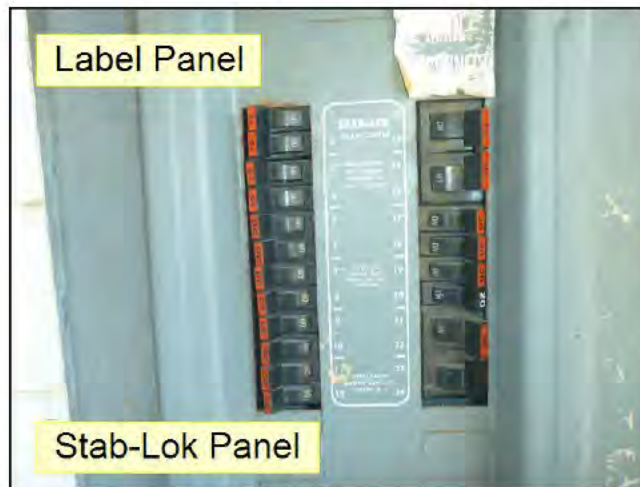
10.2 (See Picture(s))

Doubled up circuit noted in panel. Circuit tapping although common is not allowed. Suggest consulting electrician to evaluate and make repairs. See supplemental comments for additional information. (See Picture(s))

"Stab-Loc" circuit breaker panel manufactured by Federal Pacific Electric (FPE) is installed as main distribution panel and has been known to present a latent hazard by failing to trip under load, causing arcing which can result in an electrical fire. Recommend contacting a licensed electrical contractor to determine replacement cost estimate prior to close of escrow. (See Picture(s))

Labelling of service panel breakers is required for safe operation. (See Picture(s))

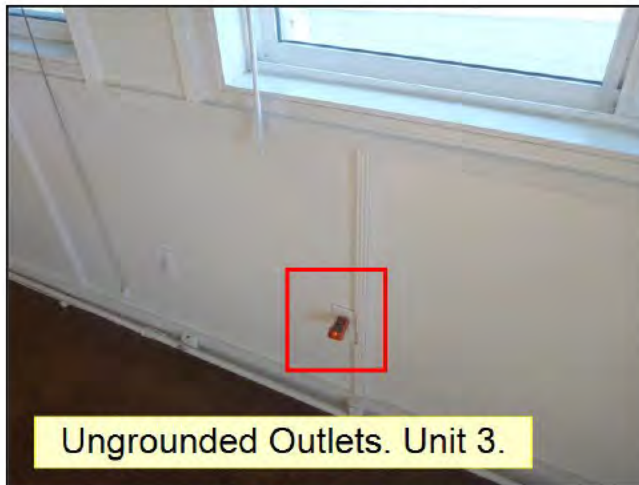
10.5 (See Picture(s))

Numerous ungrounded outlets observed. Ungrounded outlets pose a shock risk. Consult an electrician for options for upgrade (ask about using GFCI outlets or breakers as a possible solution) and to determine repair cost estimate prior to close of escrow. See Non-Grounded Receptacles in Supplemental Information.

Ungrounded Outlets. Unit 3.

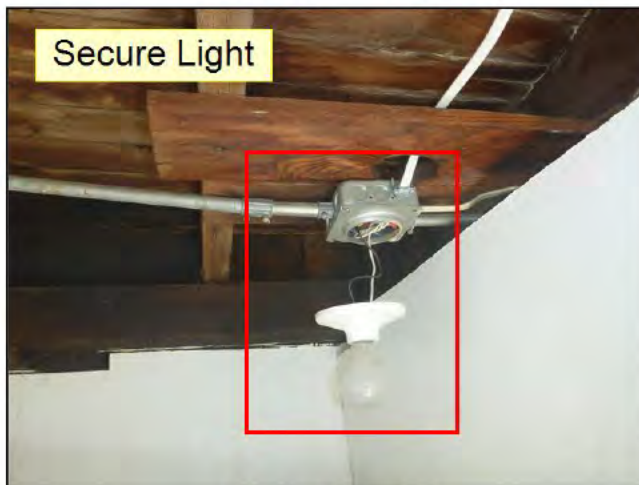
10.5 (See Picture(s))

Secure Light

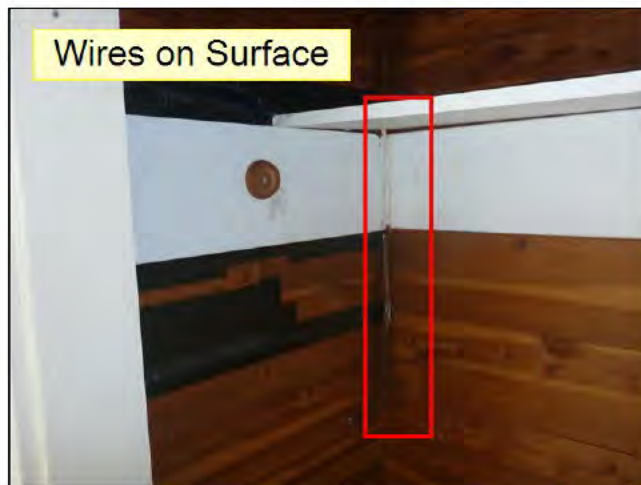
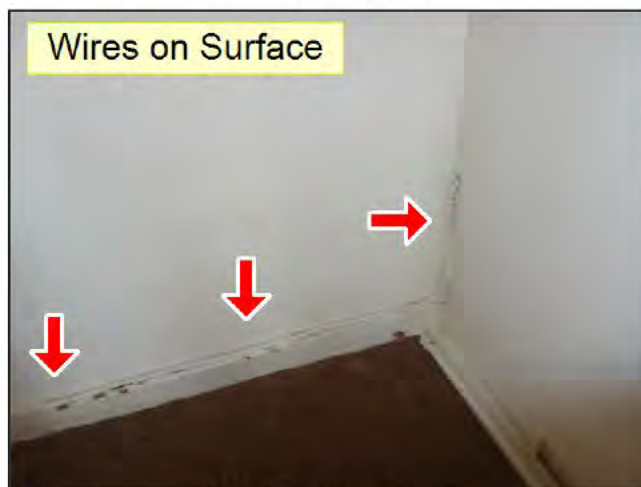
10.6 (See Picture(s))

Wires ran on surface of walls in multiple units. Contact an electrician for correction for electrical safety. (See Picture(s))

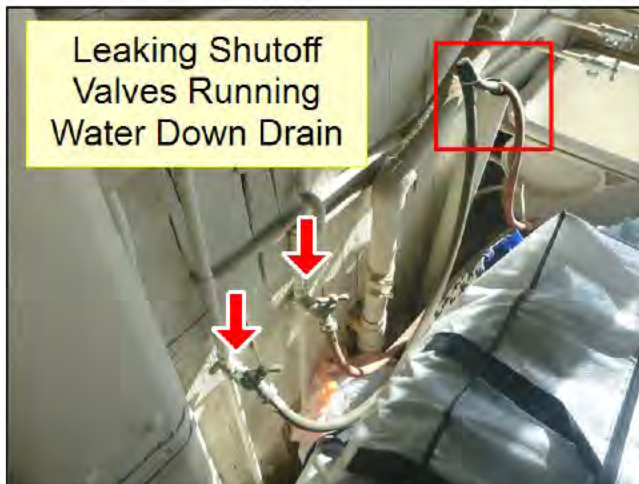
11.0 (See Picture(s))

Angle stops at upstairs laundry are running water down laundry drain and cannot be shutoff. Contact a plumber to replace shutoff valves. (See Picture(s))

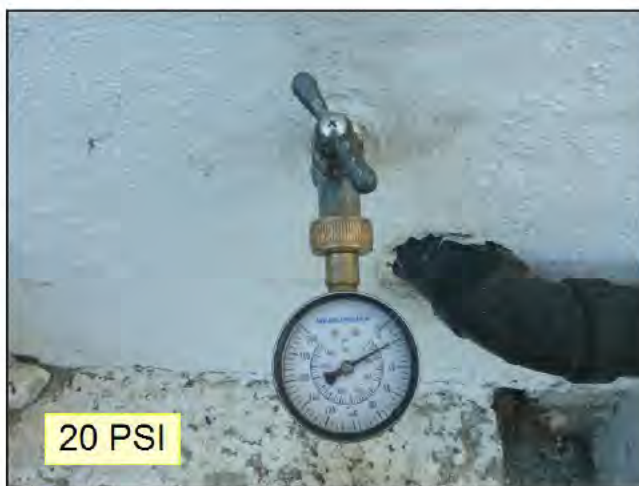
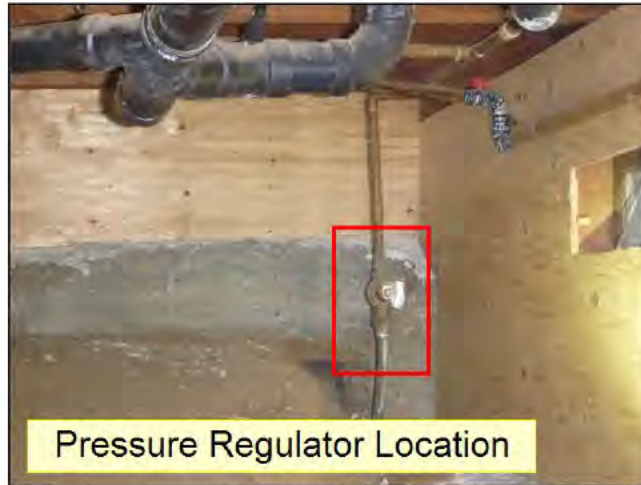
11.1 (See Picture(s))

The water pressure was 20 psi at the time of inspection which is below the normal range of 40 to 80 psi. Consult a plumber for evaluation and pressure regulator adjustment/replacement prior to close of escrow. See supplemental comments below for additional information. (See Picture(s))

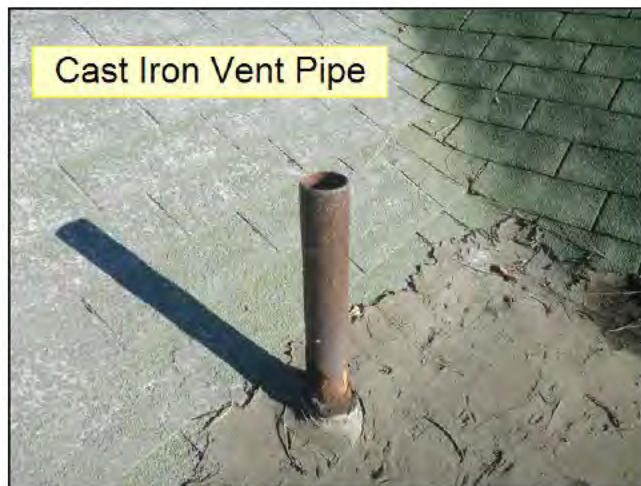
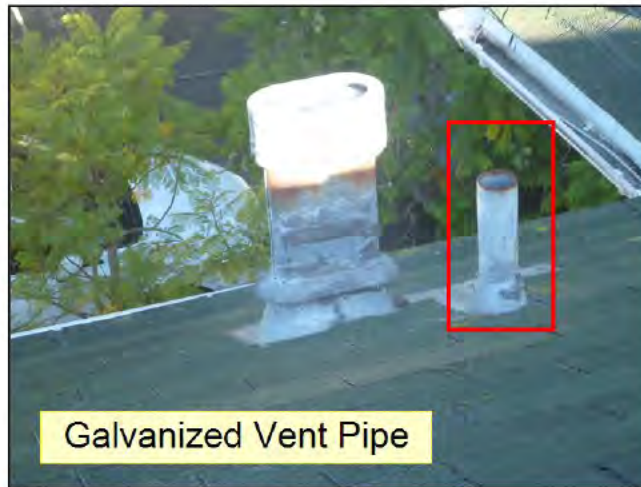
11.3 (See Picture(s))

Anticipate future replacement of remaining original cast iron and galvanized drain piping. (See Picture(s))

Suggest having in slab **AND** in ground drain lines video scoped to determine interior condition due to age of home.

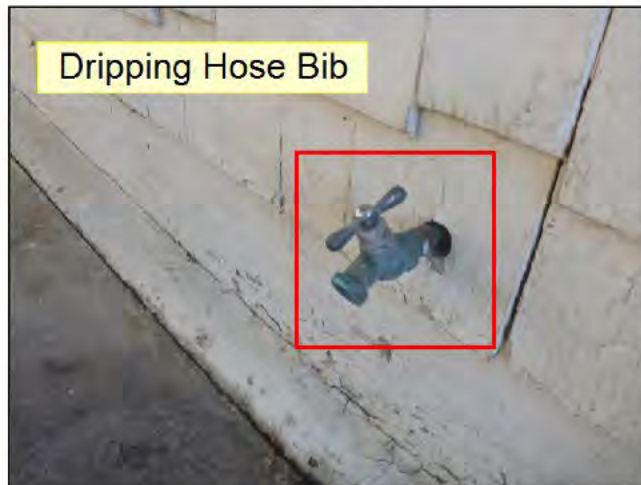
11.4 (See Picture(s))

Dripping hose bib at front of building. Anticipate replacement. (See Picture(s))

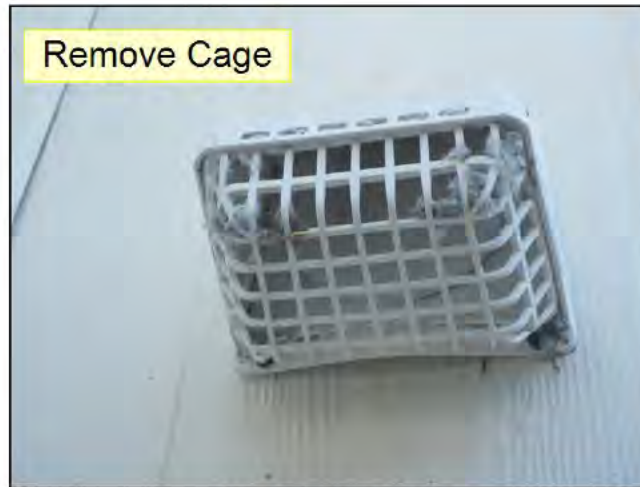
11.6 (See Picture(s))

Cage on dryer vent can trap lint, restrict air flow, and is not allowed. Replace with flapper type cover. (See Picture(s))

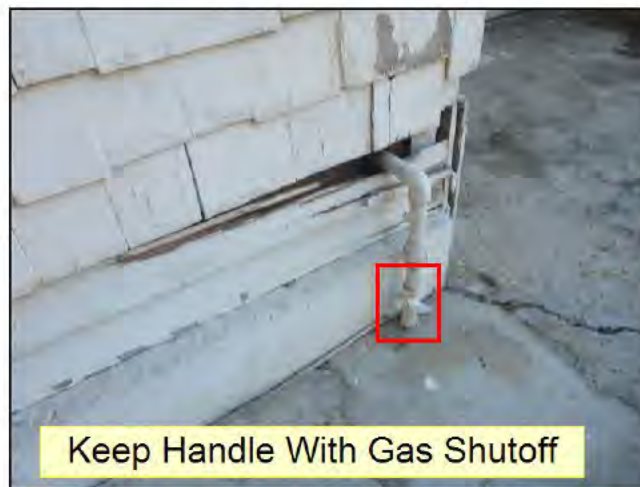
11.7 (See Picture(s))

Gas line through cracked/displaced retaining wall at front of building could pose a hazard to break gas line. Consult a general contractor for retaining wall evaluation and repair. Consult a licensed plumbing contractor to discuss if installation of an excess flow valve on gas line would be a beneficial safety precaution.

Note: Suggest keeping a valve handle at gas meter shut off valve in order to shutoff gas in an emergency. (See Picture(s))

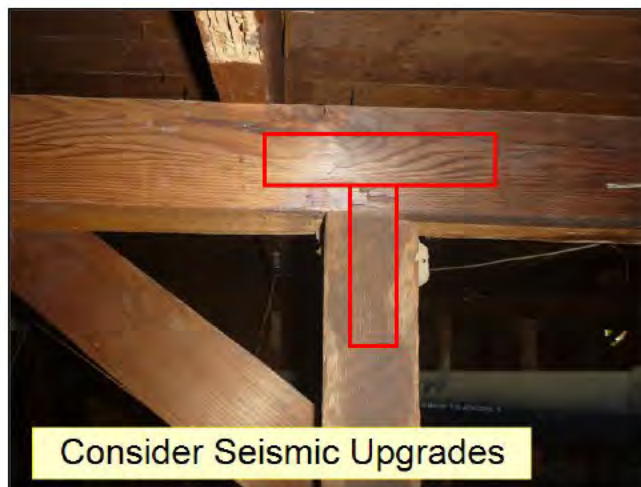
12.1 (See Picture(s))

Consult foundation contractor regarding upgrading brick piers to concrete. (See Picture(s))

Earthquake bracing at post and piers are not installed. Consider seismic upgrades for added stability of structure. Consult a foundation contractor if desired. (See Picture(s))

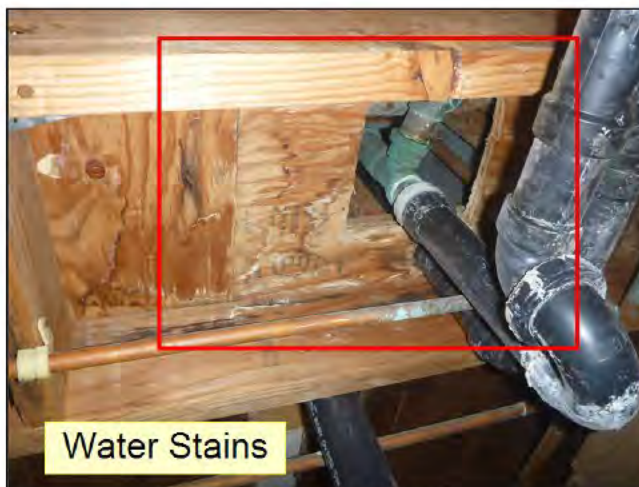
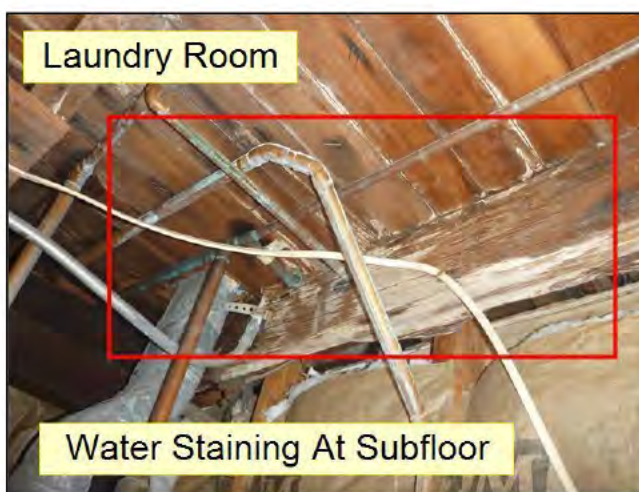
12.2 (See Picture(s))

Moisture staining at subfloor in crawlspace and laundry room were dry at time of inspection. Monitor conditions and make repairs as needed. (See Picture(s))

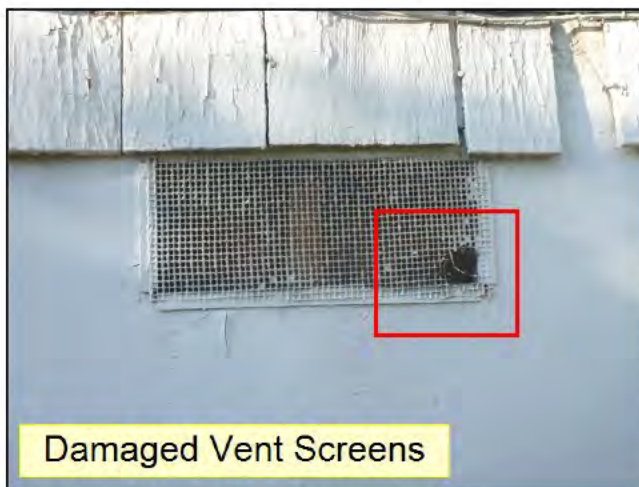
12.4 (See Picture(s))

Damaged vent screens noted at various locations. Repair/replace screens to help keep pests out of crawlspace. (See Picture(s))
