Prepared for Exclusive Use by:

[REDACTED]
Solvang CA [REDACTED]

HouseMaster
1187 Coast Village Rd. 1-284
Santa Barbara, CA 93108
(805) 898-2698

Commercial

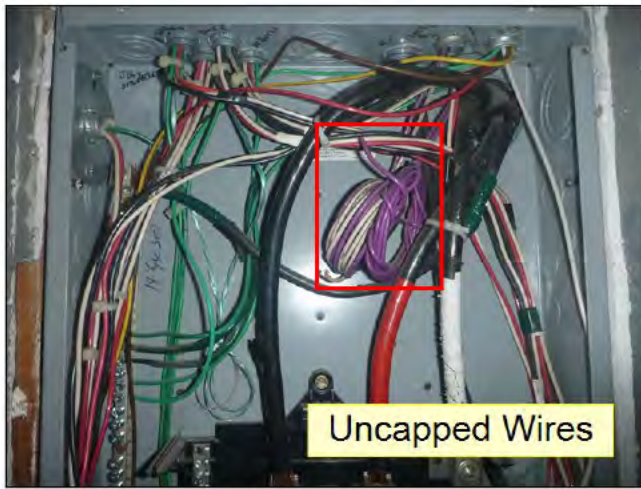
6.6 SUBPANEL (See Picture(s))

Uncapped Wires

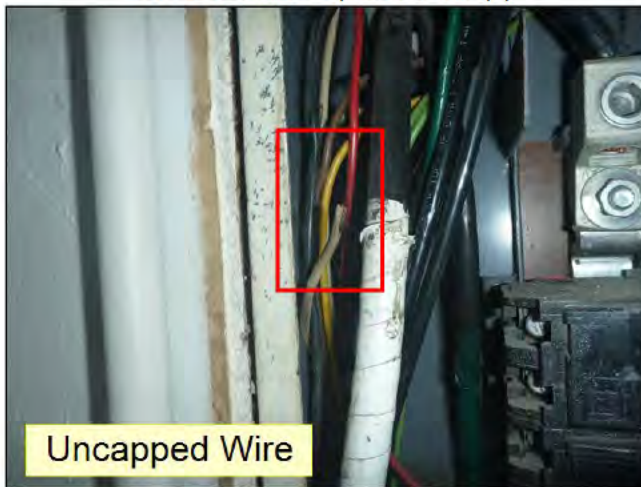
6.6 SUBPANEL (See Picture(s))

Uncapped Wire

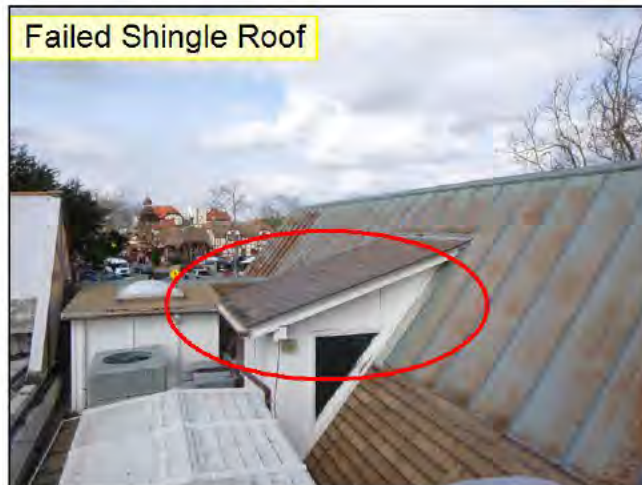
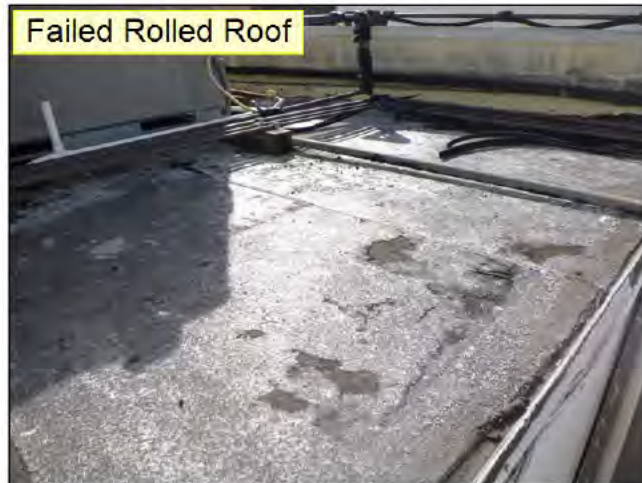
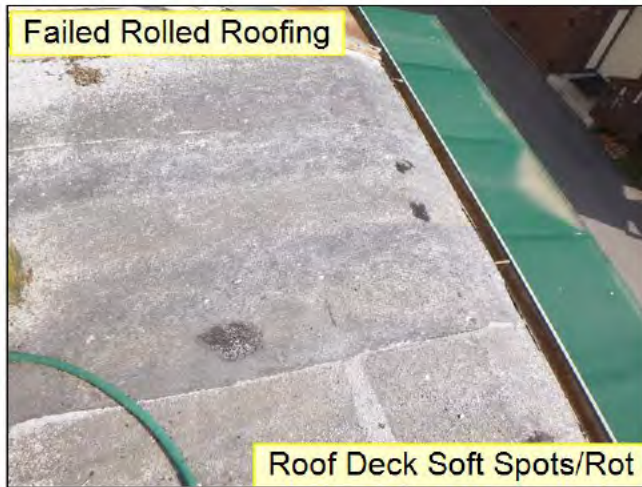
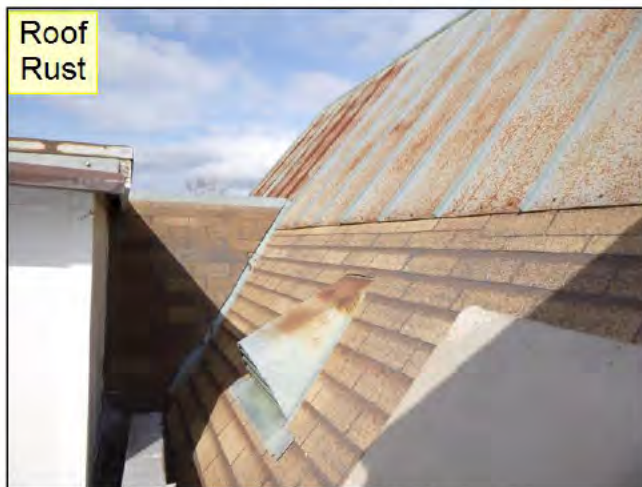
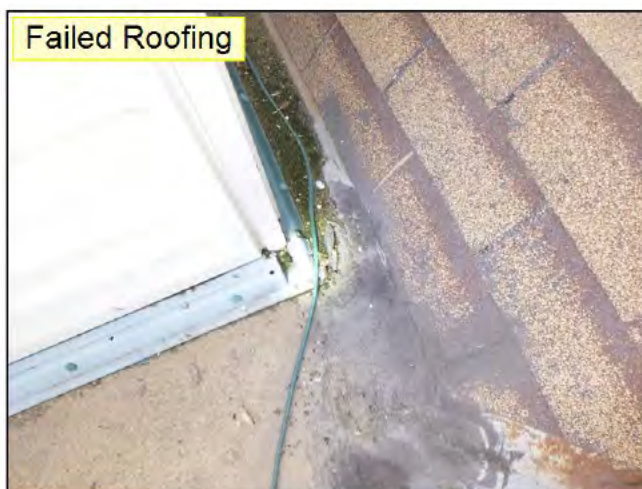
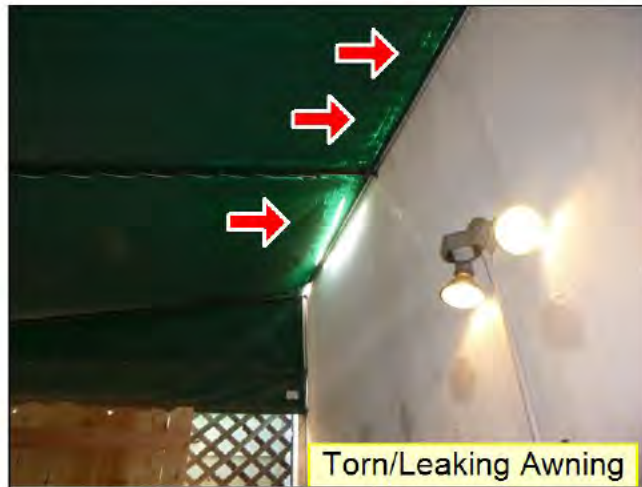
1.0 (See Picture(s))

1.0 ROOFING Failing rolled and shingle roofs. Soft/rotting roof deck noted at numerous locations. Consult a roofing contractor for evaluation and replacement cost estimate prior to close of escrow. Anticipate extra expense for roof deck repair/replacement at hidden rotted areas. (See Picture(s)) Rusting metal roof noted. Repainting needed to extend service life. Torn/leaking awning at rear door. Anticipate replacement. (See Picture(s)) Roof coverings require periodic repairs and sealant, especially at roof penetrations. Suggest periodic evaluation and sealing/repairs as needed to aide in preventing water penetration into structure.

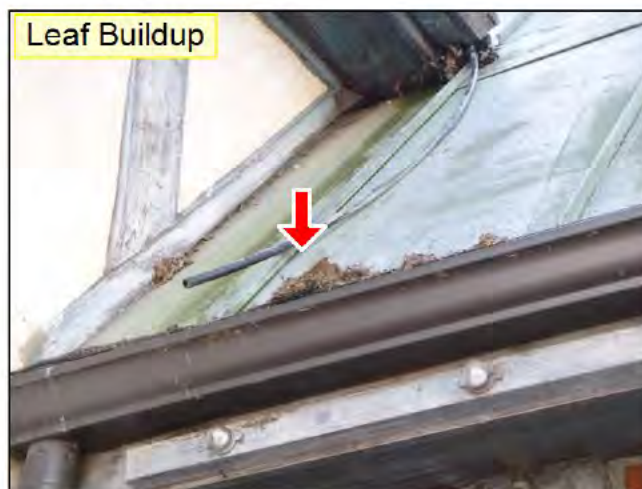
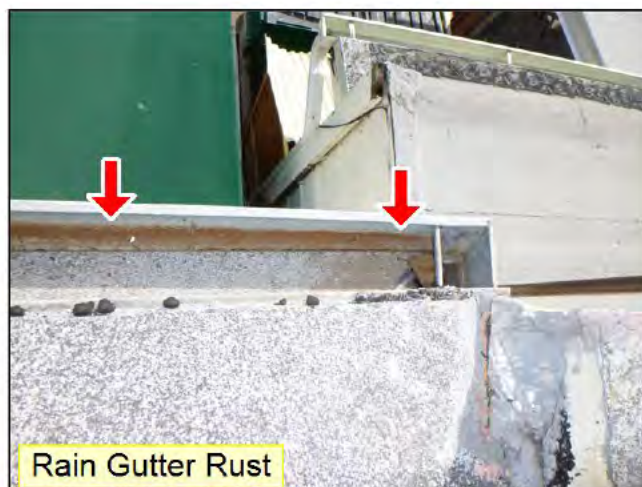
1.4 (See Picture(s))

Rusted/failing rain gutter sections need replacement. (See Picture(s))

Leaf buildup noted in rain gutters. Suggest cleaning and flushing now and on an annual basis for proper drainage. Consider upgrade of gutter guards to prevent leaf buildup. (See Picture(s))

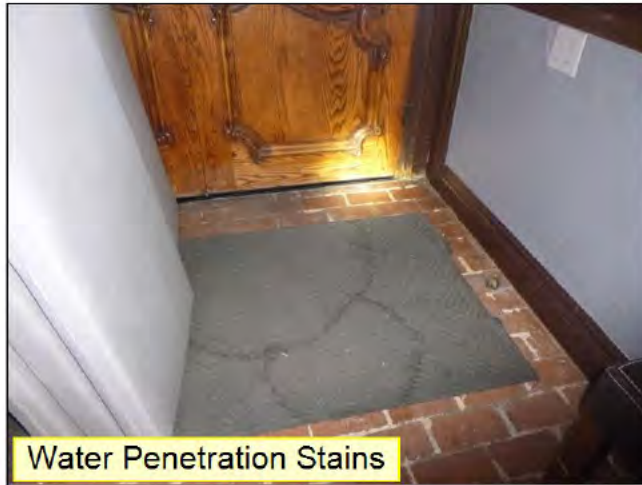
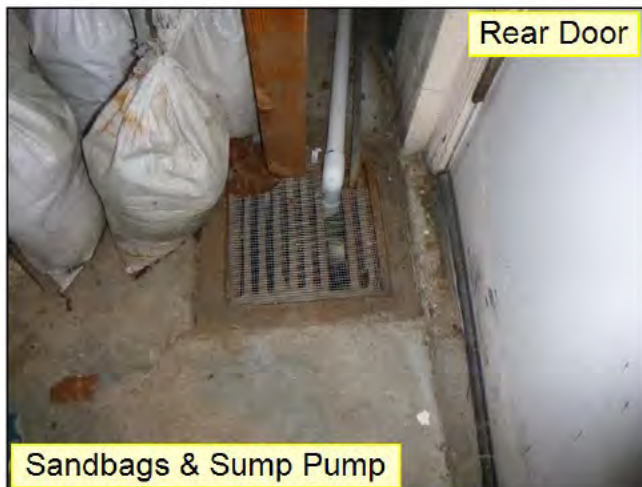
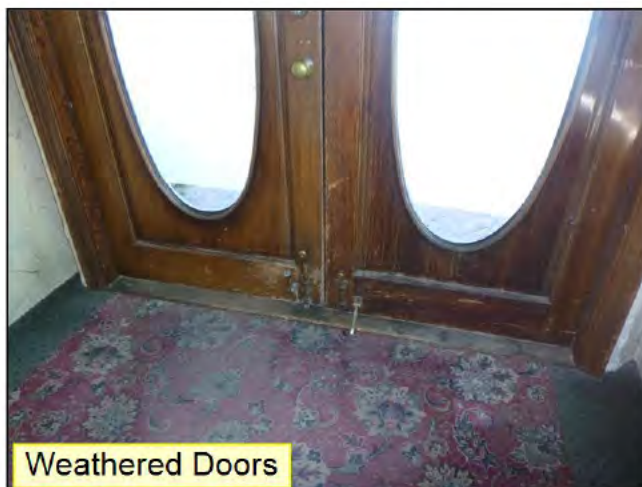
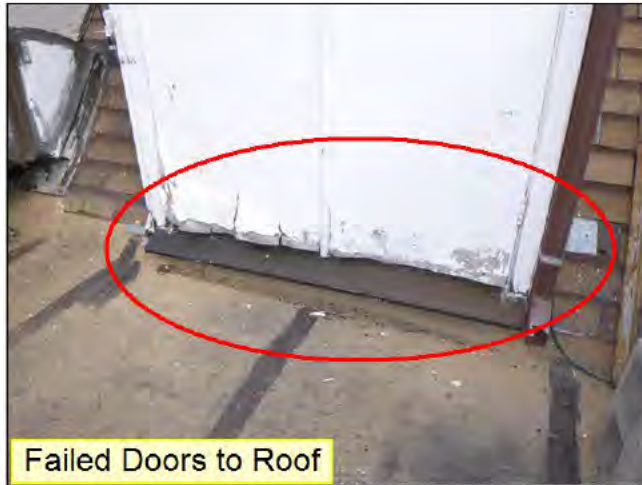
2.2 (See Picture(s))

Weathered/worn doors at ground floor. Repaint/stain to extend service life. (See Picture(s))

Weather stripping missing at entry doors. Install weather stripping for energy savings and to prevent pest intrusion.

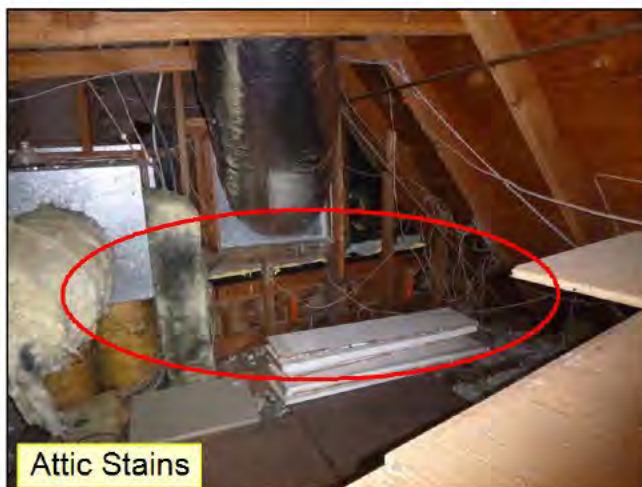
3.1 (See Picture(s))

Stains noted at numerous locations of framing in the attic. See comments in roof section of report. See pest control company report. (See Picture(s))

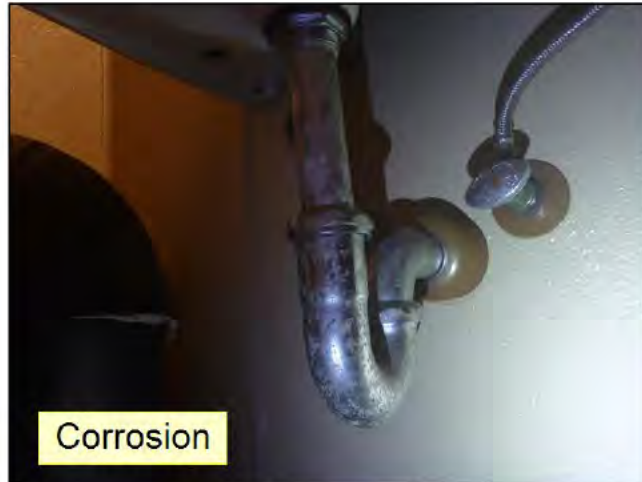
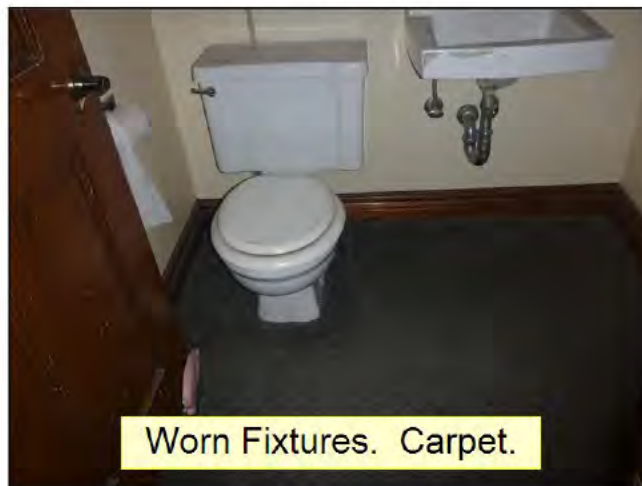
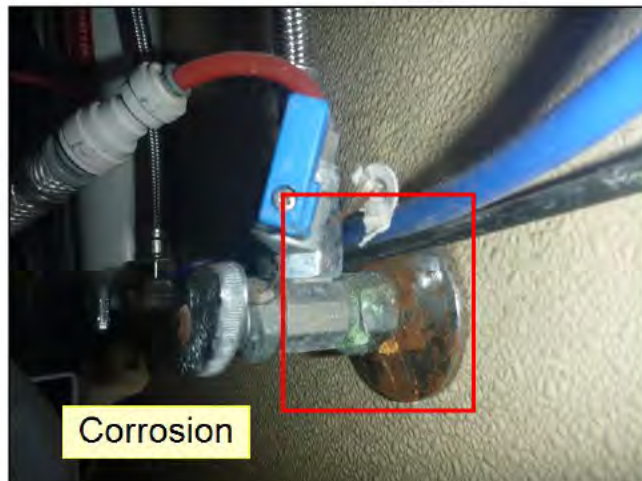
4.0 (See Picture(s))

Corrosion noted at plumbing beneath sinks. Replace components as needed to prevent leaks and moisture damage. (See Picture(s))

Older and worn sink and faucet noted. Anticipate replacement. (See Picture(s))

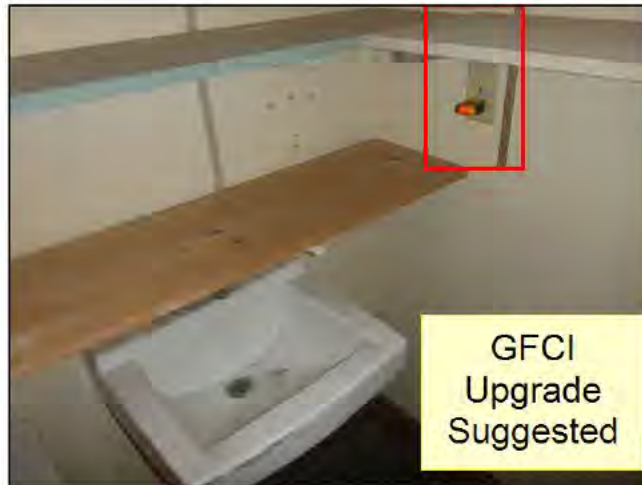
4.3 (See Picture(s))

Suggest upgrades to GFCI (Ground Fault Circuit Interrupter) type outlets for added safety at all bathroom outlets. Due to the age of original construction, this is considered an upgrade item. However, it is highly recommended for safety reasons. Consult electrician for installation.

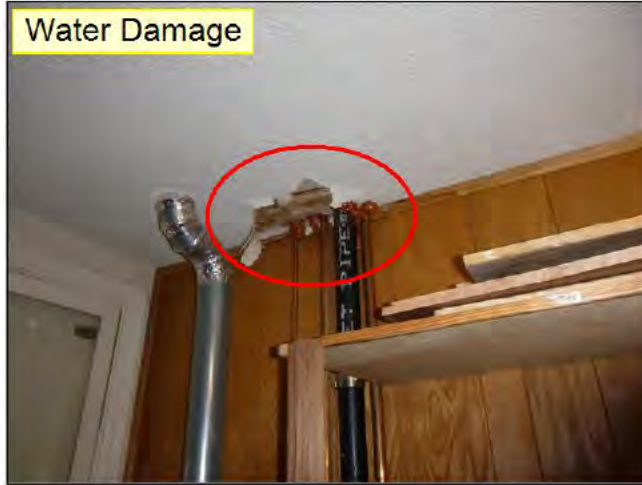
5.0 (See Picture(s))

Water stains and damage at numerous locations of walls and ceilings. See comments in roof section of report and see window comments below. (See Picture(s))

Water Damage

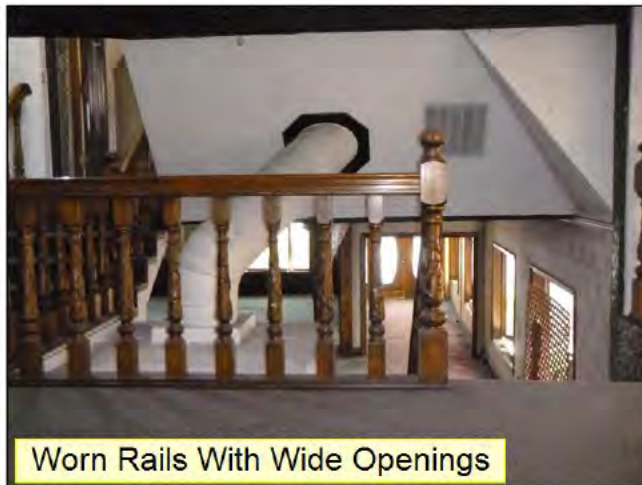
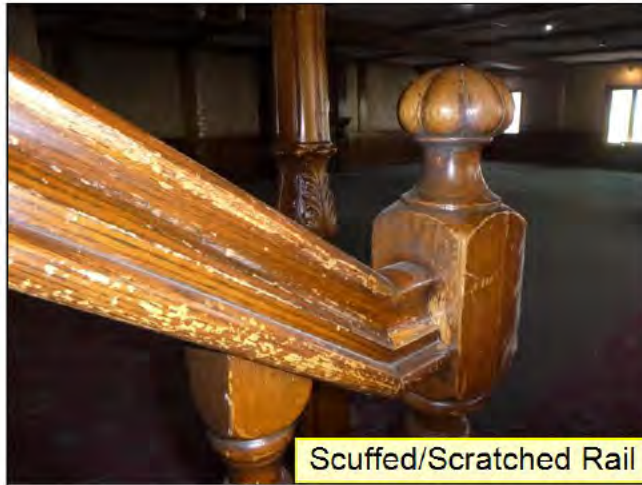
5.3 (See Picture(s))

Openings at railings are wider than today's standards allow. Consider upgrades for added safety to protect children and pets. (See Picture(s))

Scuffed/scratched rails are in need of re-staining/painting. (See Picture(s))

Worn Rails With Wide Openings

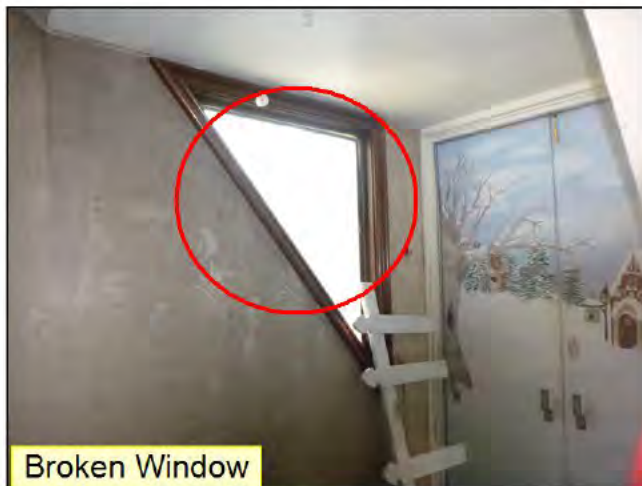
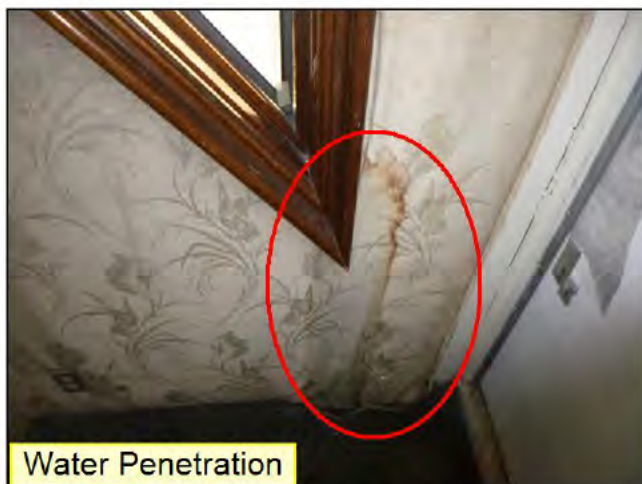
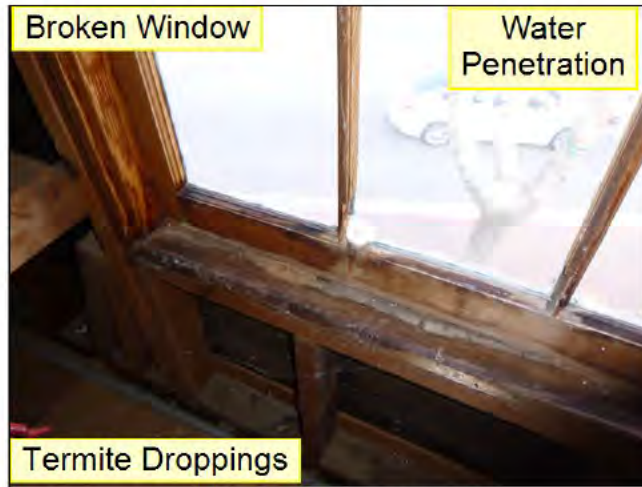
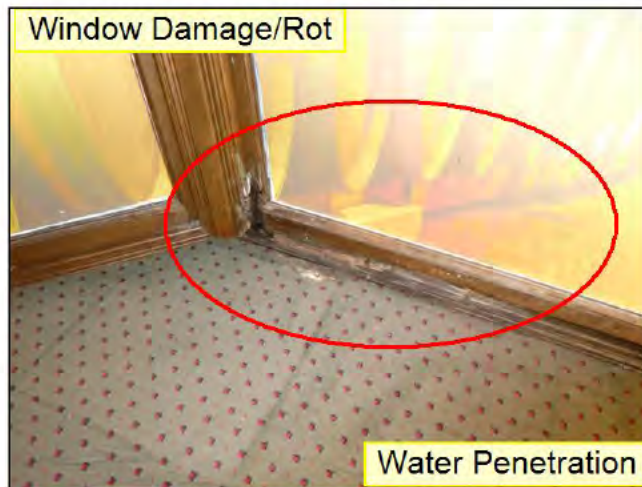
5.5 (See Picture(s))

Broken window and loose/delaminating window film noted. Anticipate replacement. (See Picture(s))

Water penetration and rot noted at several windows. Consult a window company for evaluation and repair/replacement cost estimate prior to close of escrow. (See Picture(s))

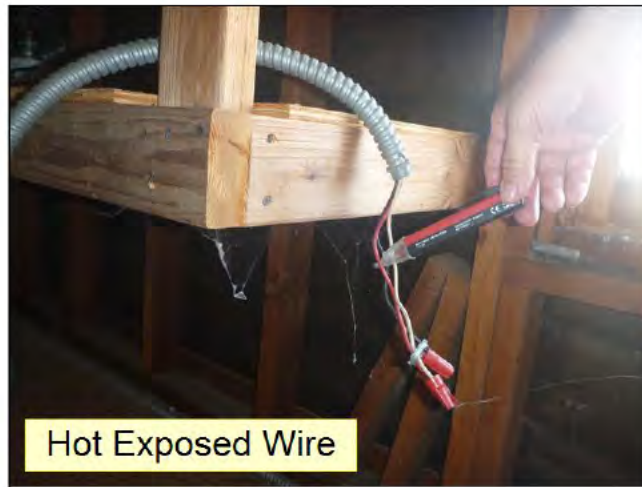
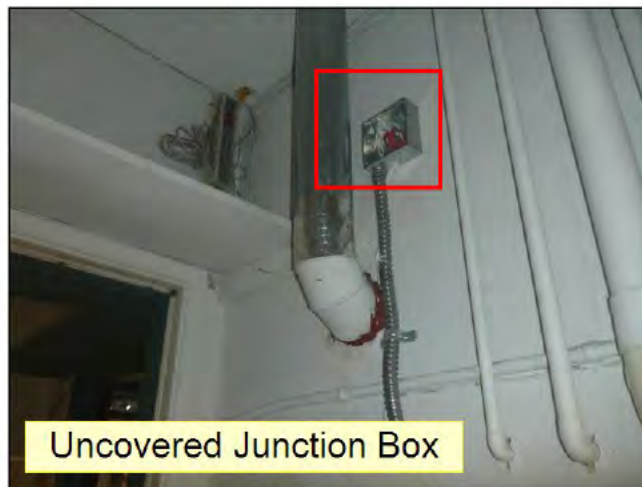
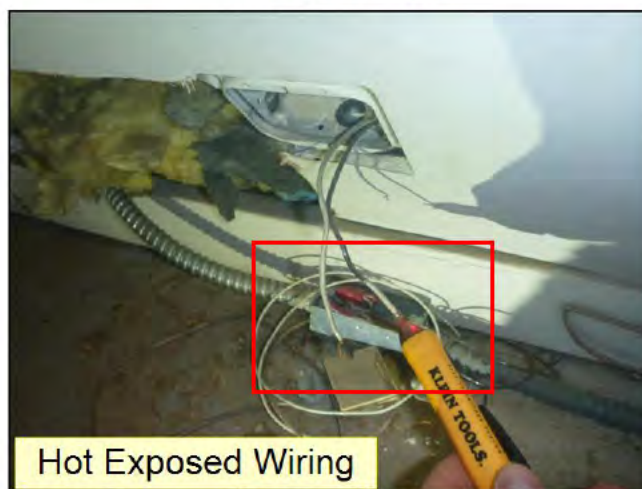
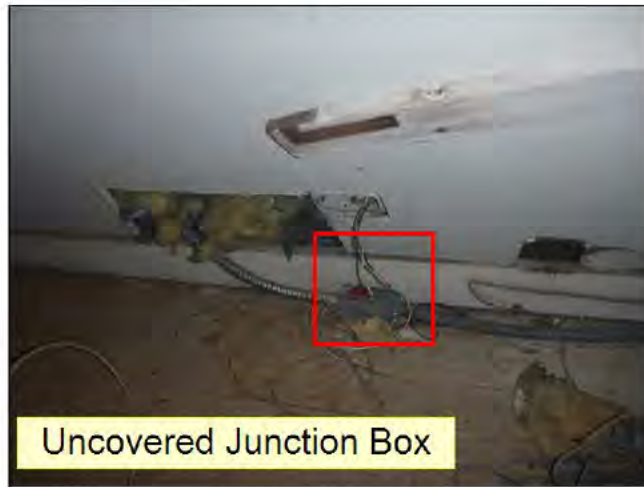
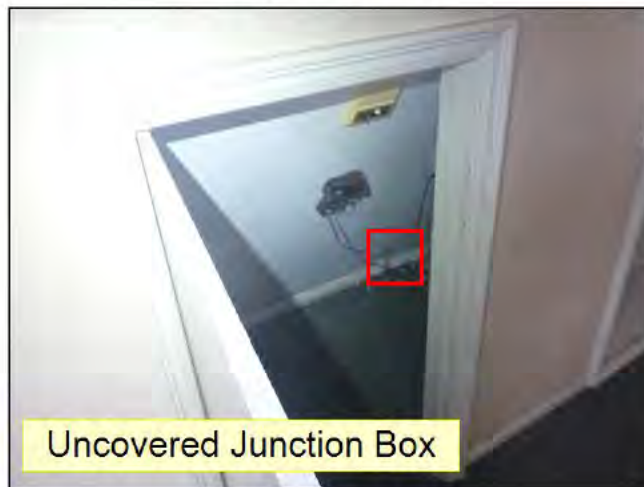
6.5 (See Picture(s))

Wire splices outside of junction boxes noted in attic. Properly terminate wiring for correct/safe installation. (See Picture(s))

Open junction boxes with exposed wiring noted in attic. Add cover plates at any/all open junction boxes and/or properly terminate wiring for proper and safe installation. (See Picture(s))

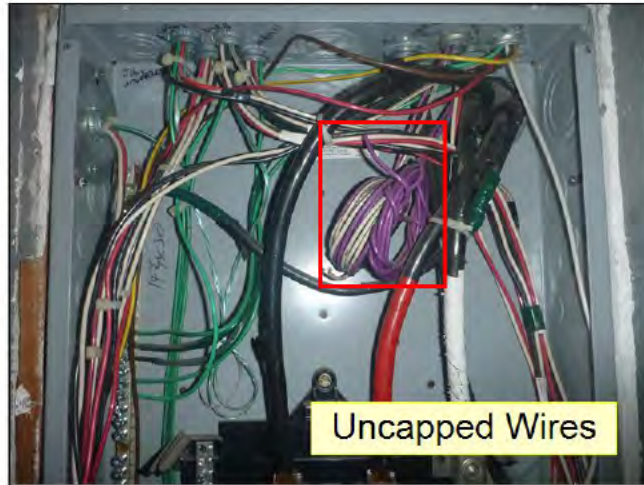
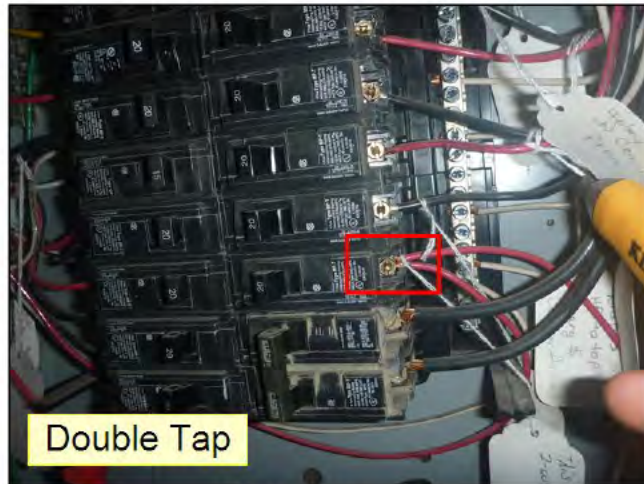
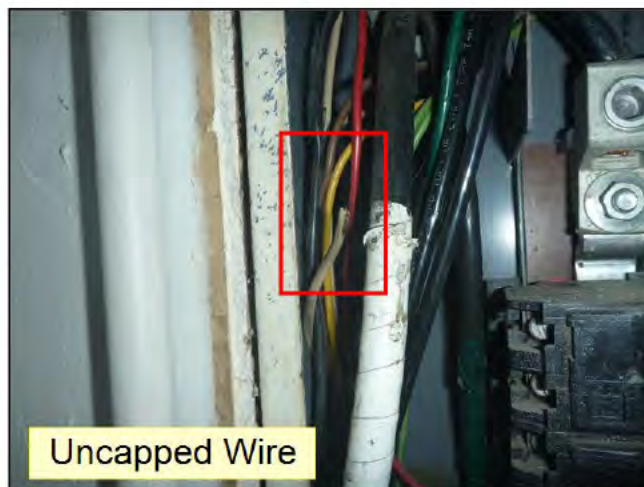
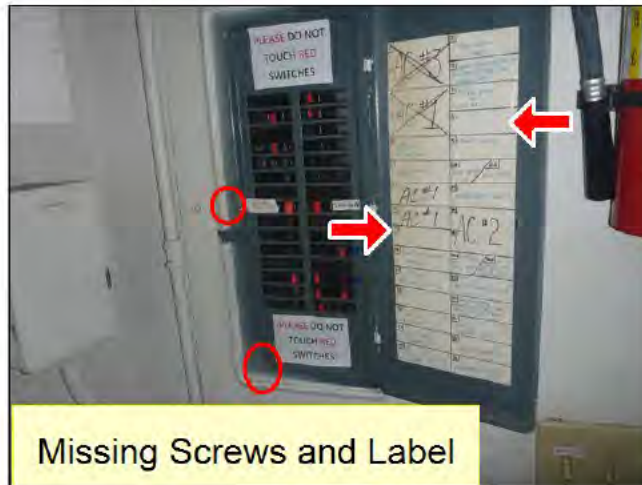
6.6 (See Picture(s))

Doubled up circuits noted at one or more breaker(s) in 1672 sub panel. Circuit tapping although common is not allowed. Suggest consulting electrician to evaluate and make repairs. See supplemental comments for additional information. (See Picture(s))

Missing screws in dead panel plate at 1656 subpanel. Install missing screws for correct installation. (See Picture(s))

1656 sub panel is not fully labeled. Have panel fully labeled for safety. (See Picture(s))

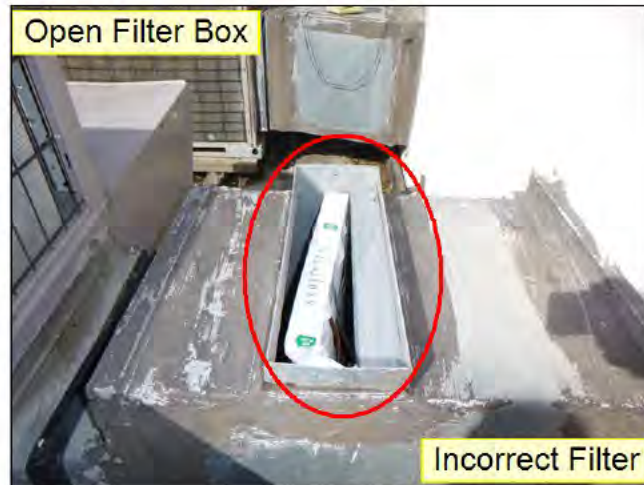
7.5 (See Picture(s))

Open filter box is allowing water to enter and incorrectly sized filter is installed at one unit. Consult a HVAC contractor for correction. (See Picture(s))

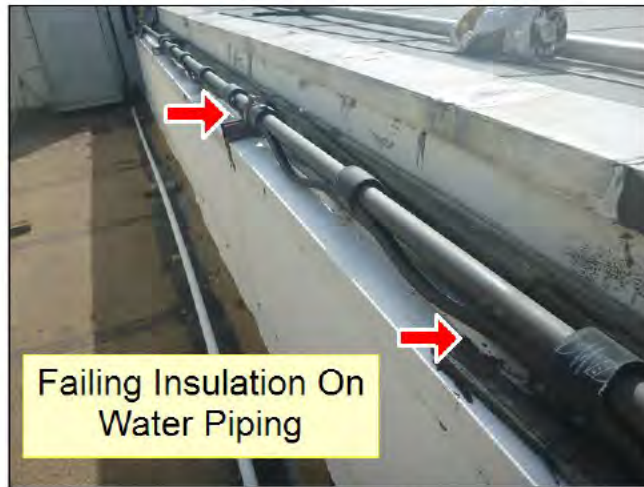
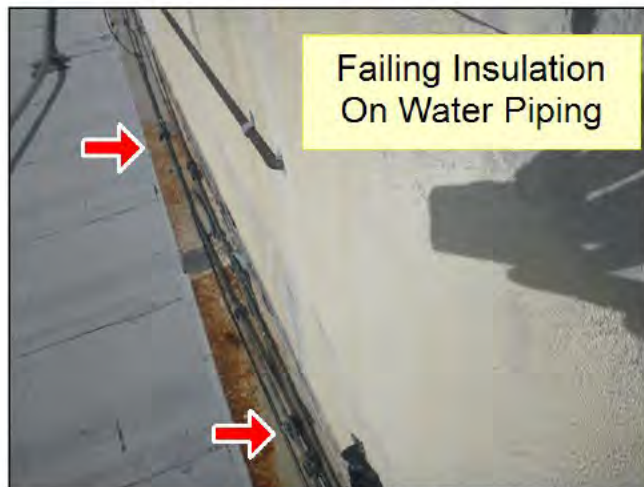
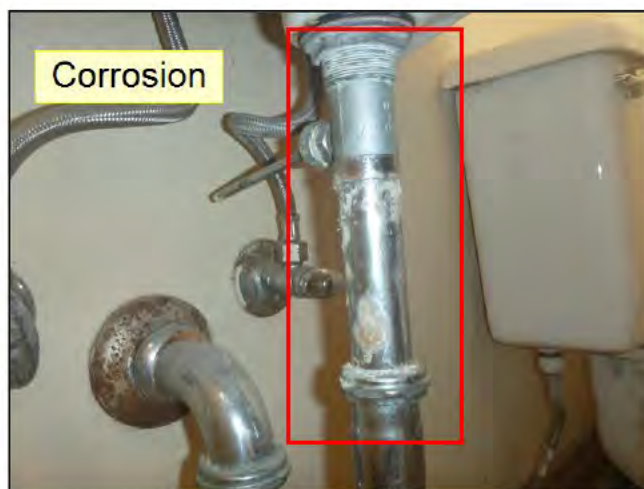
8.0 (See Picture(s))

Plumbing corrosion noted at numerous locations. See bath and water heater sections of report. Consult a plumber for evaluation/replacement.

Failed insulation on copper piping on roof. Replacement needed.

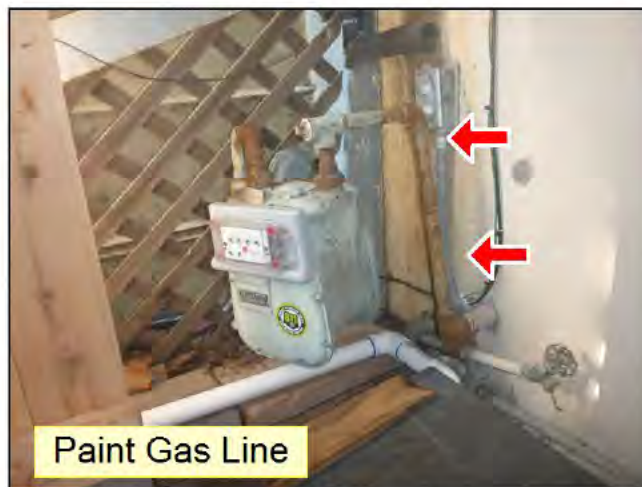
8.7 (See Picture(s))

Rusting gas lines on exterior of building/roof. Contact a plumber for evaluation/repair cost estimate. (See Picture(s))

Rusting gas lines noted at meter. Suggest painting to extend service life. No gas leaks detected at the time of inspection. (See Picture(s))

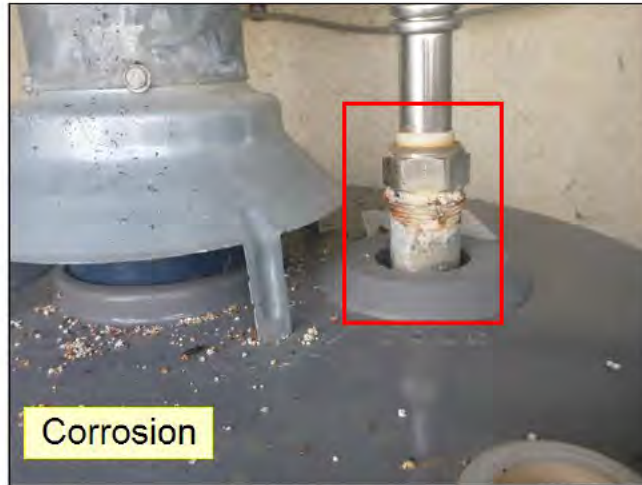
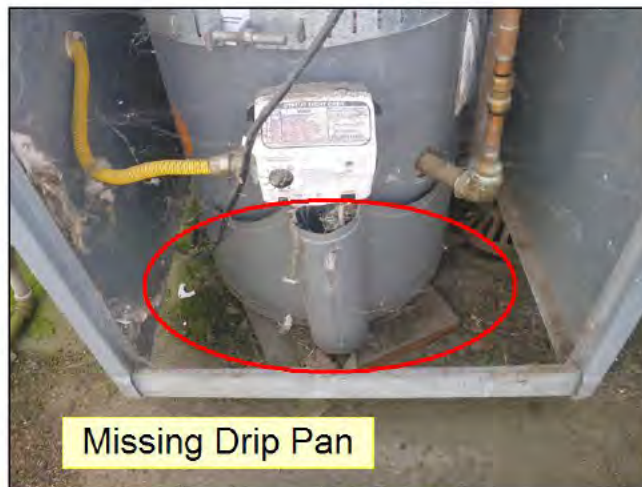
9.0 (See Picture(s))

Corrosion noted at plumbing of water heater. Replace components as needed to prevent leaks and moisture damage. (See Picture(s))

No water heater drip pan installed. Suggest drip pan installation to protect from moisture damage. Drain pipe on drip pan should be routed to exterior location. Consult a plumber for proper installation. (See Picture(s))

Blocking required at seismic straps as per California State Architect requirements. Consult a licensed plumbing contractor for proper installation. (See Picture(s))

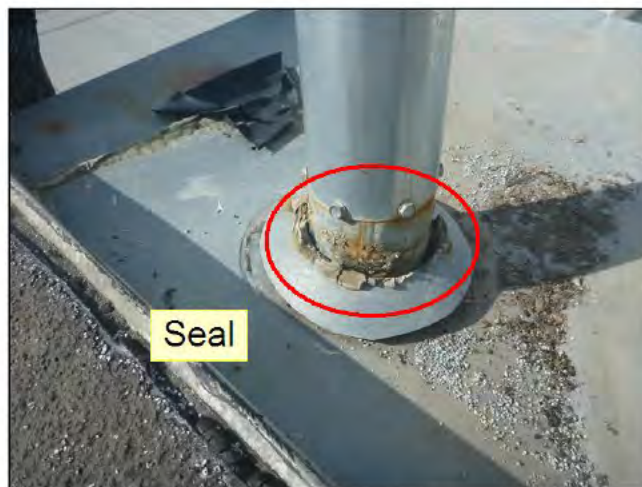
9.1 (See Picture(s))

Seal vent pipe penetration through cabinet to prevent rain water from getting into cabinet. (See Picture(s))
