Address of Inspected Property:

[REDACTED]
Santa Barbara CA [REDACTED]

Dayne Haigh

HouseMaster

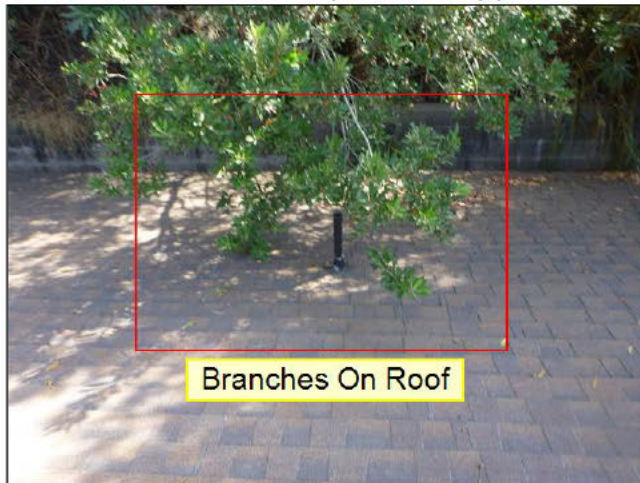
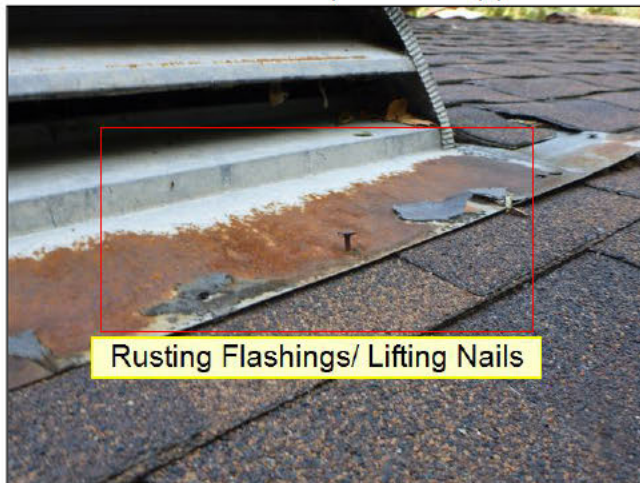
1.0 ROOFING (See Picture(s))

●			1.0 ROOFING Roof shingles are failing. Granule loss and exposed fiberglass noted. Consult roofer for repair/ replacement cost estimates prior to close of escrow. Roof sag noted. Multiple layers noted. Stripping will be required when re-roofing. Consult roofer for cost estimate. A determination should be made at time of re-roofing as to if flashing and roof decking replacement will be necessary.(See Picture(s)) Roof coverings require periodic repairs and sealant, especially at exposed/rusting nails, flashings and around roof penetrations. Suggest sealing penetrations now and annual evaluation/servicing as needed to prevent water penetration. Tree branches noted in contact with roof. Suggest trimming/ removing branches to eliminate pest access to roof and roof wear.(See Picture(s))
		●			1.1 EXPOSED FLASHING Lifting/exposed and rusting nails noted. Consult a roofing contractor for repairs as required to prevent water penetration.(See Picture(s)) Rusting noted at flashings. Suggest painting to prevent water penetration and extend service life.(See Picture(s)) Missing drip flashing noted at various locations of eaves. Consult a roofing contractor for evaluation/ proper installation to prevent moisture damage to sheathing. (See Picture(s))

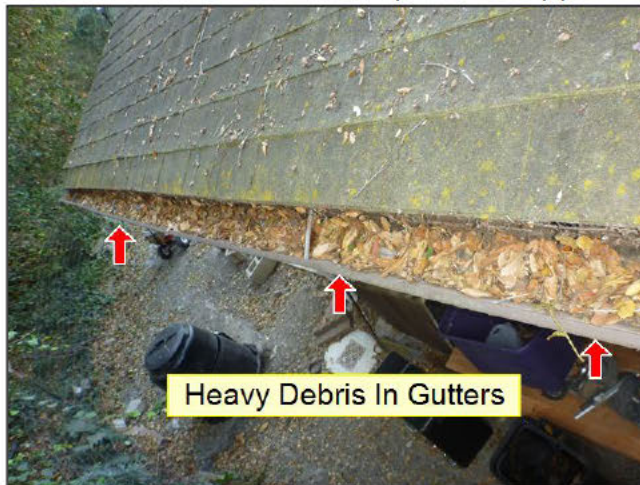
1.2 CHIMNEYS / VENTS (See Picture(s))

●			1.2 CHIMNEYS / VENTS Cracking noted at chimney. Suggest consulting qualified chimney professional for further evaluation and repairs prior to close of escrow.(See Picture(s))
●					1.3 PLUMBING STACKS
		●			1.4 VENTILATION COVERS Rusting noted at water heater and furnace gas vent caps. Paint or replace to extend service life and prevent water penetration.
		●			1.5 RAIN GUTTERS / EAVETROUGHES Older/ Worn Gutters noted. Monitor condition and anticipate replacement. Heavy leaf buildup noted in rain gutters. Suggest cleaning and flushing now and on an annual basis for proper drainage. Consider upgrade of gutter guards to prevent leaf buildup.(See Picture(s))
	●				1.6 DOWNSPOUTS / ROOF DRAINS Damage noted at downspouts. Suggest replacing and/or replacing downspout(s). Consult gutter professional.(See Picture(s)) Recommend extending rain gutter downspouts to move water away from the foundation. Downspouts near structure may allow excessive water to pond and/or penetrate into structure. Consider installing downspouts into built in drains to aide in diverting water run off. See site elements section of report and supplemental comments for additional information.

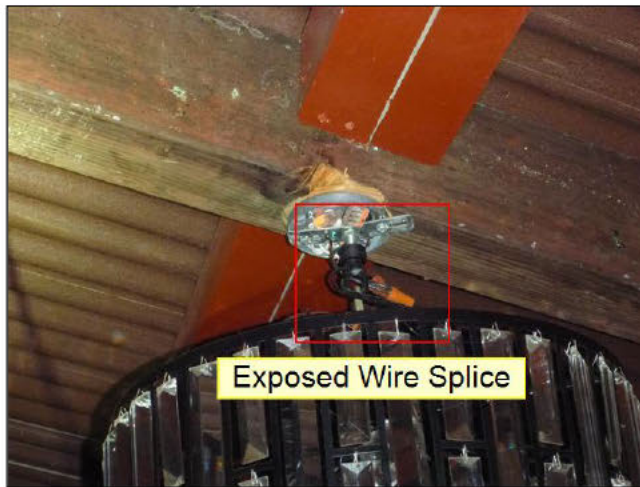
Exposed Wire Splice

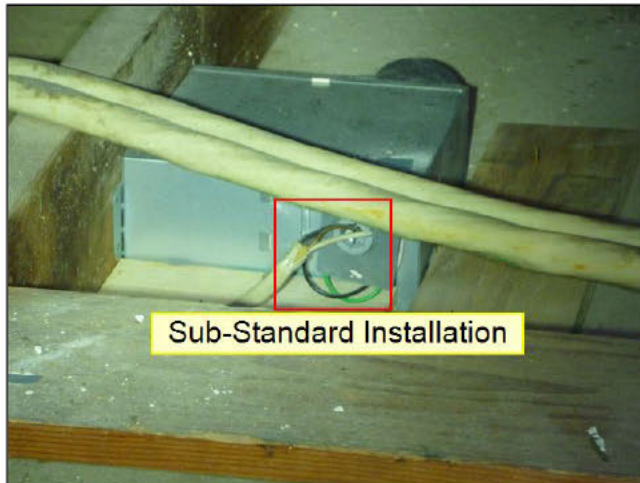
Sub-Standard Installation

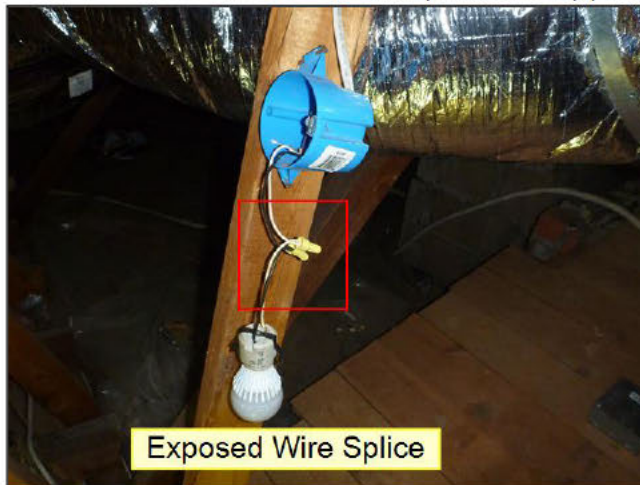
Exposed Wire Splice

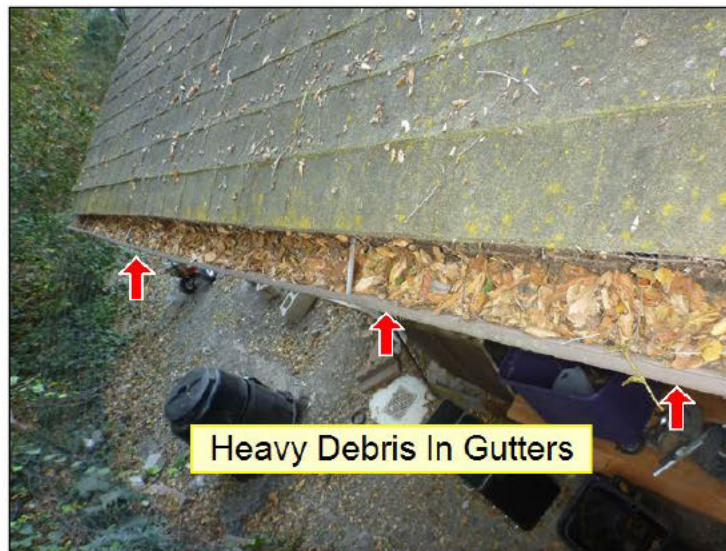
1.5 (See Picture(s))

Older/ Worn Gutters noted. Monitor condition and anticipate replacement.

Heavy leaf buildup noted in rain gutters. Suggest cleaning and flushing now and on an annual basis for proper drainage. Consider upgrade of gutter guards to prevent leaf buildup.(See Picture(s))

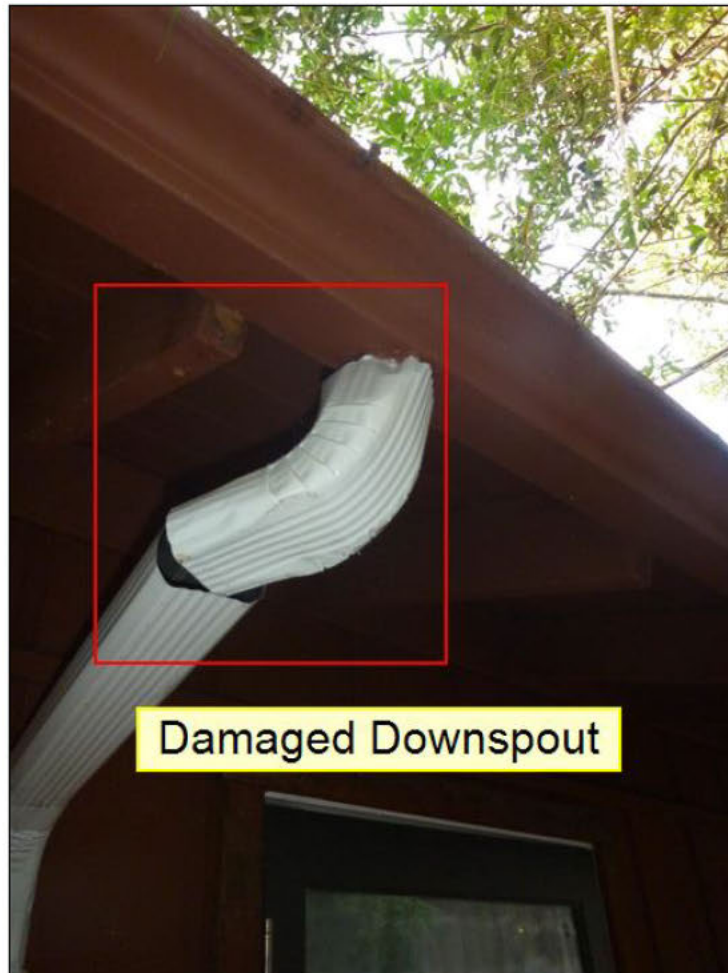
1.6 (See Picture(s))

Damage noted at downspouts. Suggest replacing and/or replacing downspout(s). Consult gutter professional.(See Picture(s))

Recommend extending rain gutter downspouts to move water away from the foundation. Downspouts near structure may allow excessive water to pond and/or penetrate into structure. Consider installing downspouts into built in drains to aide in diverting water run off. See site elements section of report and supplemental comments for additional information.

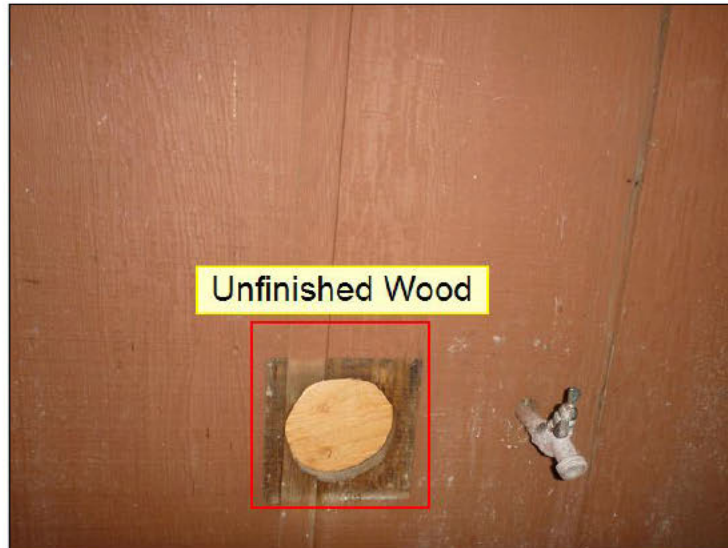
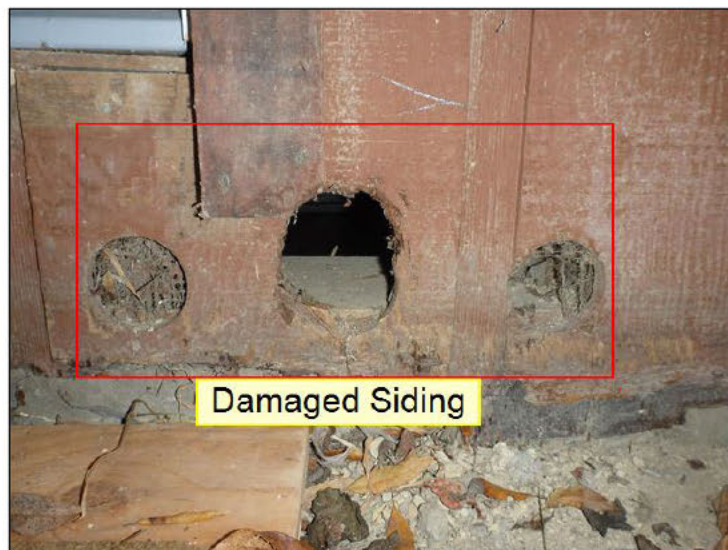
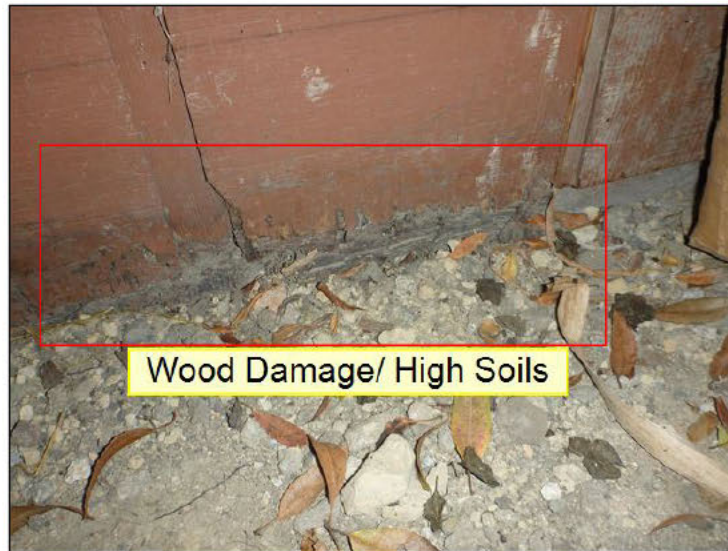
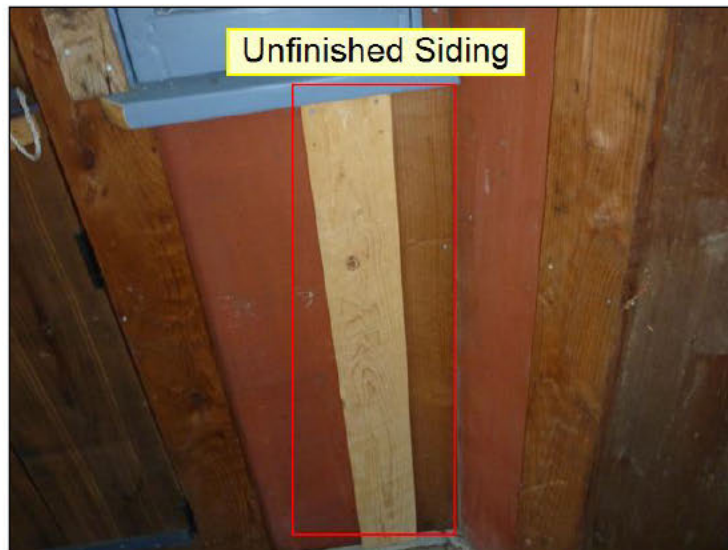
Wood damage noted at various locations of wood siding. Unfinished wood trim noted at guest unit. Missing siding noted. Consult a pest control company for evaluation/ replacement. Anticipate repairs. (See Picture(s))

Soil level is too high at several locations. Condition is conducive to wood destroying organisms, moisture damage to wood siding and penetration into structure. Suggest lowering soil and maintaining proper drainage away from structure. Siding should be a minimum of four inches away from soil. Two inches away from concrete is recommended.

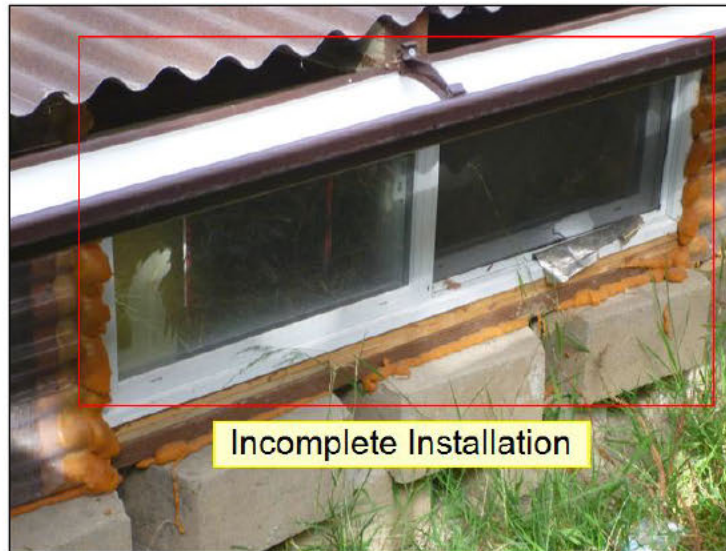
2.1 (See Picture(s))

Incomplete installation of windows noted at guest unit. Consult a contractor for evaluation/ proper installation to prevent moisture/ pest intrusion.(See Picture(s))

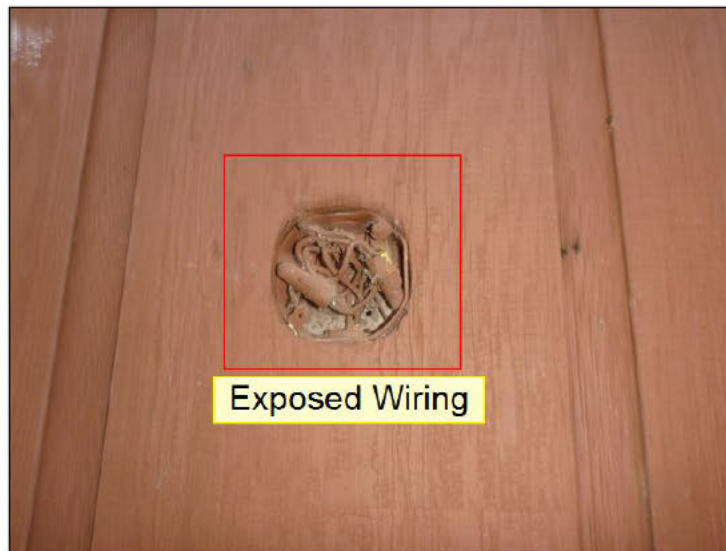
2.5 (See Picture(s))

Missing light fixtures with exposed wiring noted. Consult an electrician for evaluation/ installation of fixture/ coverplate for safety.(See Picture(s))

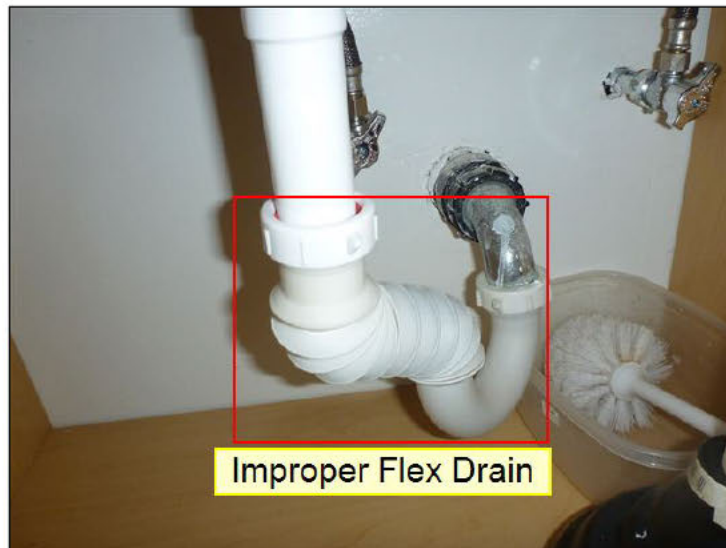
4.0 (See Picture(s))

Flexible drain piping noted under sink. This is not allowed per the plumbing codes. Suggest changing to approved drain piping.(See Picture(s))

Leak at plumbing under hall bath sink noted. Consult plumber for further evaluation and repairs.(See Picture(s))

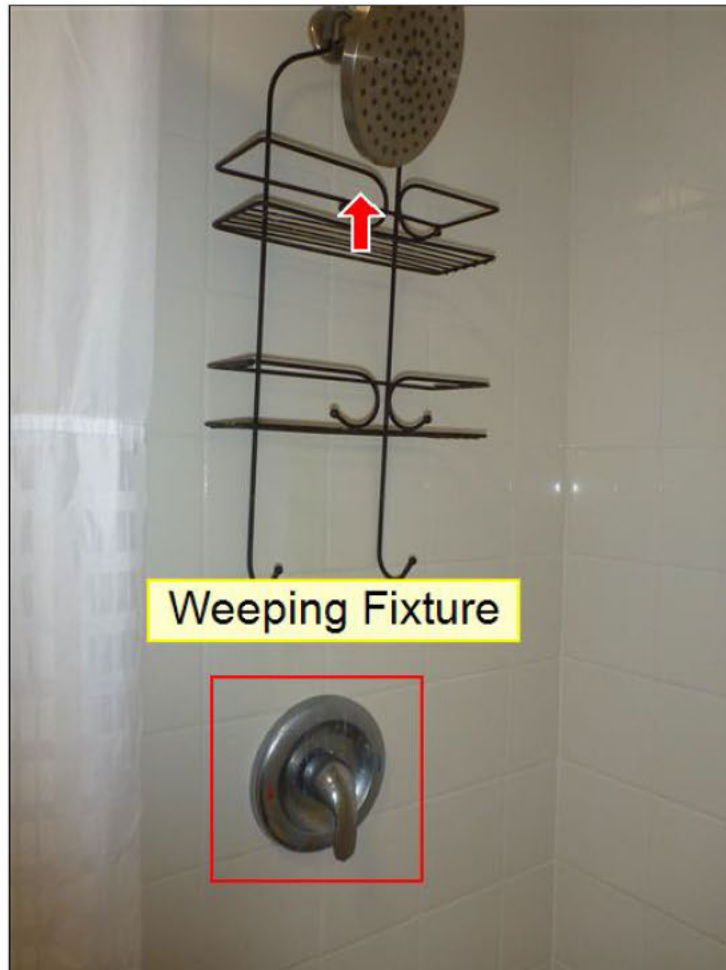
4.3 (See Picture(s))

Weeping/ Dripping shower fixture noted. Consult a plumber for evaluation/ repairs to conserve water.(See Picture(s))

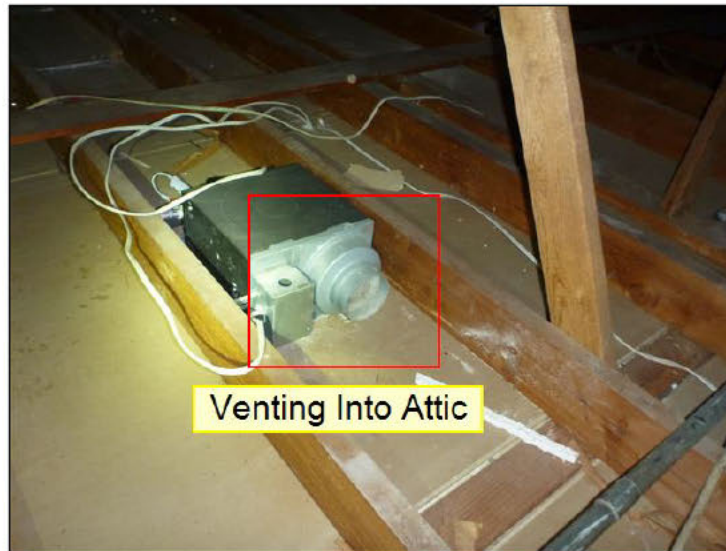
4.5 (See Picture(s))

Bathroom ceiling exhaust fan vents into attic. Suggest directing vent to an exterior location to keep moisture out of attic.(See Picture(s))

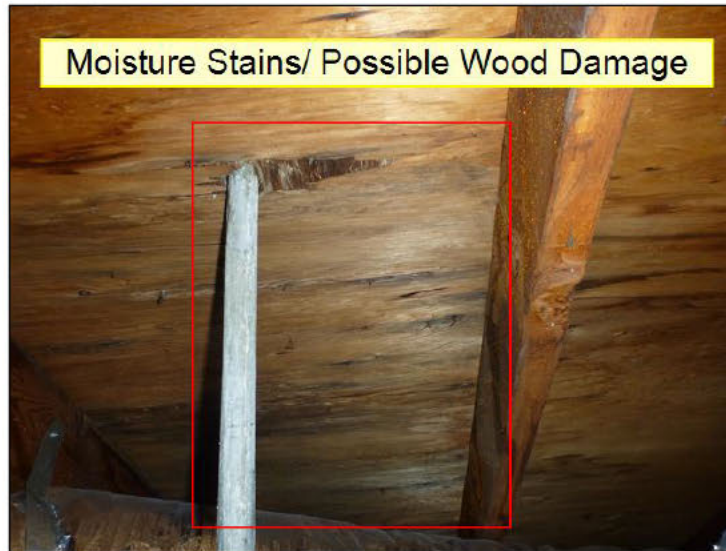
5.1 (See Picture(s))

Stains noted at framing in the attic appear to be from water leaks prior to current roof installation. See pest control report.

Evidence of possible wood destroying organisms and/or damage noted in attic. Consult pest control company to evaluate and repairs/ remediation as required. Anticipate repairs.

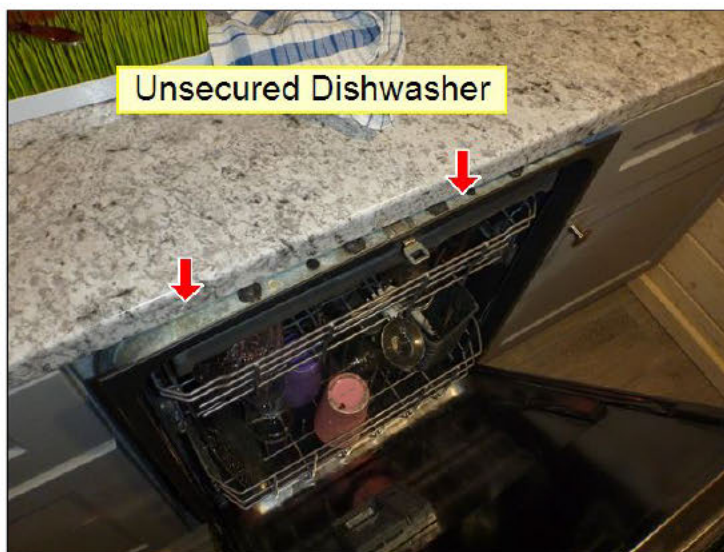
6.3 (See Picture(s))

Guest unit dishwasher is not properly secured to cabinet. Have screws installed at tabs under cabinet to properly secure dishwasher.(See Picture(s))

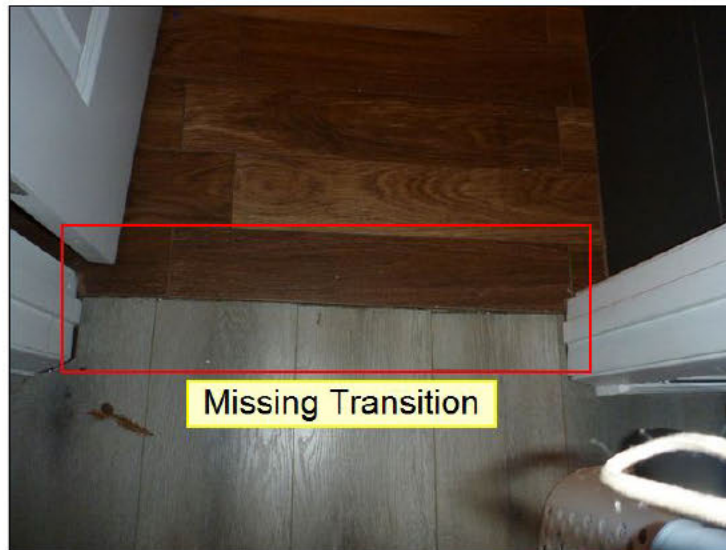
7.2 (See Picture(s))

Missing transition piece noted at master bathroom flooring noted. Consult flooring professional for evaluation and repairs. (See Picture(s))

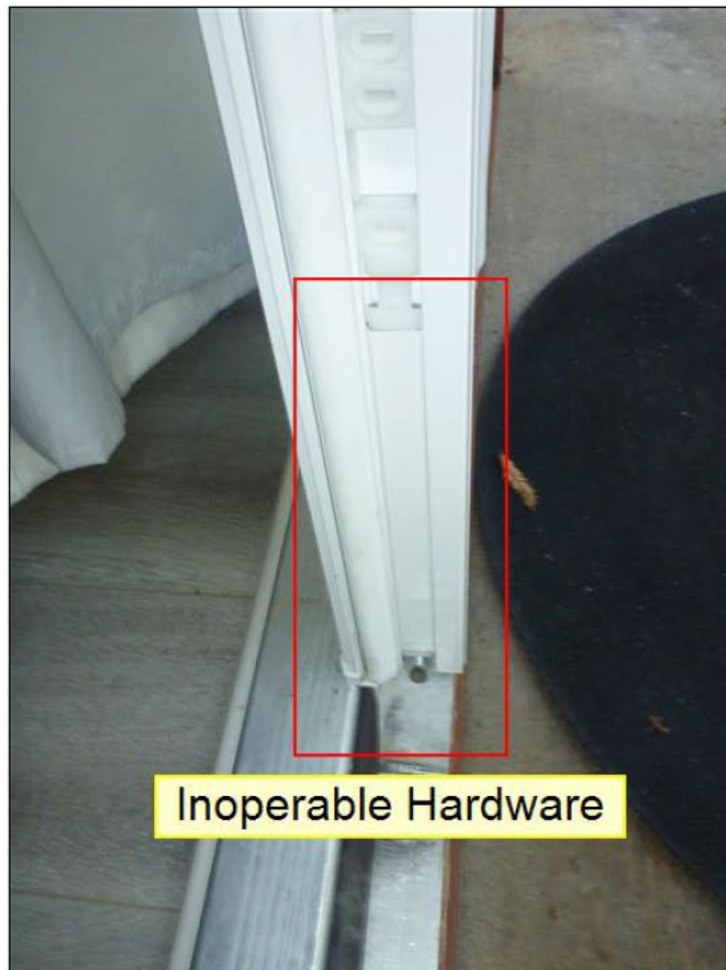
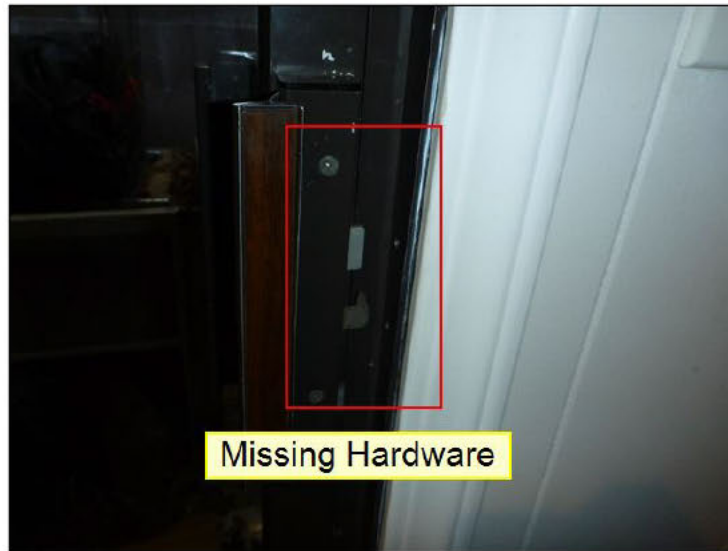
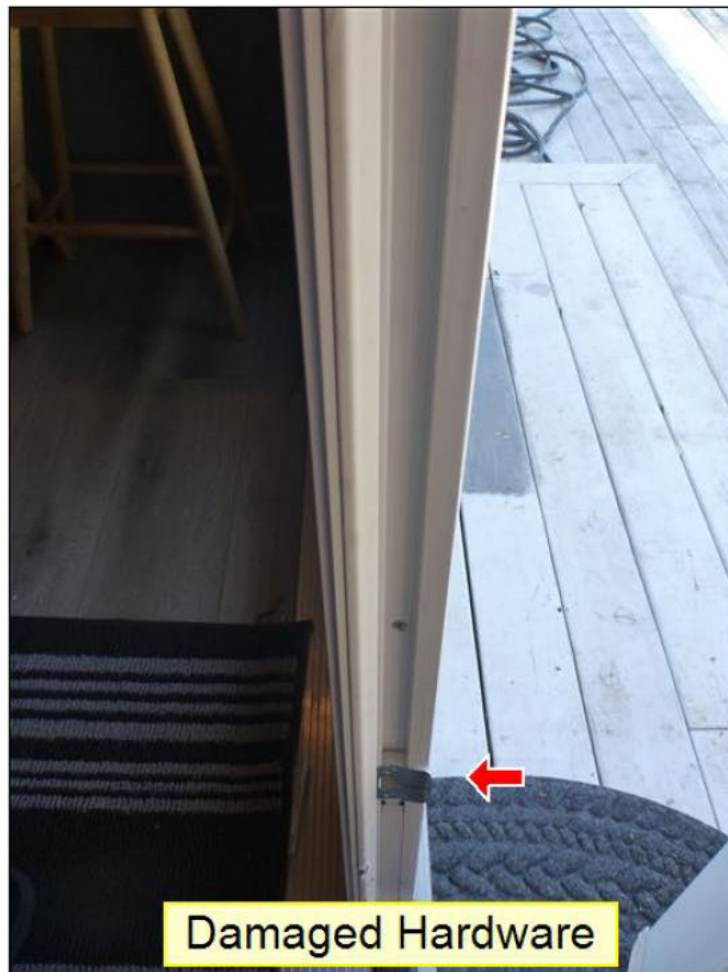
Inoperable/ damaged/ missing hardware noted at french doors/ sliding glass door. Sub-standard installation of hardware noted at various entrance doors. Consult a contractor for evaluation/ proper installation as needed.(See Picture(s))

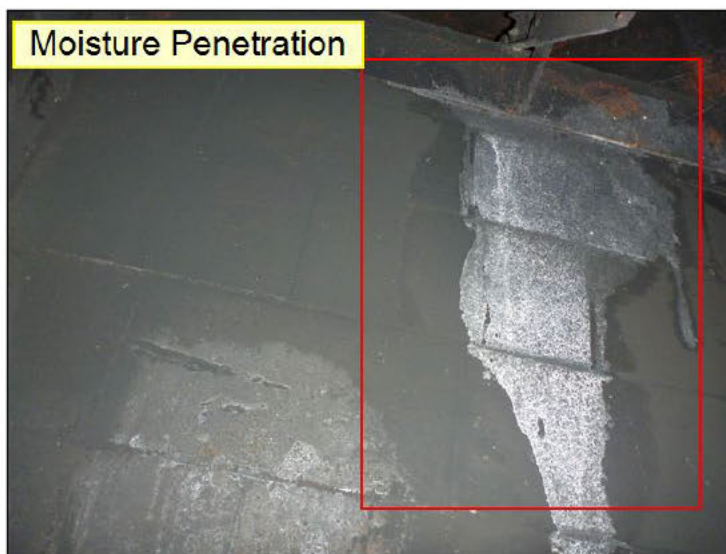
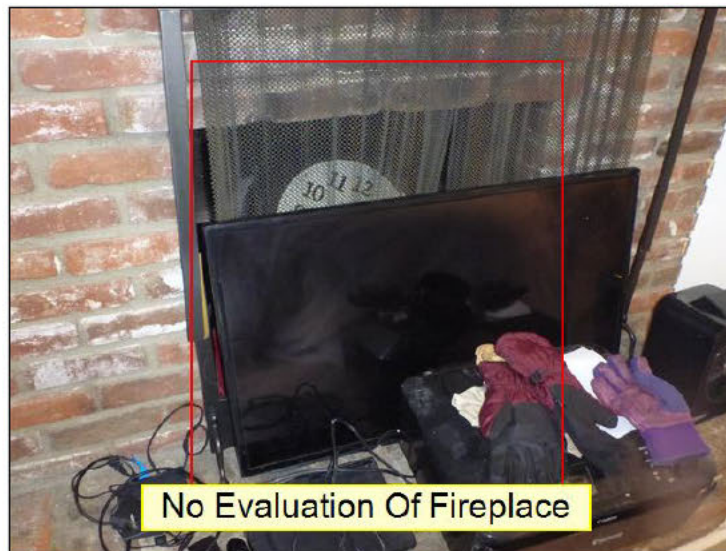
Damaged damper noted at family room fireplace noted in firebox. Damaged grate noted. Suggest repairs. Consult chimney sweep/ qualified professional for further evaluation and repairs.(See Picture(s))

Efflorescence/ signs of moisture penetration noted in fireplace. Control sprinklers/ roof drainage/ check mortar cap and rain cap and monitor condition. Repairs suggested to prevent moisture damage.(See Picture(s))

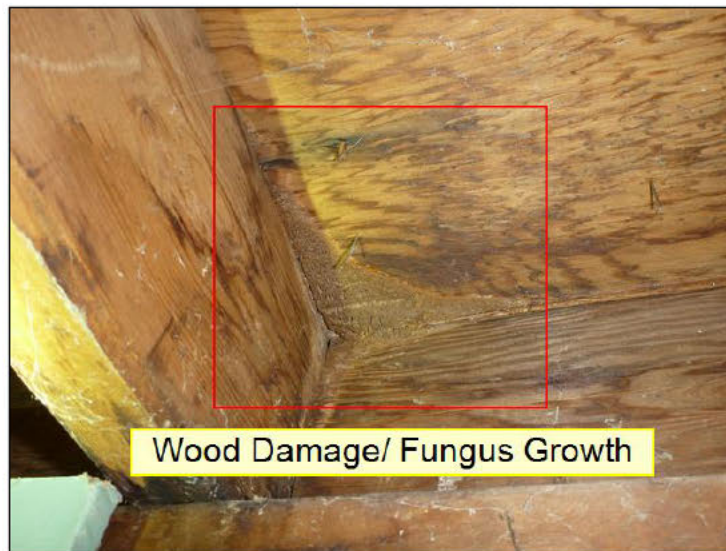
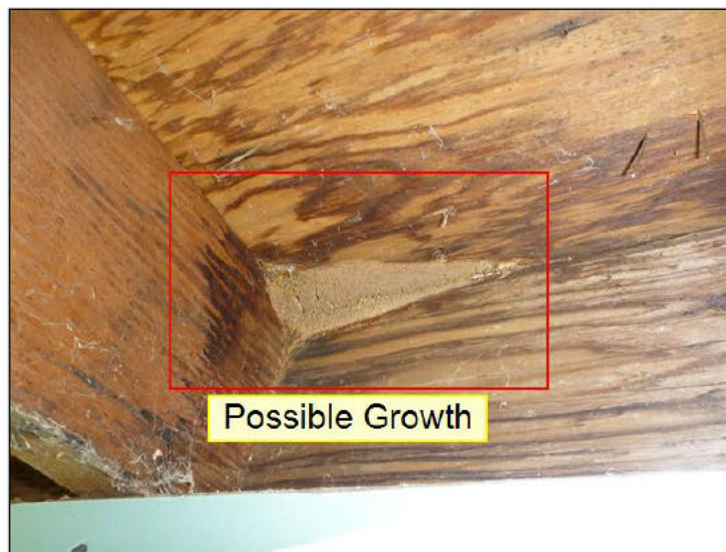
Evidence of possible wood destroying insects/ organisms and/or damage noted in crawlspace. Consult pest control company to evaluate and repairs/remediation as required.(See Picture(s))

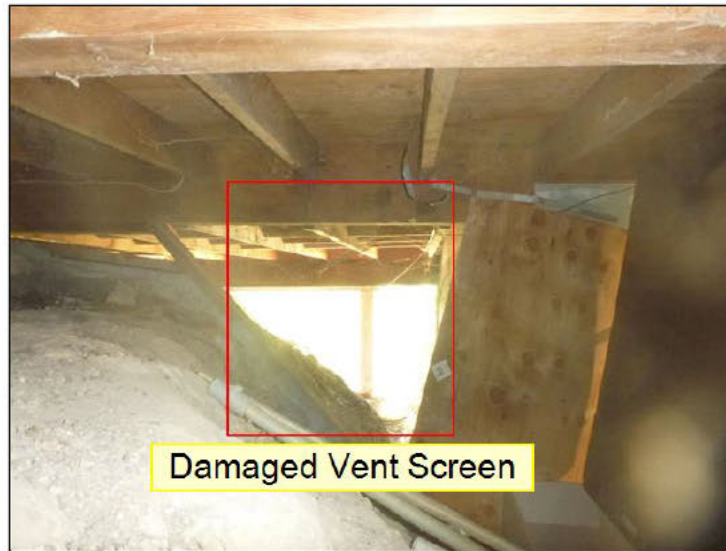
8.3 (See Picture(s))

Damaged vent screens noted. Repair/ replace screens to help keep pests and pets out of crawlspace.(See Picture(s))

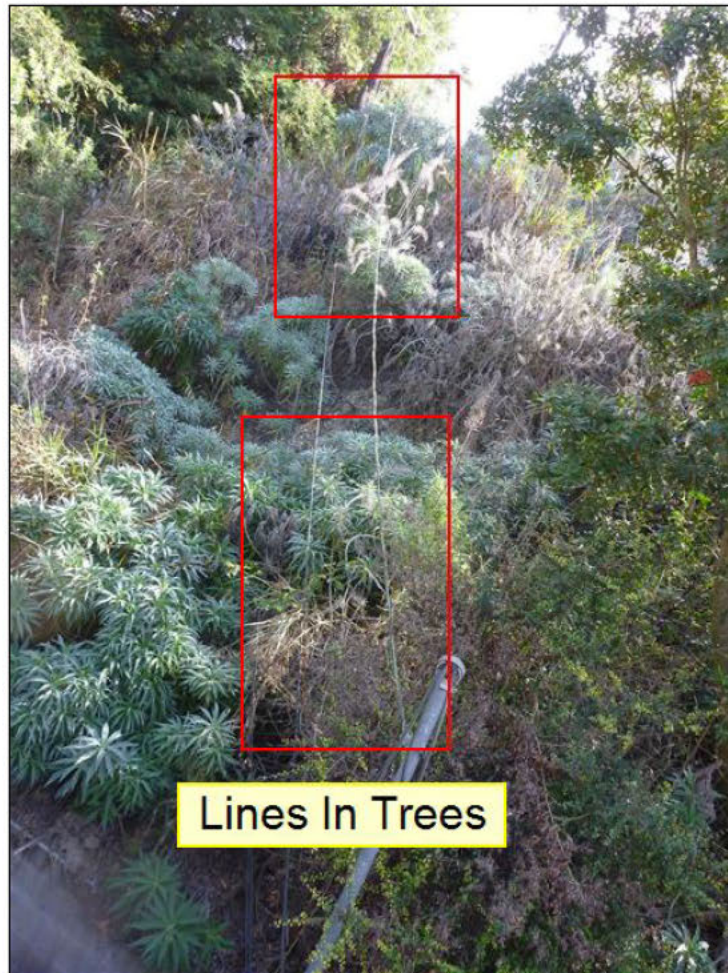
9.0 (See Picture(s))

Service wires are in tree and may be damaged by branches. Consult utility company to trim branches away from service wires to prevent damage.(See Picture(s))

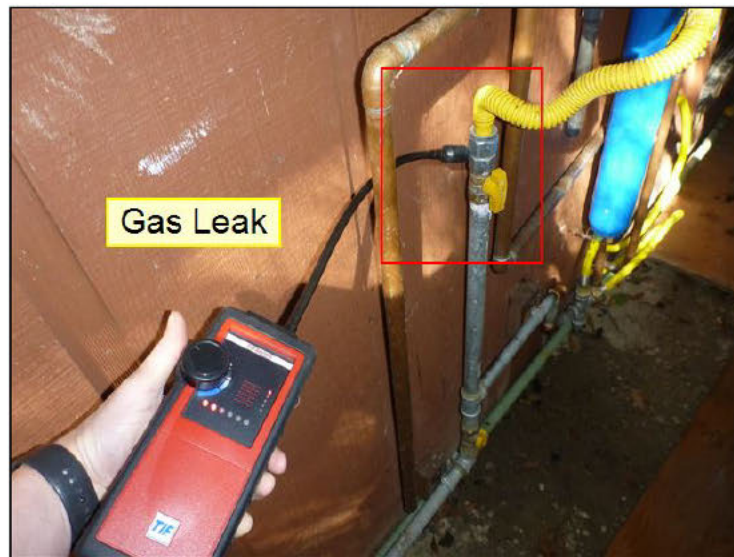
12.2 (See Picture(s))

Gas leak noted at main house water heater. Consult a plumber for evaluation/ repairs for safety prior to close of escrow.(See Picture(s))
