██████████ Winery

██████████
Santa Ynez Ca ██████████

HouseMaster

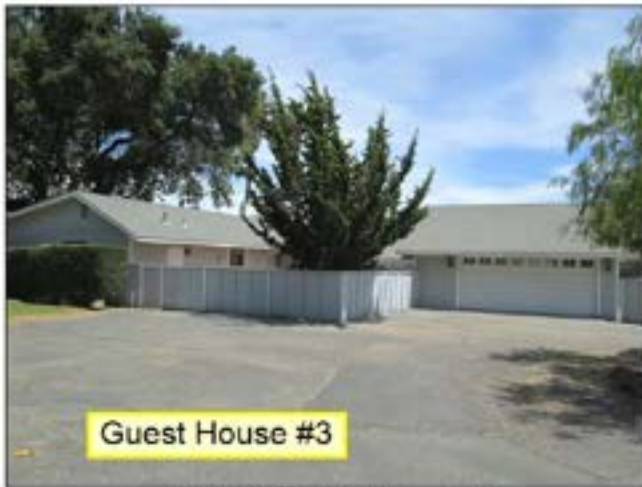
1.0.D ROOFING Picture 1

Guest House #3

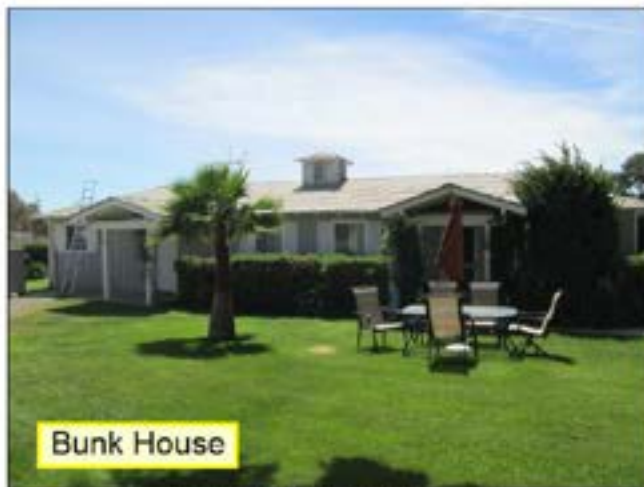
1.0.E ROOFING Picture 1

Bunk House

Loose/Broken Tiles

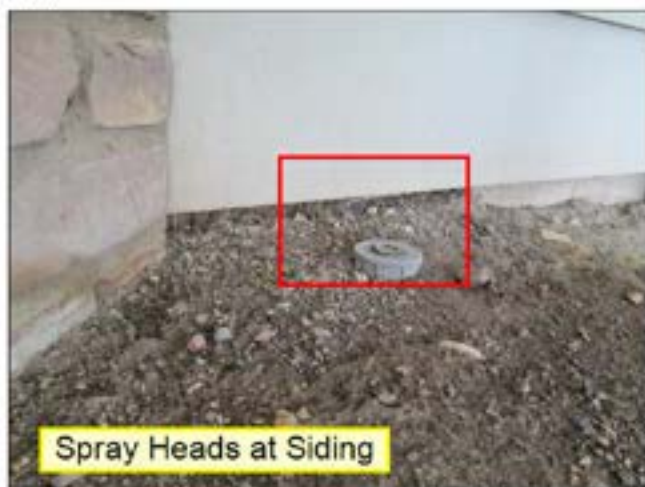
2.0 SIDING Picture 1

S	F	P	N	ANI	Findings
		●			2.0 SIDING Damaged/worn siding noted at all guest houses and bunk house. Anticipate repairs and painting. (Picture 2,3&4) See pest control report. Suggest changing all irrigation spray heads near all structures to drip style to prevent overspray on to siding and subsequent damage. (Picture 1)
		●			2.1 WINDOWS Older, worn and broken windows noted at guest houses and bunk house. Anticipate maintenance/repairs/replacement. Consult a window company for evaluation/cost estimate prior to close of escrow. Wood damage noted at trim of numerous windows. Anticipate repairs. See pest control report. (Picture 1)
		●			2.2 ENTRY DOORS Weather stripping gaps noted missing at majority of entry doors. Install weather stripping for energy savings and to prevent pest intrusion.
		●			2.3 SLAB FOUNDATION Foundation surfaces is not fully visible (slab on grade) therefore limited inspection noted. No significant cracking noted at exposed edge at the time of inspection.

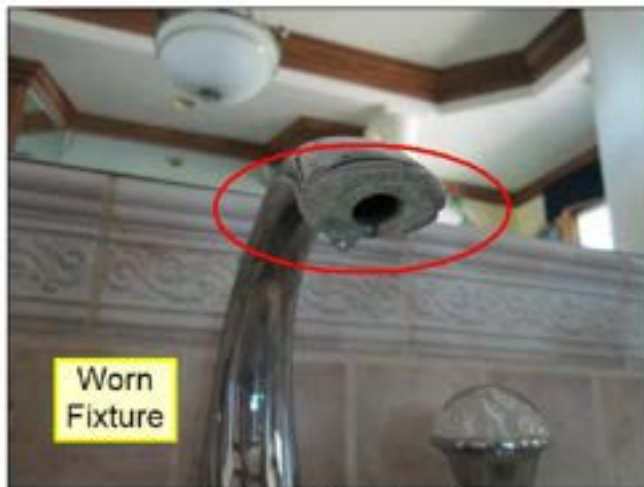
6.0 SINK(S) Picture 1

S	F	P	N	A	N	I	DESCRIPTION
•							6.0 SINK(S) Older and worn sinks and faucets noted. Anticipate repair/replacement. (Picture 1) Corrosion noted at shutoff valves beneath majority of sinks. Anticipate replacement of corroded shut off valves. (Picture 3)

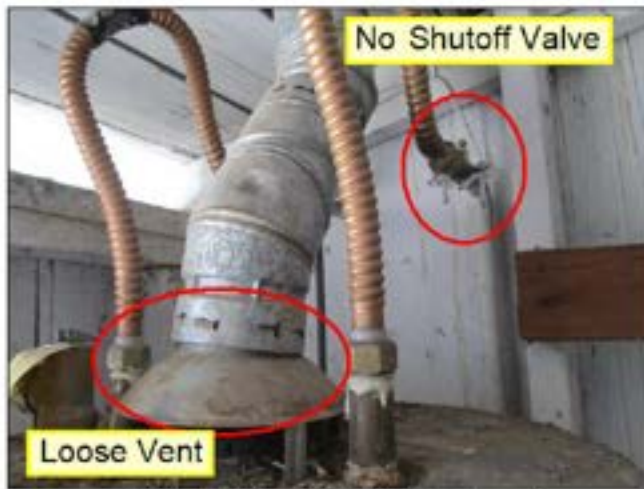
13.0.B WATER HEATER Picture 3

●										<p>13.0.B WATER HEATER</p> <p>Corrosion and rust stains noted at plumbing of water heater. (Picture 1)</p> <p>Water heater is 24 years old with a manufacturers design life of 8 - 12 years. Anticipate replacement.</p> <p>Seismic straps not installed as per California State Architect requirements. Lower strap is not installed. Consult licensed plumbing contractor for proper installation.</p> <p>Consult seller and county building department regarding permits related to laundry room addition at rear of guest house #1. (Picture 1)</p> <p>No shutoff valve and loose vent pipe at laundry room water heater. Consult a plumber for repairs. (Picture 3)</p>
●										<p>13.1.B VENT CONNECTOR</p> <p>No screws noted in vent pipe. Recommend adding 3 screws to each joint to keep vent pipe connected properly, especially during possible seismic activity. Loose and/or damaged vent pipes pose a possible safety concern. Consult plumber for repair as required for occupant safety.</p>
